Upper Barwon River Macroinvertebrate Sampling Report 2019-2023

- Final
- July 2023

Austral Research and Consulting
ABN 73 007 840 779
15 Buntings Rd
Kirkstall Vic 3283 Australia
Web: www.austral.net.au

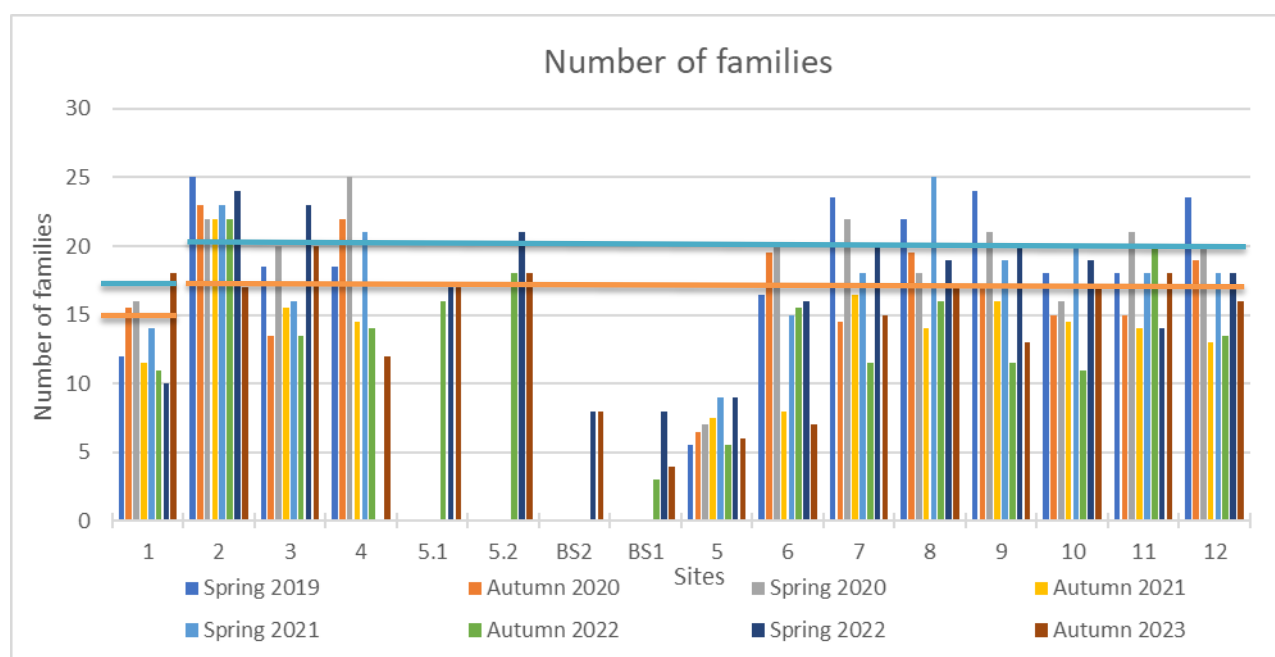
■ **Figure 2: Number of families found in edge habitats in the Barwon River and Boundary Creek. Blue line denotes Spring objective and orange line denotes Autumn objective.**

Figure 2 shows that the East Barwon River at Dewings Bridge Road (Site 2) and Boundary Creek above Big Swamp (Site 5.2) are the only sites to consistently meet the objectives for Number of Families. In addition, Sites 1, 3, 8, 10 and 11 on the Barwon River and Site 5.1 on Boundary Creek also met the Number of Families objective in Autumn 2022. There are no consistent patterns along the waterways over time but it is interesting to note that Site 1 on the Barwon River appears to be recovering from the willow removal works and the Boundary Creek sites above Big Swamp (Sites 5.1 and 5.2) have comparable numbers of families present to sites on the Barwon River. Site BS1 at the downstream edge of Big Swamp had the least number of families present in Autumn 2023.

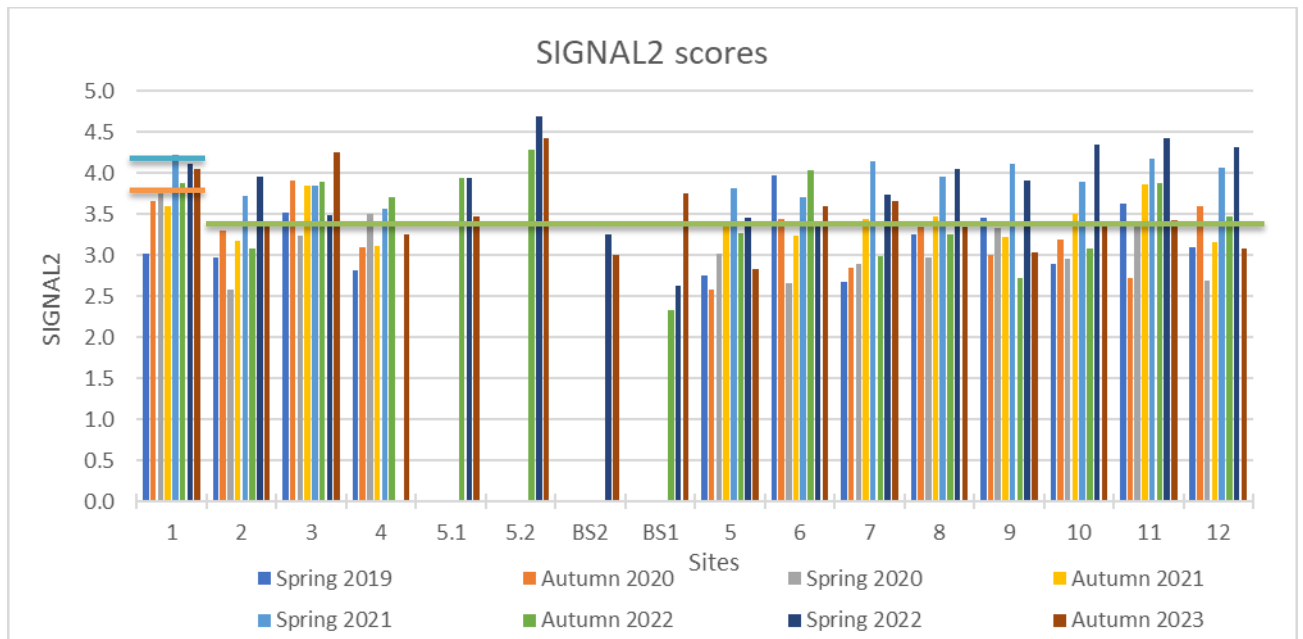
■ **Figure 3: SIGNAL2 index scores from edge habitats in the Barwon River and Boundary Creek. Blue line denotes Spring objective and orange line denotes Autumn objective for Uplands B objectives and green line denotes both Spring and Autumn objective for Central Hills and Coastal Plains objective.**

Figure 3 shows that the two new sites on Boundary Creek upstream of Big Swamp have met the objectives for SIGNAL2 on each of the three sampling occasions with Site 5.2 immediately above the swamp recording the second highest score in Autumn 2023 of all sampling events. Site 3 on the West Barwon River at Seven Bridges Road and Site 11 on the Barwon River upstream of Winchelsea have met objectives during seven of the eight sampling events.

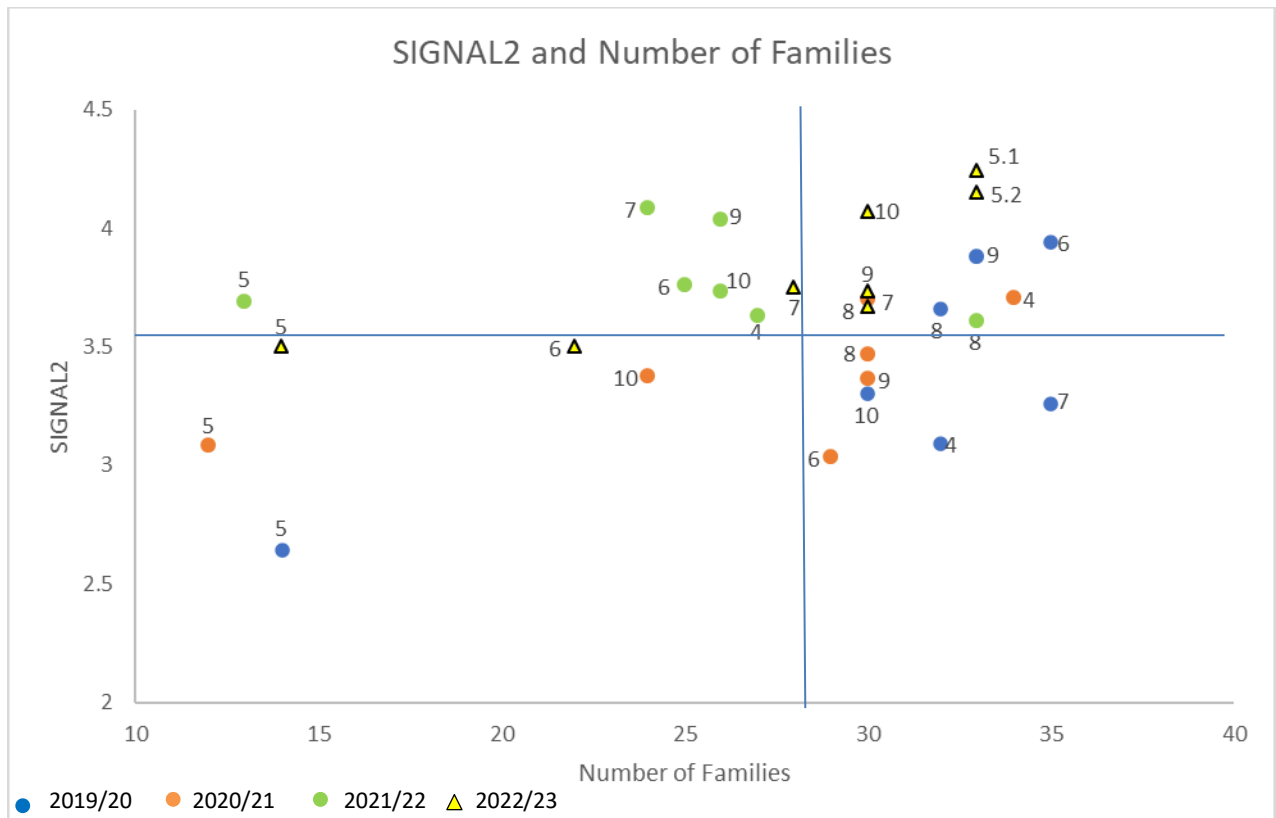
■ **Figure 4: SIGNAL2 index plotted against number of families recorded for sites 4 to 10 combined over season for four years.**

Only sites 4 to 10 have been shown in Figure 4 above as the graph was becoming increasingly difficult to interpret with the increased number of data points over the years. Site 4 in 2022/23 has not been shown as it was only sampled in one season (Autumn). Site 5 on Boundary Creek at Colac-Forrest Road continues to show improvement in the last two years compared to the first two years of sampling. Site 6 on the Barwon River immediately below the Boundary Creek confluence continues to report a fluctuation in macroinvertebrate communities, exhibiting a long-term decline over the monitoring period however this does not correlate with a corresponding decline in water quality or SIGNAL score. Site 7 was losing diversity along with Site 6 but that trend has reversed this last year. Site 8 at the Colac-Lorne Road is the most consistent with three of the four years in the top left quadrant where habitat and water quality is typically favourable. Sites 9 and 10 at Birregurra and Conns Lane both improved in the past year with Site 10 returning to the same number of families as in 2019/20 but with a higher sensitivity score.

Whilst SIGNAL2 scores give an indication of water quality in the river from which the sample was collected, combining the score with the richness score (how many different macroinvertebrate families are present), can provide an indication of the types of pollution and other physical and chemical factors that are affecting the macroinvertebrate community. This is shown in the plot in Figure 4 where quadrant boundaries are defined according to Chessman (2003) with the top right quadrant (Quadrant 1) containing the healthiest sites. As all sites are subject to human disturbance, those sites that met or were close to meeting EPA biological objectives for number of families and SIGNAL scores were included in Quadrant 1 and a cross check of which sites had the most EPT families (Figure 5) confirmed the quadrant borders using 2019/20 data.

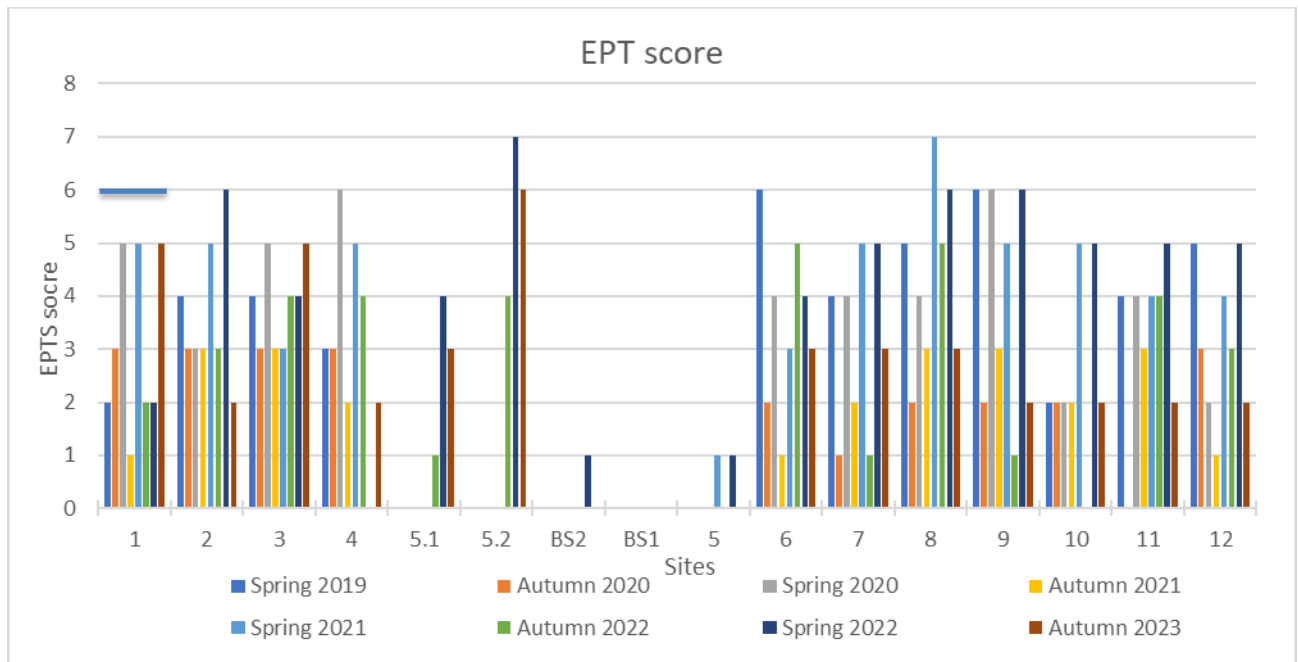
■ **Figure 5: EPT (Ephemeroptera, Plecoptera, Tricoptera families) index scores from edge habitats in the Barwon River and Boundary Creek. There is only a Spring objective for Uplands B region (blue line).**

Whilst the number of pollution sensitive taxa present (EPT score) does not have an objective for many of the sites in this study, Figure 5 shows that Site 5.2 on Boundary Creek above Big Swamp recorded the highest number of EPT taxa in 2022/23 and that sites such as Site 8 at Colac-Lorne Road and Site 9 at Birregurra have good numbers of these taxa present during most Spring sampling events.

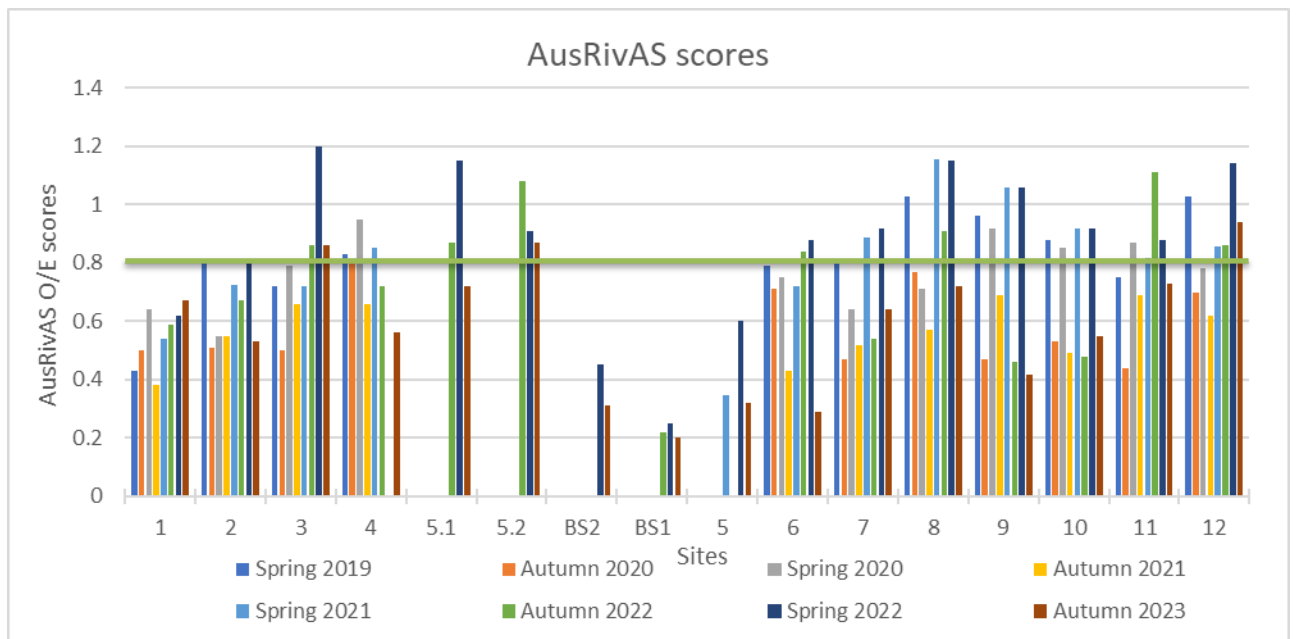
■ **Figure 6: AusRivAS observed vs expected (O/E) scores from edge habitats in the Barwon River, Boundary Creek and Big Swamp. Green line denotes both Spring and Autumn objective (Band A).**

Sites 9 (Birregurra) and 10 (Conns Lane) meet AusRivAS objectives during every Spring sampling event over the four years (Figure 6). AusRivAS objectives were met in both the latest Spring and Autumn sampling events at Site 3 (Seven Bridges Road), Site 5.2 (Boundary Creek above Big Swamp) and Site 12 (Winchelsea). Site 5 recorded its highest AusRivAS score in Spring 2022.

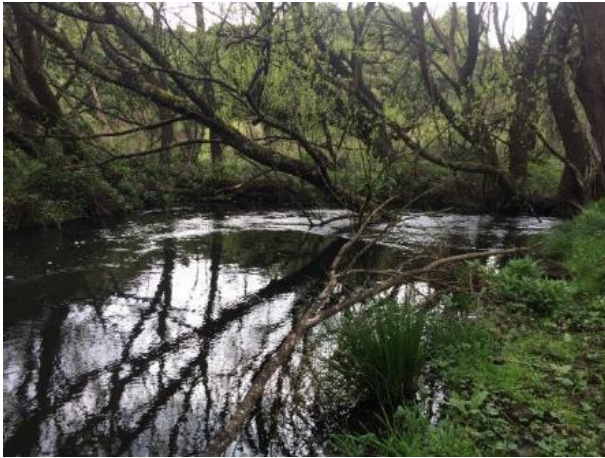
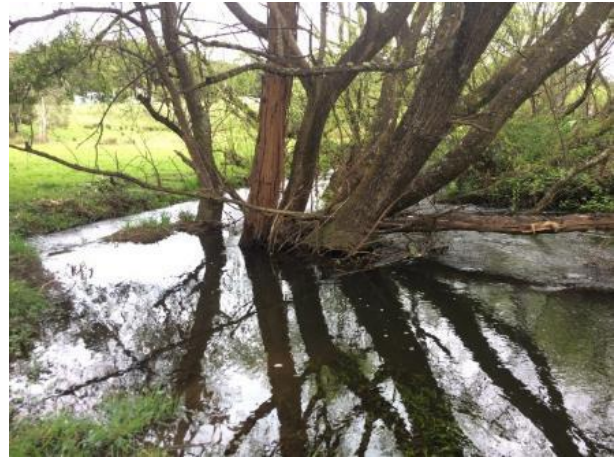
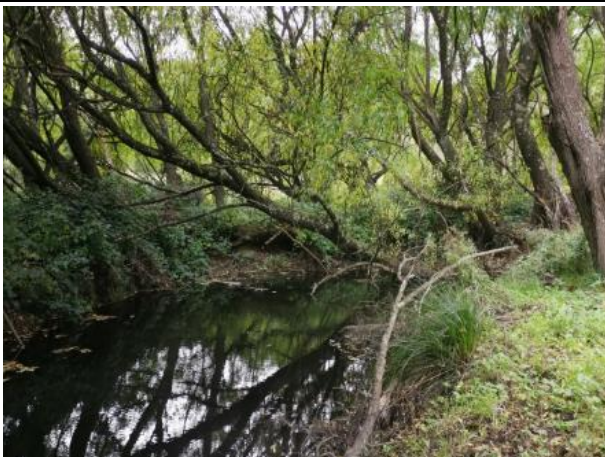
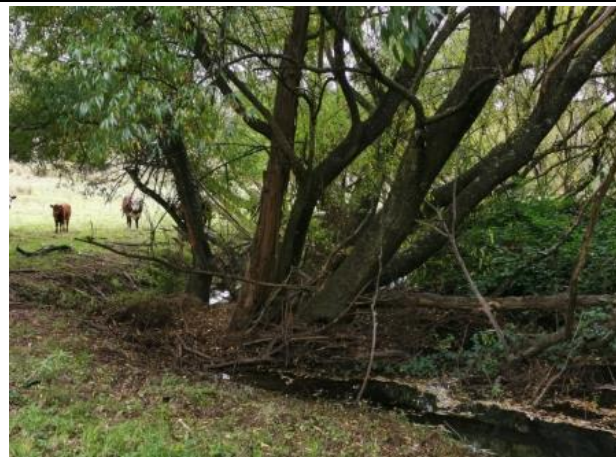
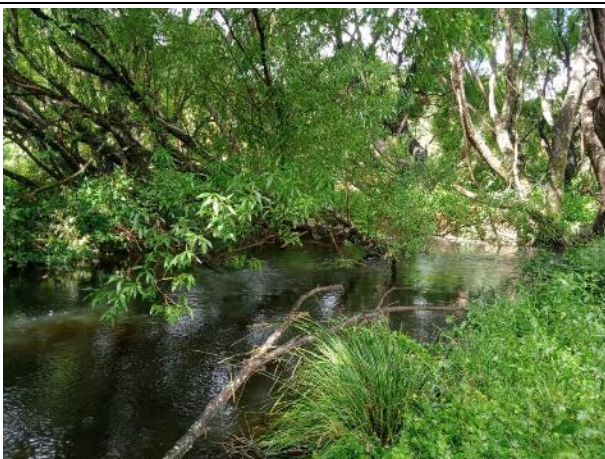
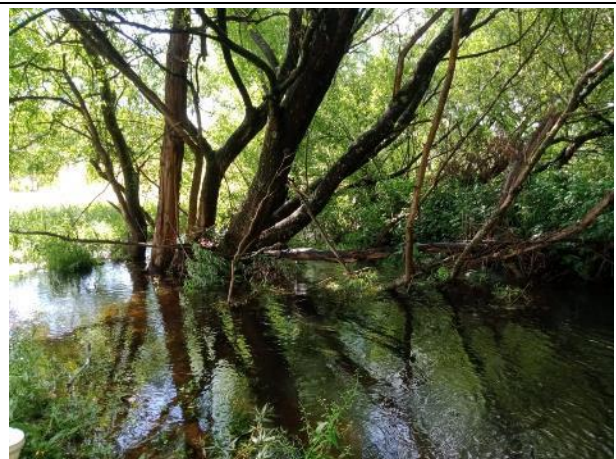
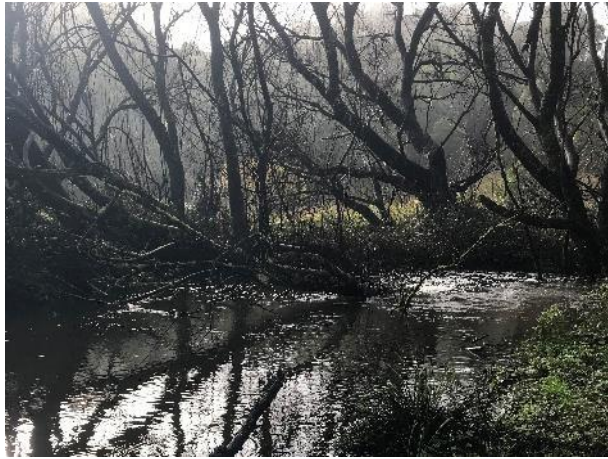
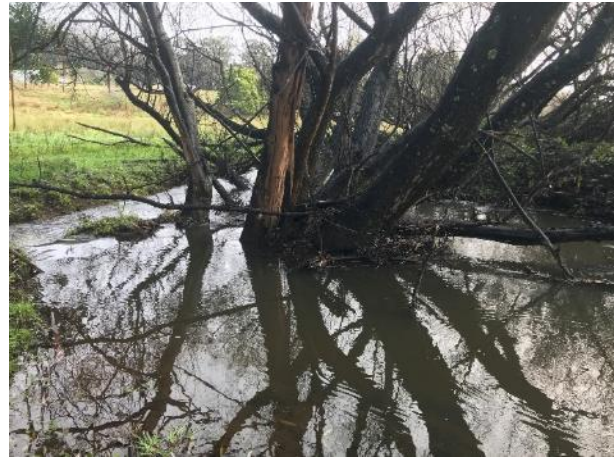
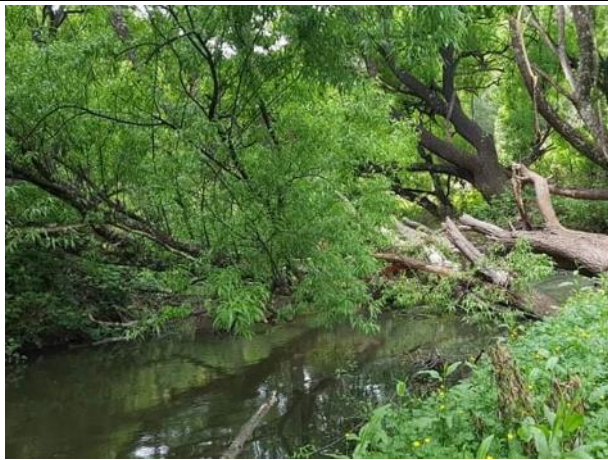
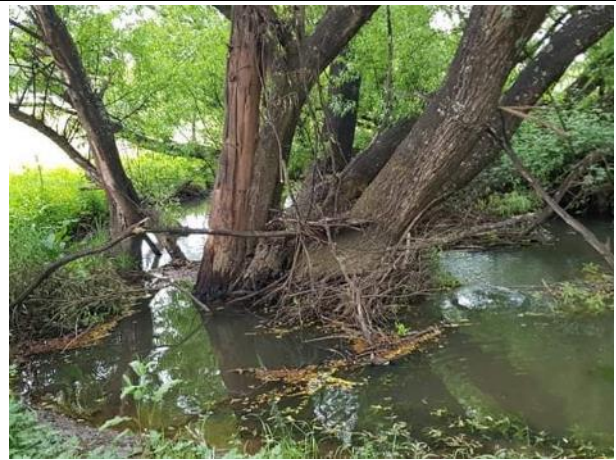
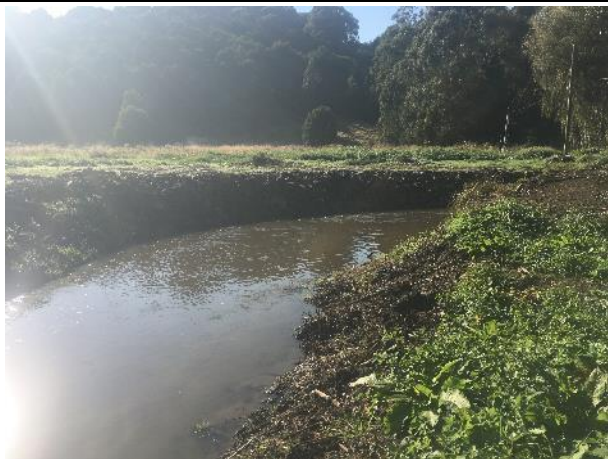
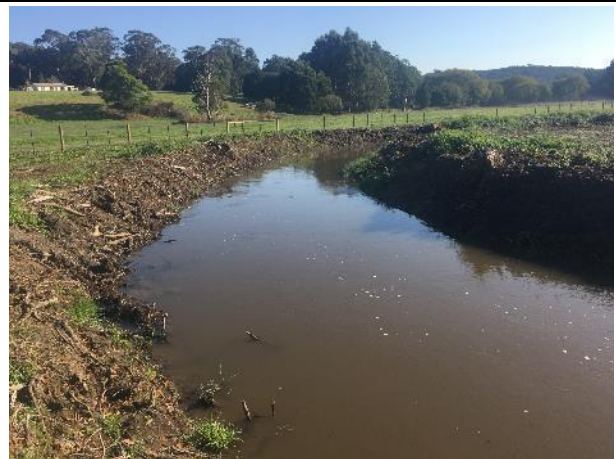
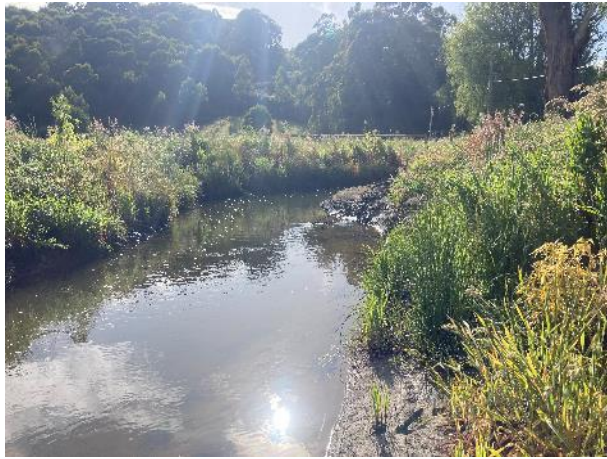
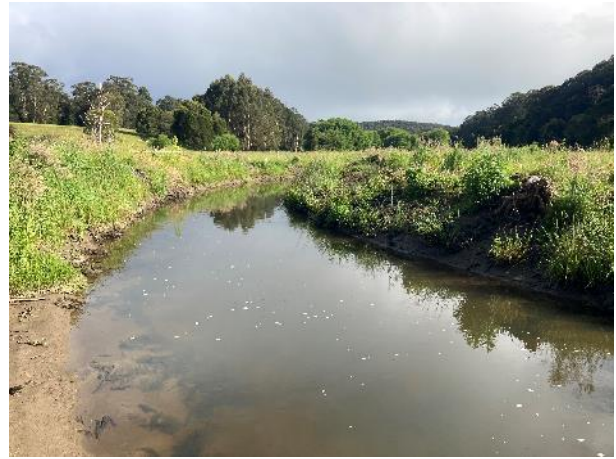
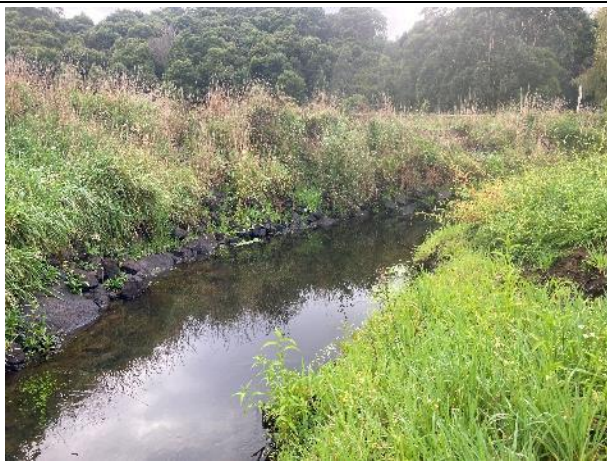
Overall analysis of the health of the waterway using EPA habitat parameters for Low Gradient Streams gives this site a score of 74 out of 140 in 2019 and a downgraded score of 57 out of 140 in 2022 due to the recent works. It is expected that this score will improve following the planned revegetation works and ongoing stock exclusion.

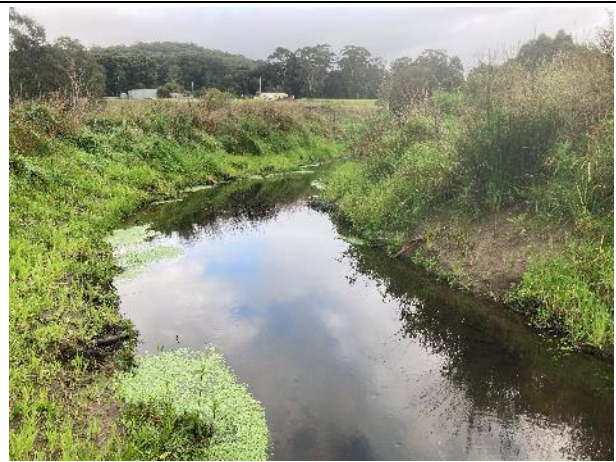
Site 1: upstream Autumn 2023

Site 1: downstream Autumn 2023

Prior to the willow removal and river realignment in early 2022, the East Barwon River at Kents Road had diverse habitat with large deep pools and some riffle/ run areas. These runs had dried to trickles in Autumn 2020 but were flowing well in Spring and Autumn 2021. The average stream width was eight meters and bank full but had contracted to five meters in Autumn 2020. Willows dominated the riparian zone and were growing within the stream channel prior to removal. The substrate was a mix of clay and silt with a number of aquatic macrophytes growing in the margins and shallow pool areas. The majority of the riparian zone was exotic vegetation, dominated by blackberries (possibly poisoned in Summer 20/21), willows and pasture grass. One larval fish has been collected as bycatch during macroinvertebrate sampling. A concurrent snapshot study by EnviroDNA (2019) found evidence of platypus at this site.

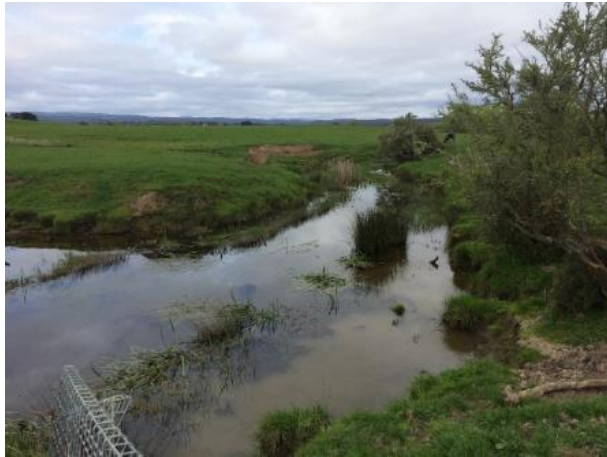
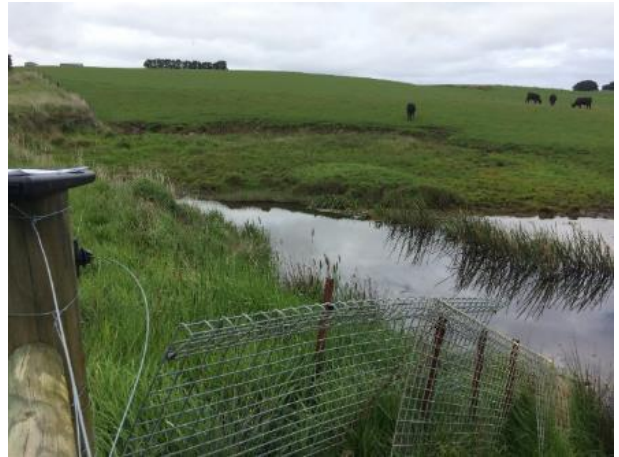
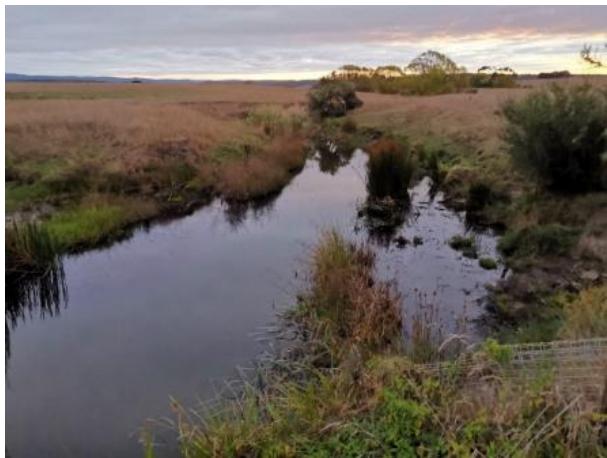
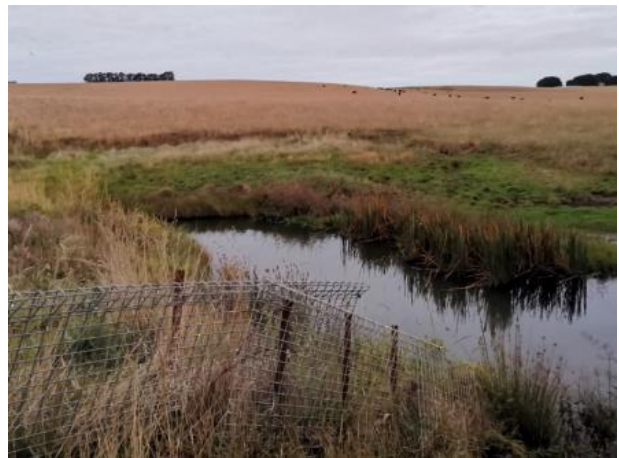
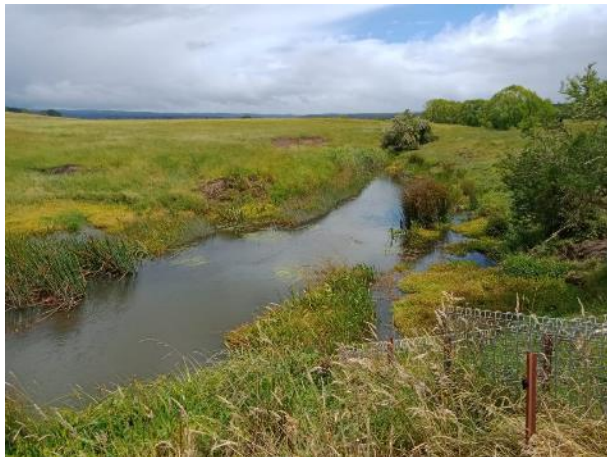
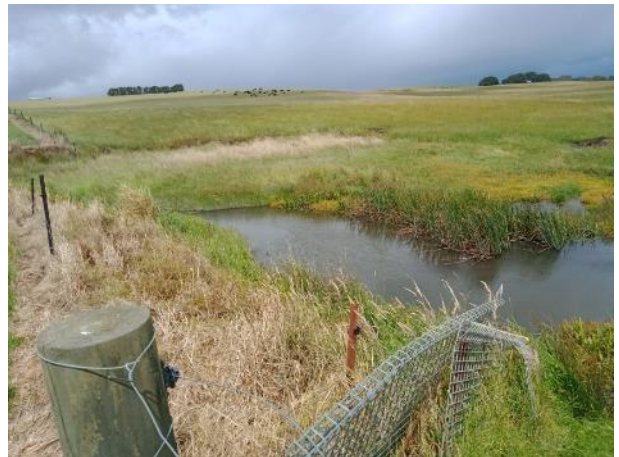
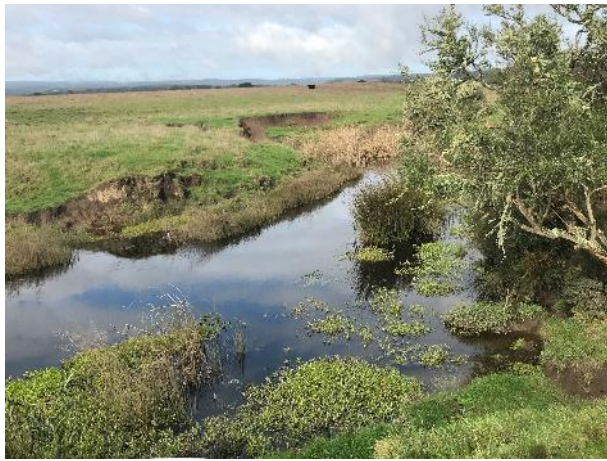
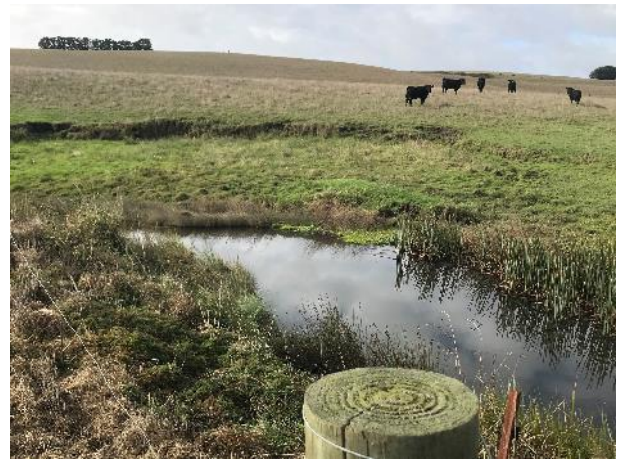
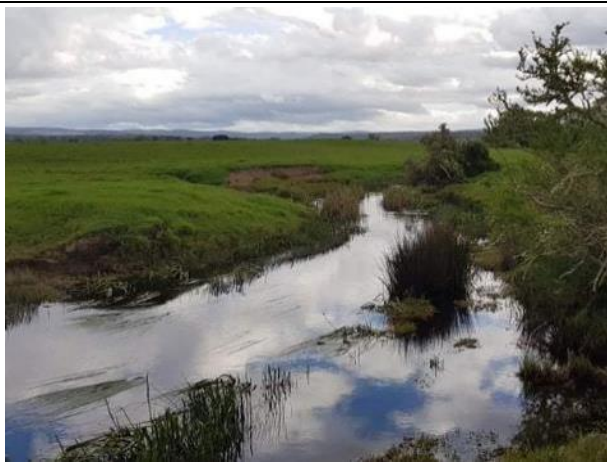
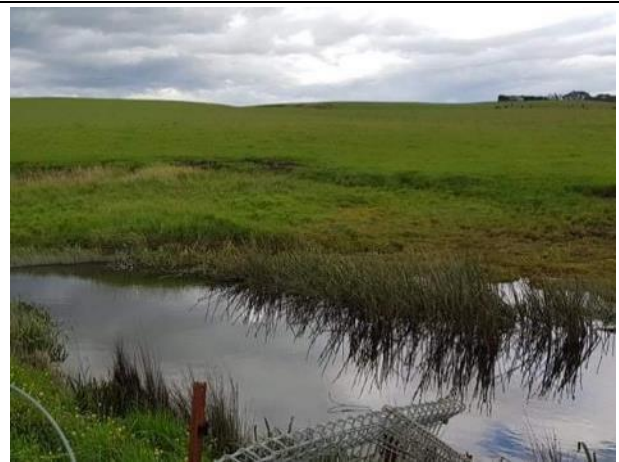
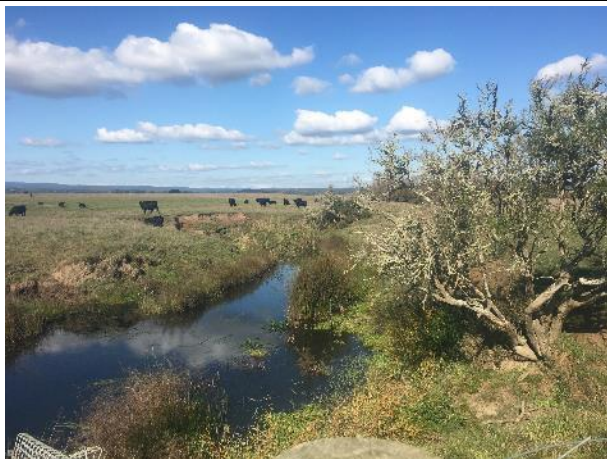
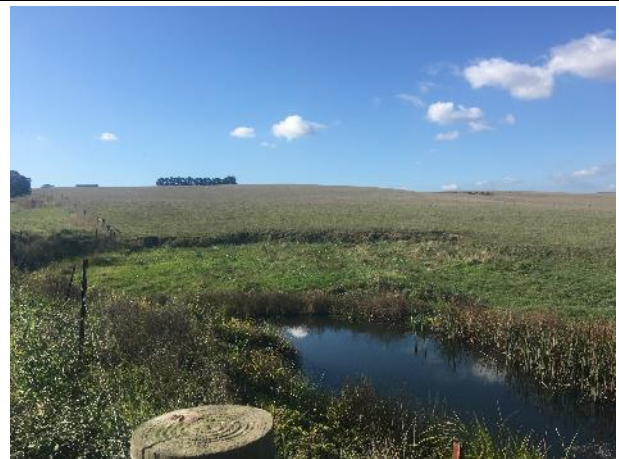
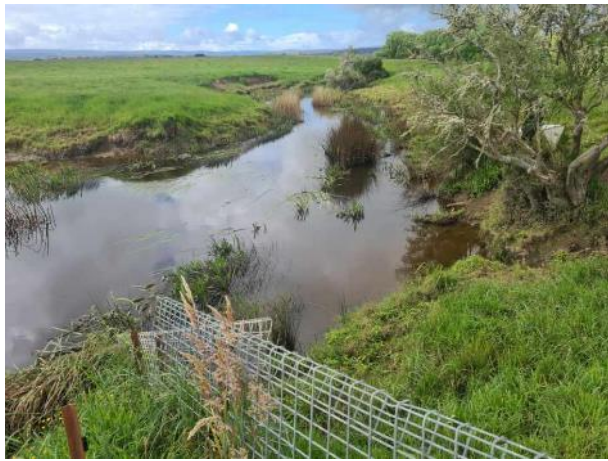
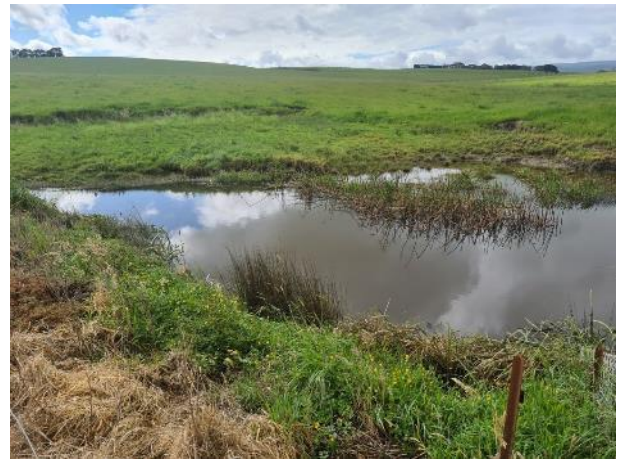
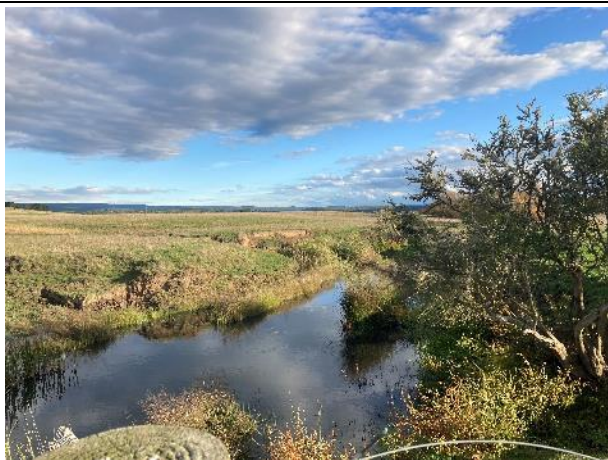
The East Barwon at Dewings Bridge Road consists of a slow flowing channel with extensive backwaters. There is very little riparian zone present but a number of submerged and emergent macrophytes provide good habitat for macroinvertebrates and fish. One larval fish was found in the sample net in Autumn 2020, three pygmy perch in Spring 2020 and a pygmy perch in Spring 2021. The substrate is a mix of clay and silt with some sand. The average stream width at this site was seven meters and was bank full during both Spring and Autumn sampling. The majority of the riparian zone is pasture grass with stock access on both sides. Overall analysis of the health of the waterway using EPA habitat parameters for Low Gradient Streams gave this site a score of 59 out of 140 and increased to 70 out of 140, primarily due to the gradual reduction in erosional scars and the increase in submerged and emergent macrophyte beds, despite the constant stock access. Removing stock access and establishing riparian vegetation will improve the health of this site significantly.

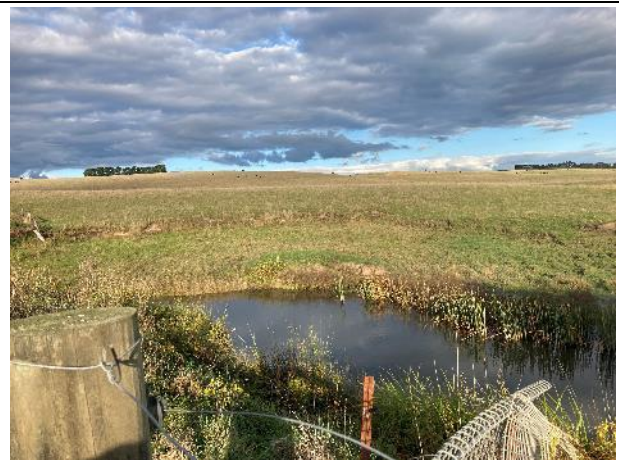
Site 2: upstream Autumn 2023

Site 2: downstream Autumn 2023

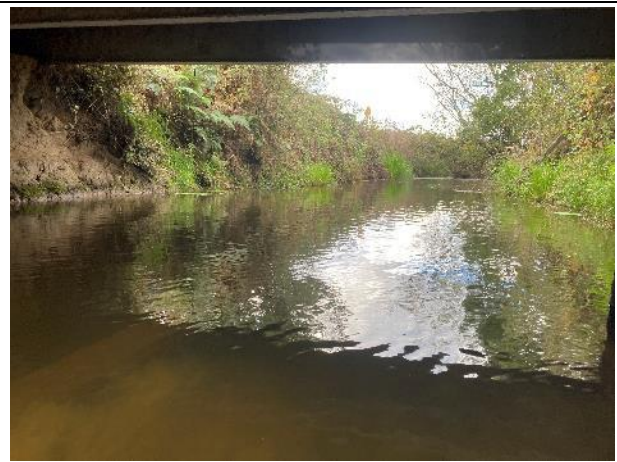
Site 3:upstream Autumn 2023

Site 3: downstream Autumn 2023

The West Barwon River at Seven Bridges Road has large deep pools with a number of backwaters. The average stream width at this site is seven meters, narrow at the top of the surveyed reach and widening into a large pool near the bridge. The substrate is clay and silt mixed with 20% sand. There are some macrophytes present along with trailing bank vegetation, roots and instream large woody debris (primarily willow branches). Willows dominate the riparian zone a mix of shrubs and native and pasture grasses in the understory. Usual access to the river was blocked in Autumn 2023 by a ground nest European Wasps, one of a number of sites that had nests. Four larval fish were collected as bycatch during macroinvertebrate sampling in Spring 2019. One mountain galaxias, one common galaxias, one pygmy perch and a laval galaxias were collected in Spring 2020 and another galaxias in Spring 2021. A number of pygmy perch were collected in Autumn 2022. A concurrent snapshot study by EnviroDNA (2019) found evidence of platypus at this site in Spring 2019. Overall analysis of the health of the waterway using EPA habitat parameters for Low Gradient Streams gave this site a score of 85 out of 140 in 2019 and this has remained steady over the three years of the study.

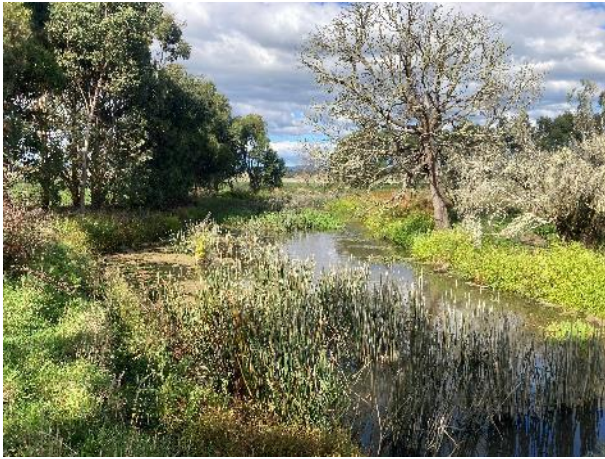
Site 4: Upstream Autumn 2023, new site

Site 4 was moved in Autumn 2023 from 100 meters upstream of the confluence with Boundary Creek to 50 meters upstream of the confluence and sampled from the opposite site. The primary difference is that the Barwon River is narrower at this point and has larger beds of *Juncus*. The Barwon River 50-100 meters upstream of the Boundary Creek confluence is a large slow flowing channel with shallow side sections that support a number of macrophyte beds. The average stream width at this site is nine meters. The substrate is clay and black silt with some large woody debris and filamentous algae present in addition to the macrophytes. *Juncus*, *Typha*, *Triglochin* and *Polygonum* species are all present instream though riparian vegetation is limited to some isolated trees, a narrow native plantation and pasture grass with stock access. The introduced *Gambusia* (mosquito fish) were collected as bycatch during macroinvertebrate sampling in Spring 2019, Autumn 2021 and Autumn 2022 and a pygmy perch sampled in Spring 2021. Overall analysis of the health of the waterway using EPA habitat parameters for Low Gradient Streams gave this site a score of 79 out of 140 in 2019 and an increased score of 99 due to the establishment of more aquatic macrophytes and healed erosion. Fencing and revegetation of the left side of the river to a similar standard as the right side would see further improvements to the health of the river.

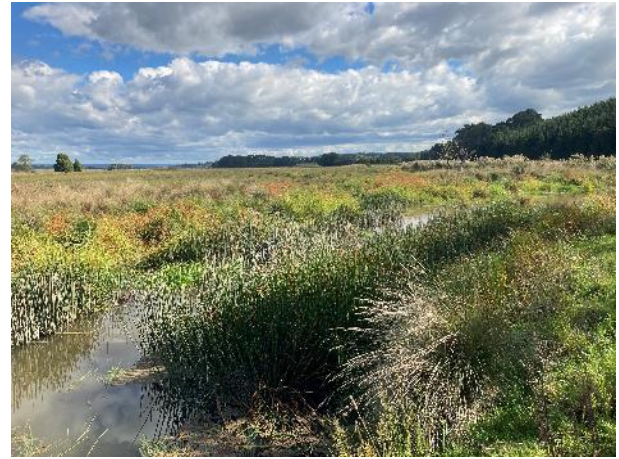
Site 4: downstream Autumn 2023, new site

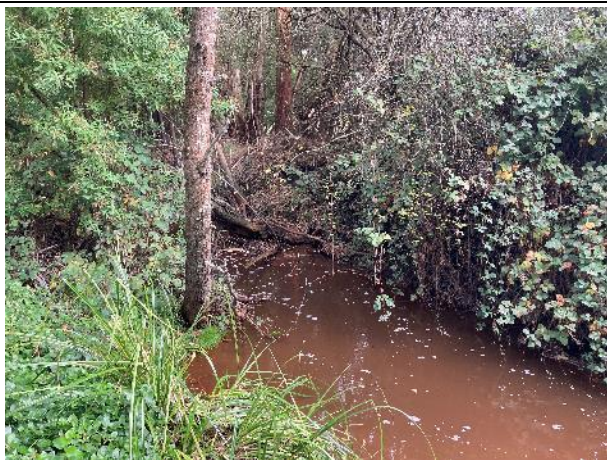
Site 5: upstream Autumn 2023

Boundary Creek at Colac- Forrest Road has a mix of large deep pools, a large shallow pool at the bridge and shallow runs. It has been bank full with an average stream width of four meters, narrow at the top of the surveyed reach and widening into a large pool upstream of the bridge during each sampling event excepting during Autumn 2020 sampling when the creek had contracted to a pool approximately 4 meters long by 2.5 meters wide. During this time the pooled water was stagnant, with low oxygen concentrations and very high turbidity. The substrate is a mix of cobble, pebble, gravel, sand, clay and silt. There are no macrophytes but there was some filamentous algae in Spring 2019, (absent since) and trailing bank vegetation present. Foam was present at the top of the reach in Spring 2020, Autumn 2021, Spring 2021, Autumn 2022 and Spring 2022. The riparian zone is wide and a mix of native and exotic vegetation except the ground cover which is dominated by *Convolvulus* sp. which has taken over the pasture grass. Overall analysis of the health of the waterway using EPA habitat parameters for Low Gradient Streams has remained steady at 81 out of 140 between 2019 and 2022 and is likely to remain so until conditions allow aquatic vegetation to establish and the riparian vegetation is improved.

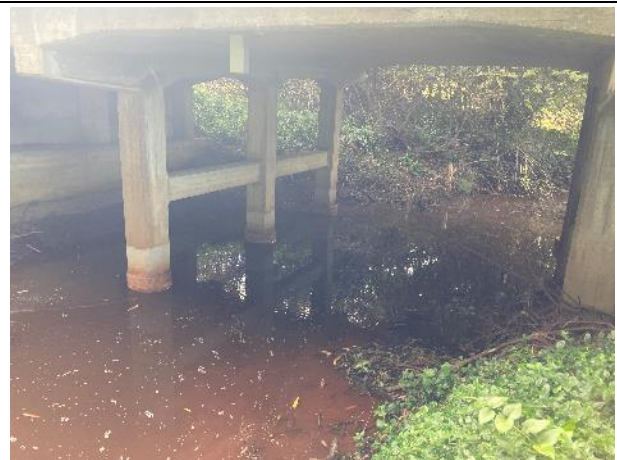
Site 5: downstream Autumn 2023

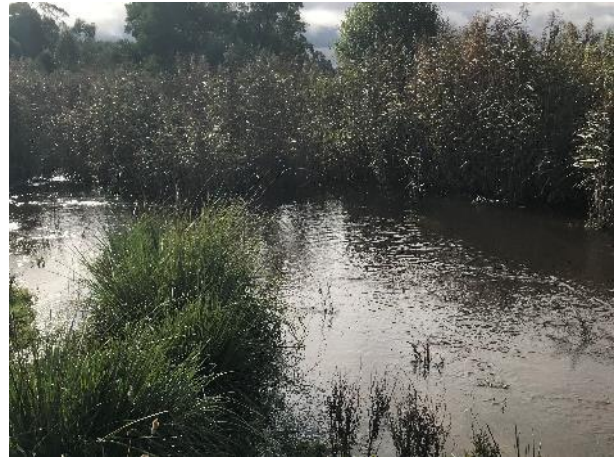
Site 6: upstream Autumn 2021

The Barwon River 100 meters downstream of the Boundary Creek confluence is a narrow deep channel with wide shallow edges dominated by grasses and aquatic macrophytes. The average stream width at this site is five meters and was bank full in Spring 2019, Spring 2020, Autumn 2021 and Spring 2021 and had contracted to a narrow (1-2 meter) channel in Autumn 2020 and Autumn 2022. There is a narrow channel at the top of the surveyed reach, narrowing to a confined channel downstream. The river had contracted to the main channel but remained flowing, leaving the fringes to dry out in Autumn 2020 and Autumn 2022. The substrate consists of clay and silt usually with filamentous algae tangled through the macrophyte beds but in Autumn 2021 and Spring 2021 the macrophyte beds were covered in a smothering floc that was easily disturbed, forming a thick plume. This plume appeared to be absent in Autumn 2022 but this could have been due to the absence of slow flowing areas where floc would be able to settle. The iron floc was back in Autumn 2023, smothering most of the instream habitat. Macrophyte species are varied with *Triglochin*, *Polygonum*, *Phragmites*, and *Juncus* species all present in addition to trailing grasses. Four different fish species have been collected at this site as bycatch; southern pygmy perch, smelt and a galaxid in Autumn 2020, gambusia and southern pygmy perch in Spring 2020. The riparian zone is limited to grasses and scattered native trees and shrubs with stock access to the site. Overall analysis of the health of the waterway using EPA habitat parameters for Low Gradient Streams gave this site a score of 70 out of 140 in 2019 and a very similar score of 71 in 2022. As with all sites that have unrestricted stock access, the health of this site would be improved by fencing and revegetating the river on both sides.

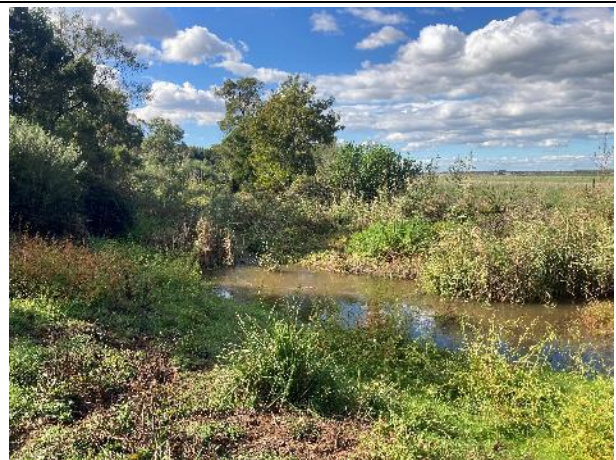
Site 6: upstream Autumn 2023

Site 6: downstream Autumn 2023

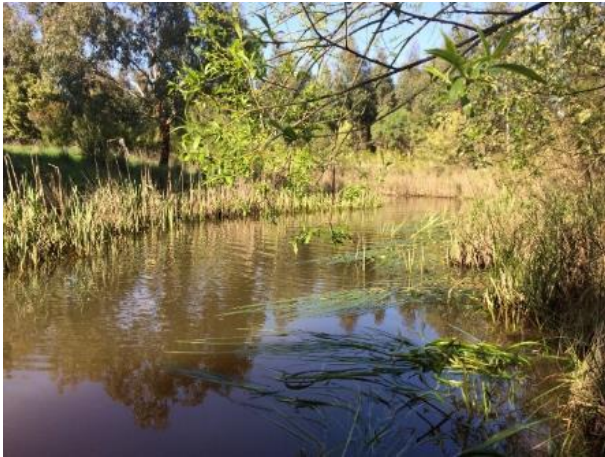
Site 7: upstream Spring 2019

The Barwon River adjacent to the northern boundary of the pine plantation has a large deep channel with any shallow areas dominated by beds of *Phragmites*. The average stream width at this site is seven meters. The substrate is clay and silt. In addition to the *Phragmites* beds there are beds of *Triglochin*, and scattered *Polygonum*, *Juncus* and other grasses. The riparian zone has a good mix of trees, shrubs and understory with a majority of native trees and shrubs. Overall analysis of the health of the waterway using EPA habitat parameters for Low Gradient Streams gave this site a score of 90 out of 140 in 2019 and increased to 104 in 2022 primarily due to continued improvements in riparian and instream macrophyte condition.

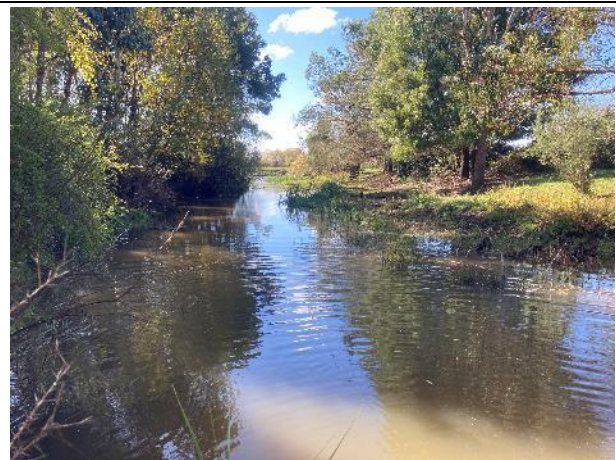
Site 7: upstream Autumn 2023

Site 7: downstream Autumn 2023

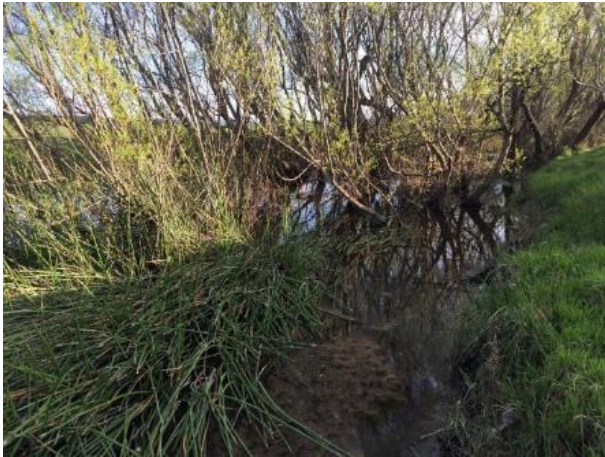
Site 8: upstream Spring 2019

The Barwon River at Colac- Lorne Road has large deep pools with a shallow areas at the sides and willow trees growing in the channel with some substrate exposed when the river level is low. The average stream width at this site is eight meters with a predominantly clay and silt substrate mixed with some sand. There are beds of *Triglochin* and *Phragmites* in addition to trailing grasses and large willows. The riparian zone consists of willow trees, pasture grasses and blackberries and allows stock access. Overall analysis of the health of the waterway using EPA habitat parameters for Low Gradient Streams gives this site a score of 69 out of 140 in 2019 and a similar score of 73 in 2022.

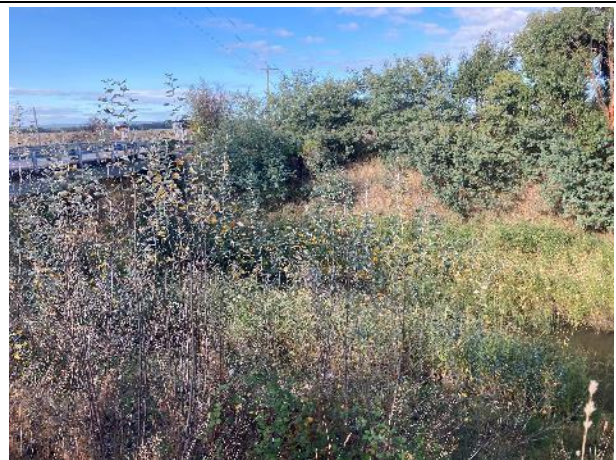
Site 10: upstream Autumn 2023

Site 10: downstream Autumn 2023

The Barwon River at Conns Lane has large deep pools with some small deep backwaters and a narrow deep run at the top of the reach. The average stream width at this site is six meters. The substrate is clay and silt mixed with some sand and gravel. *Phragmites* beds line the channel and there are isolated patches of *Triglochin* in addition to *Polygonum* and trailing grasses along the waters edge. The trailing and shallow vegetation contained filamentous algae in Autumn 2021, 2022 and 2023. Larval fish and gambusia were collected in the macroinvertebrate net in Spring 2020 and gambusia were plentiful in Autumn 2021 though not in Spring 2021. The riparian zone consists of a native revegetation project that is more successful on the right side than the left. Exotic trees are re-establishing on the left side and pasture grass dominates. Overall analysis of the health of the waterway using EPA habitat parameters for Low Gradient Streams gave this site a score of 98 out of 140 in 2019 and a similar score of 101 in 2022.

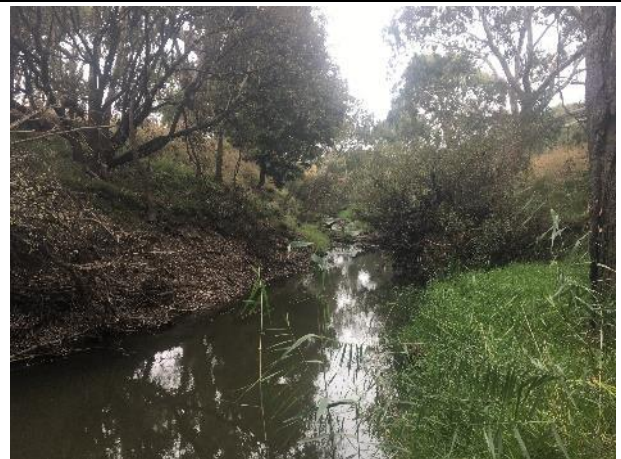
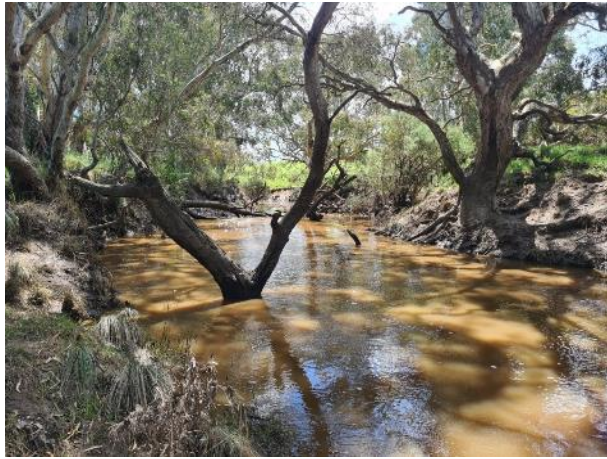
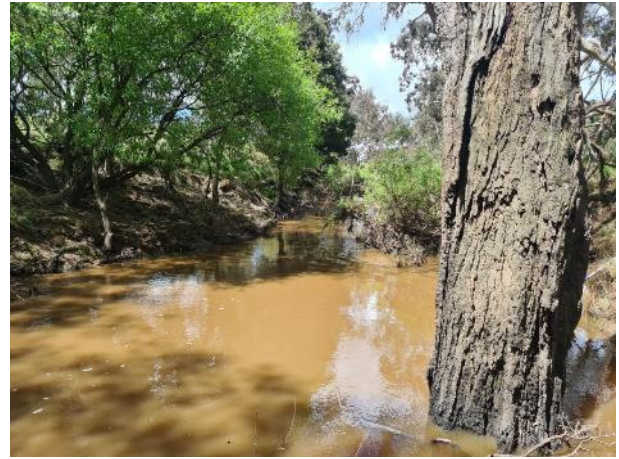
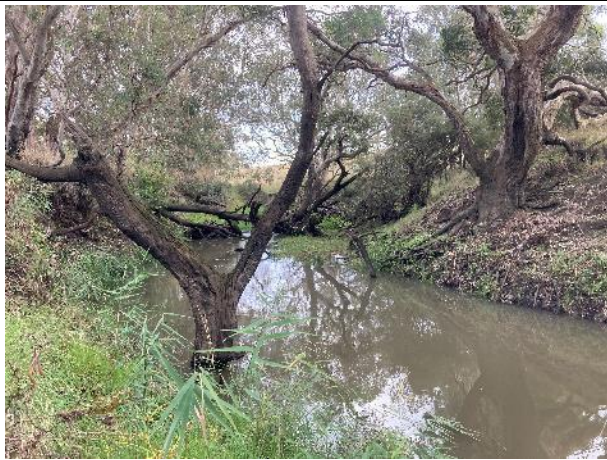
The Barwon River at Winchelsea- Deans Marsh Road has large deep pools with a shallow run at the top of the reach. The average stream width at this site is five meters and the substrate is clay and silt mixed with some sand and gravel. *Triglochin* is growing in the shallow areas of the channel and there are roots, large woody debris and trailing grasses. The riparian zone is predominately native trees and understory with a mix of grasses as groundcover. Rakali footprints were spotted at the waters edge in Spring 2019. The height and force of a flood between Autumn 2021 and Spring 2021 sampling can be seen in the upstream Spring 2021 photo of the log wedged in the forked tree in the left foreground. Overall analysis of the health of the waterway using EPA habitat parameters for Low Gradient Streams gave this site a score of 90 out of 140 in 2019 and the similar but slightly higher score of 98 in 2022 with the introduction of more woody debris into the channel following the 2021 floods and the continuing growth of riparian vegetation.
