Upper Barwon River Macroinvertebrate Sampling Report 2019-2023

- Final
- July 2023

Austral Research and Consulting
ABN 73 007 840 779
15 Buntings Rd
Kirkstall Vic 3283 Australia
Web: www.austral.net.au

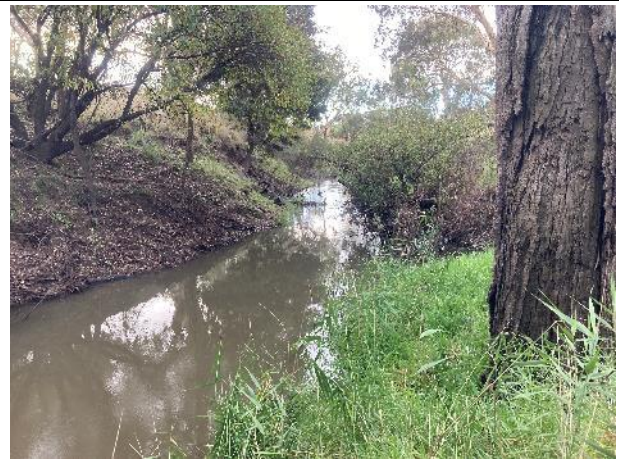
Site 11: upstream Autumn 2023

Site 11: downstream Autumn 2023

The Barwon River at Winchelsea- Deans Marsh Road has large deep pools with a shallow run at the top of the reach. The average stream width at this site is five meters and the substrate is clay and silt mixed with some sand and gravel. *Triglochin* is growing in the shallow areas of the channel and there are roots, large woody debris and trailing grasses. The riparian zone is predominately native trees and understory with a mix of grasses as groundcover. Rakali footprints were spotted at the waters edge in Spring 2019. The height and force of a flood between Autumn 2021 and Spring 2021 sampling can be seen in the upstream Spring 2021 photo of the log wedged in the forked tree in the left foreground. Overall analysis of the health of the waterway using EPA habitat parameters for Low Gradient Streams gave this site a score of 90 out of 140 in 2019 and the similar but slightly higher score of 98 in 2022 with the introduction of more woody debris into the channel following the 2021 floods and the continuing growth of riparian vegetation.

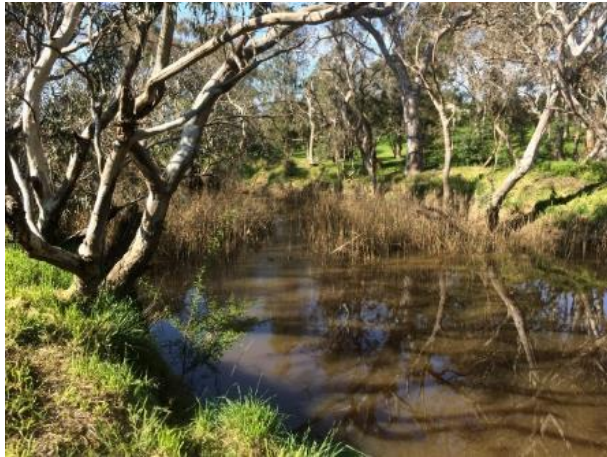
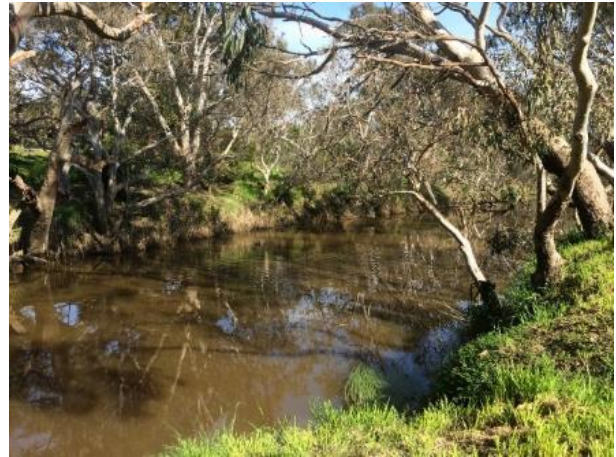
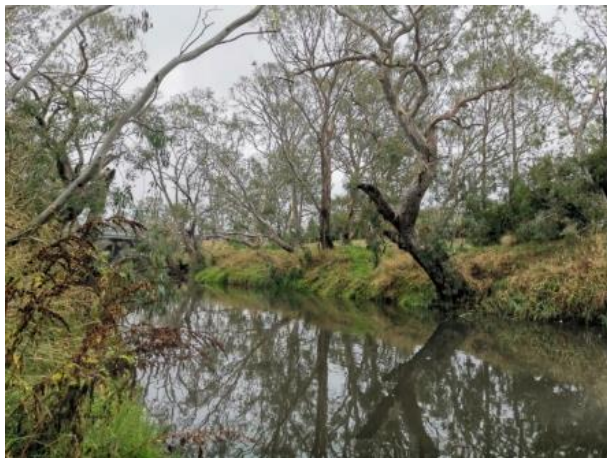
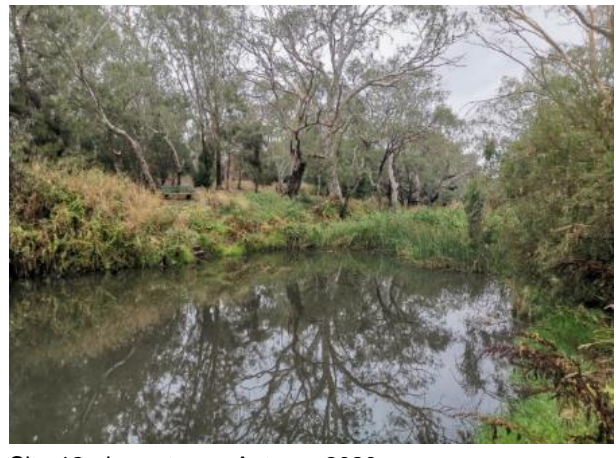
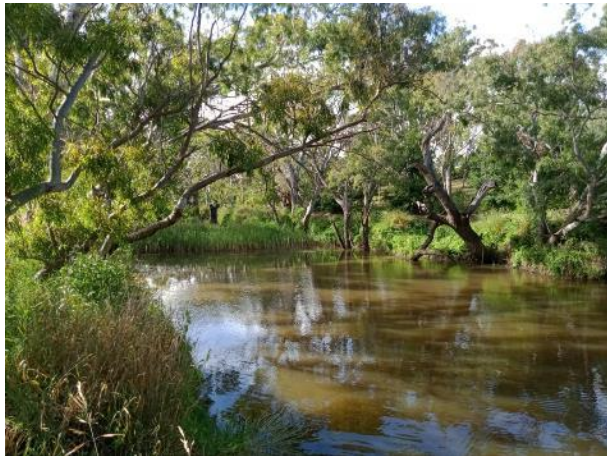
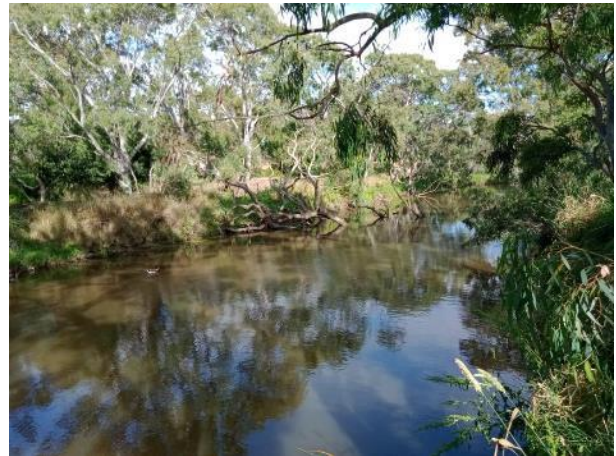
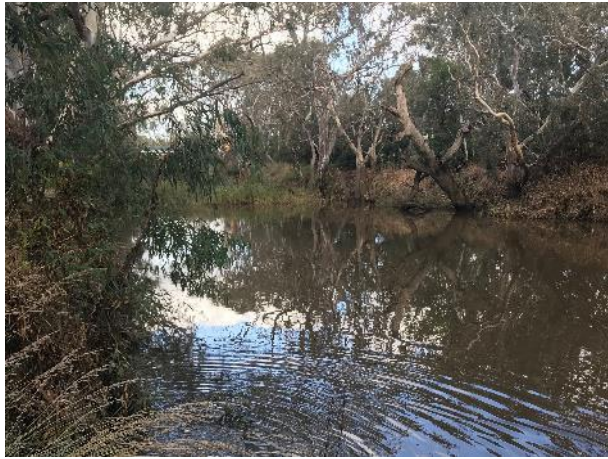
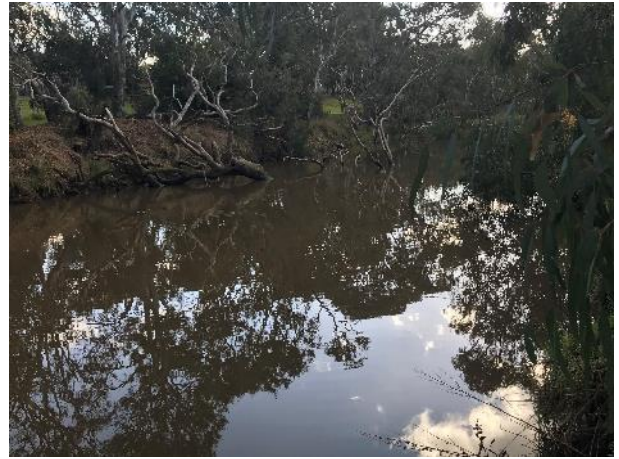
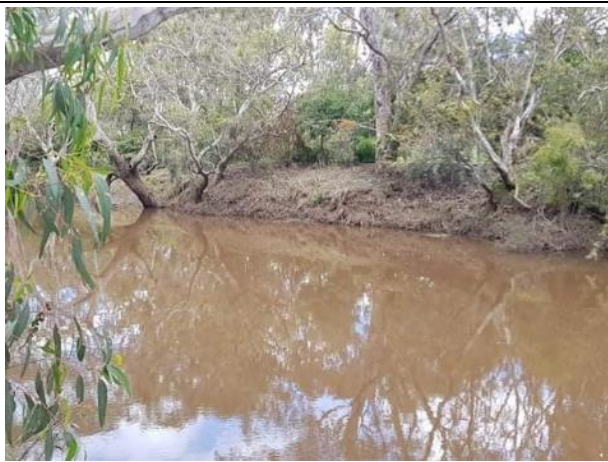
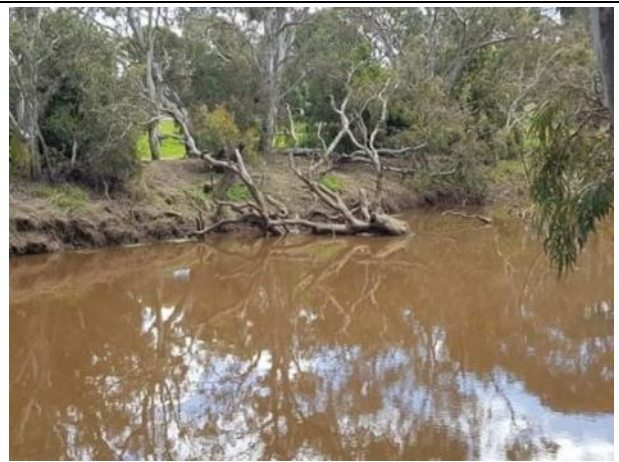
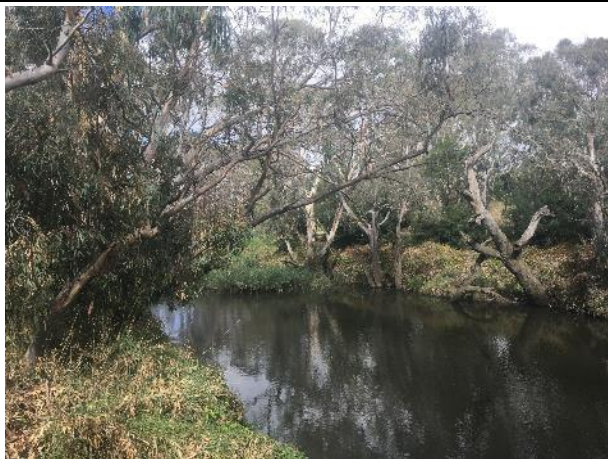
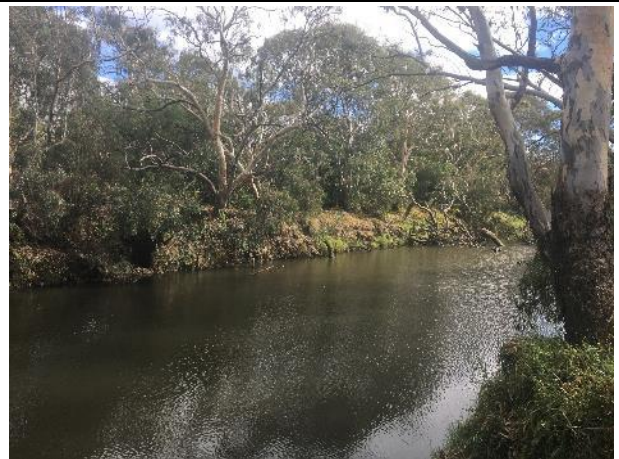
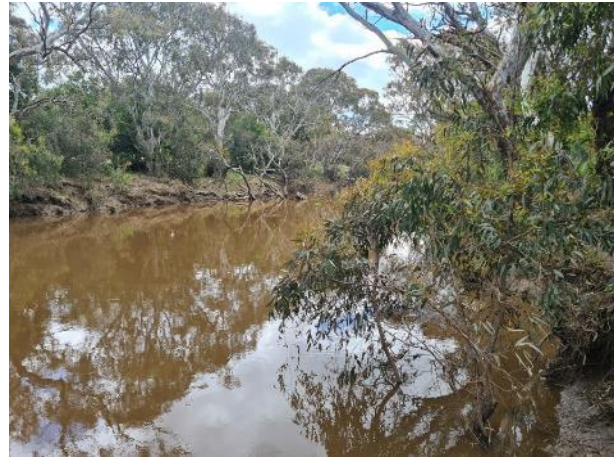
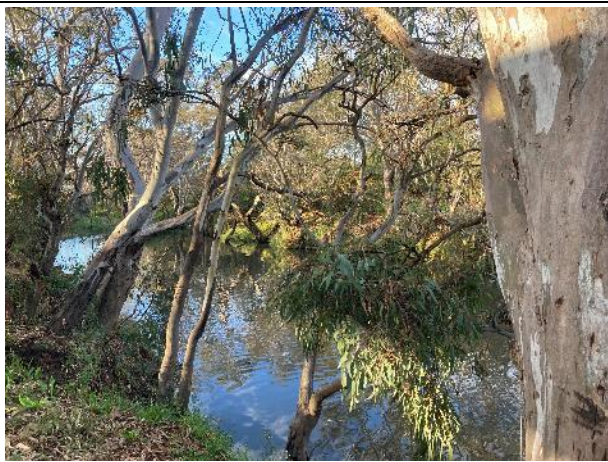
5.12. Site 12- Barwon River @ Princes Hwy bridge, Winchelsea

The Barwon River at Winchelsea has large deep pools with a large shallow pool at the top of the reach. The average stream width at this site is twelve meters. The substrate is clay and silt mixed with sand and some gravel. In addition to the *Phragmites* beds at the top of the reach and along some edges there are also patches of *Triglochin*. Large woody debris, trailing grasses and emergent vegetation such as *Polygonum* are also present. Riparian vegetation is predominantly native with many established eucalypts and groundcover is pasture grass. A concurrent snapshot study by EnviroDNA (2019) in Spring found evidence of platypus at this site. Overall analysis of the health of the waterway using EPA habitat parameters for Low Gradient Streams gave this site a score of 88 out of 140 in 2019 and a similar score of 91 in 2022.

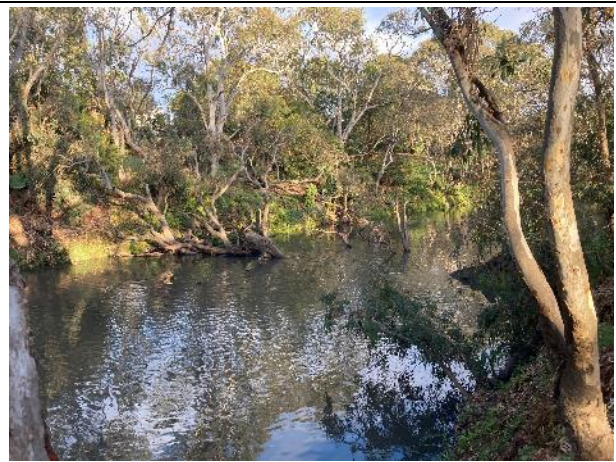
Site 12: upstream Autumn 2023

Site 12: downstream Autumn 2023

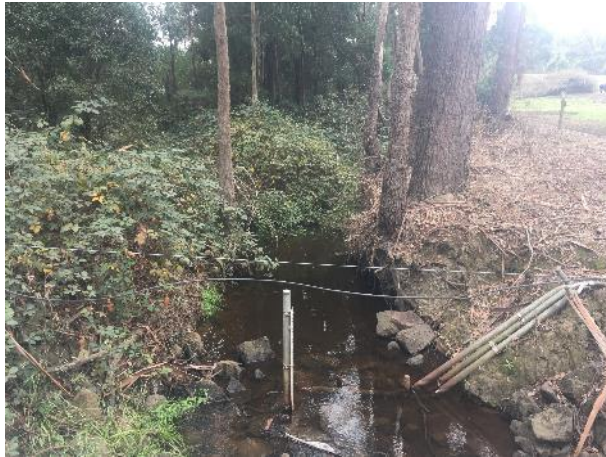
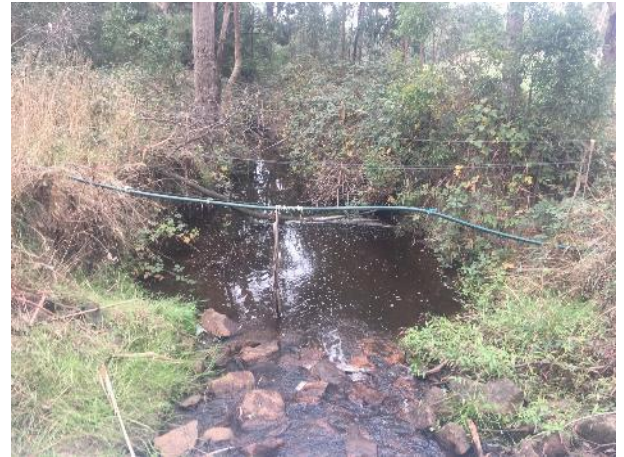
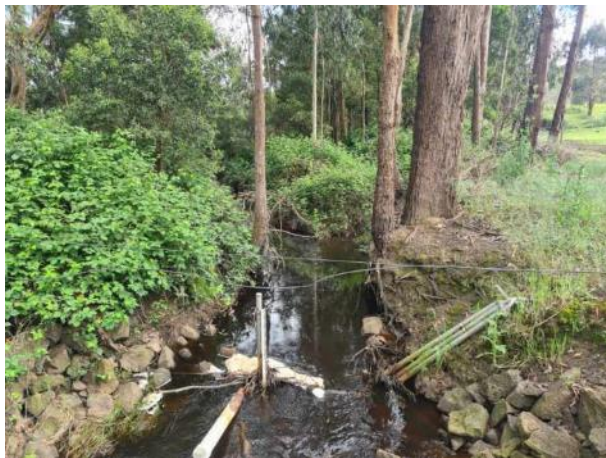
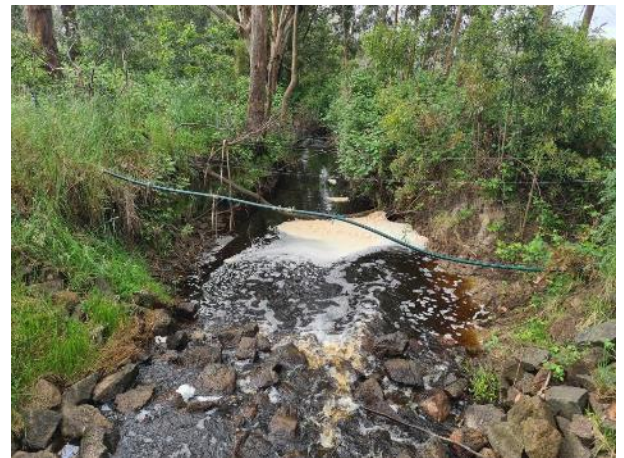
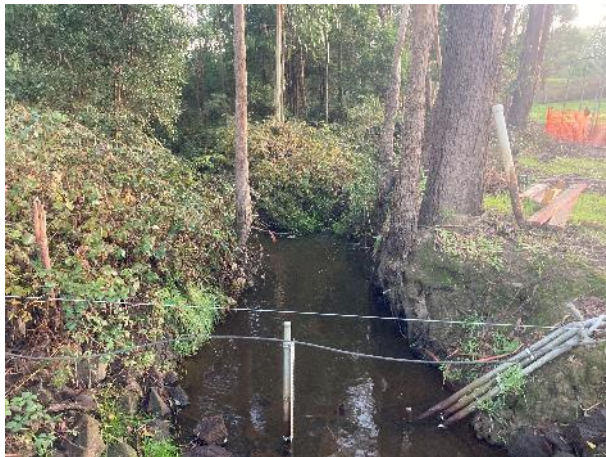
5.13. Site 5.1- Boundary Creek downstream of McDonalds Dam

Site 5.1 on Boundary Creek was added to the current sampling regime to replicate the site sampled by Austral in 2014/2015 for Jacobs (2017) and give some context to the health of Boundary Creek upstream of Big Swamp. Boundary Creek below McDonalds Dam is between 3 and 4 meters wide with a mix of deep pools, shallower pools and artificial riffle areas from the culvert/ bridge. There were isolated patches of aquatic macrophytes in 2014 but non were present in 2022. Whilst large trees are a feature of the riparian zone, live blackberries and bare ground where they have been poisoned, dominate. Intensive agriculture exists outside of the riparian zone. Overall analysis of the health of the waterway using EPA habitat parameters for Low Gradient Streams gave this site a score of 87 out of 140 in 2014 and a similar score of 91 in 2022.

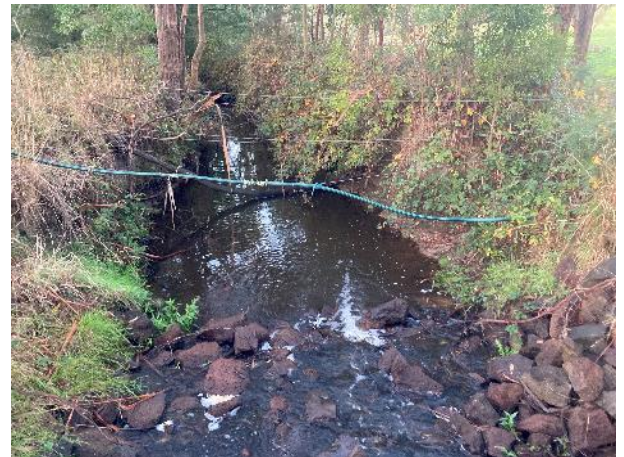
Site 5.1: upstream Autumn 2023

Site 5.1: downstream Autumn 2023

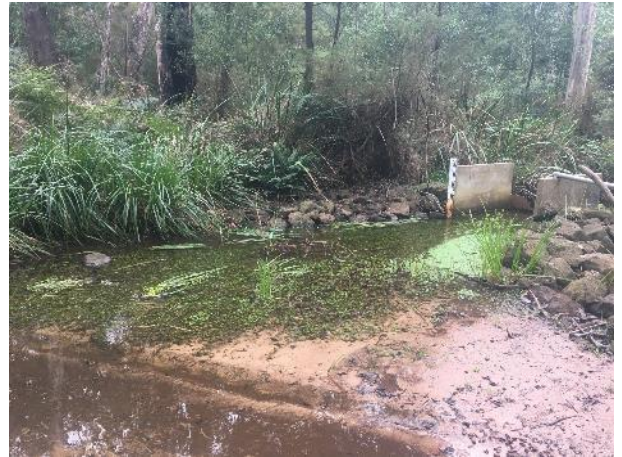
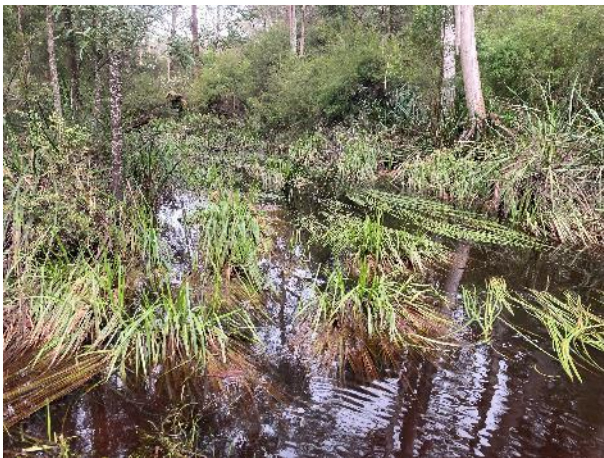
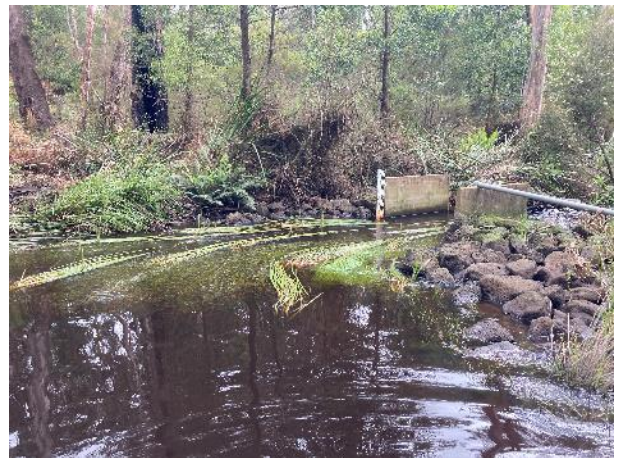
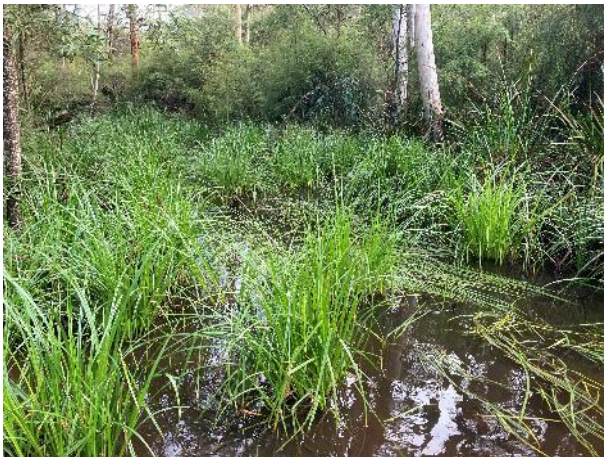
5.14. Site 5.2- Boundary Creek upstream of Big Swamp

Site 5.2 on Boundary Creek was added to the current sampling regime to give additional information on the biological health of Boundary Creek upstream of Big Swamp. Boundary Creek is between 1 and 2 meters wide either side of the vehicle crossing and is very different to all other sites sampled with a mix of large and small, deep and shallow pools and runs. There are extensive areas of macrophytes including Triglochin, Ranunculus and Cyperus beds and isolated patches of Alisma and Juncus. The riparian zone is extensive consisting of predominantly, if not totally, native species. Pool deepening works close to the gauge were in progress at the time of sampling in Autumn 2023, as is evident by the silt and rock in the downstream picture. Overall analysis of the health of the waterway using EPA habitat parameters for Low Gradient Streams gave this site a score of 130 out of 140, the highest of any in this study.

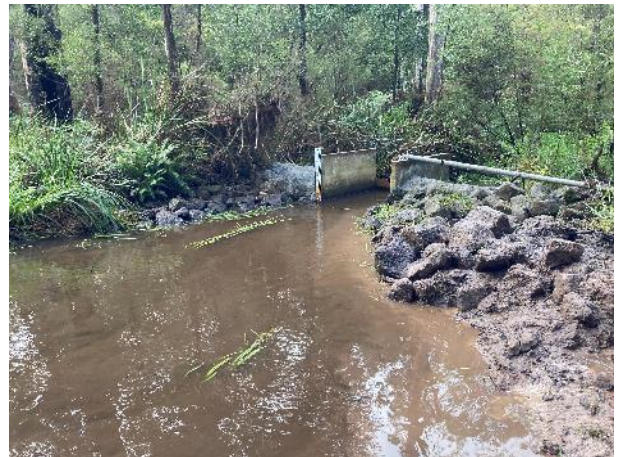
Site 5.2: upstream Autumn 2023

Site 5.2: downstream Autumn 2023

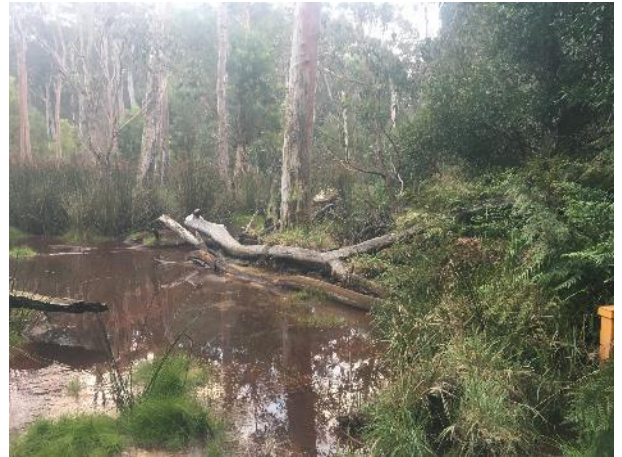
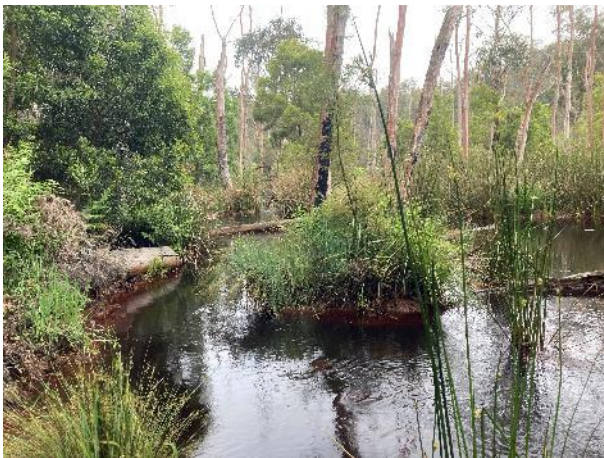
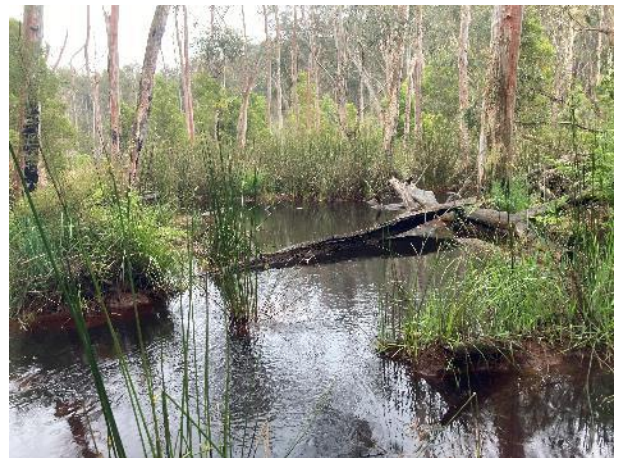
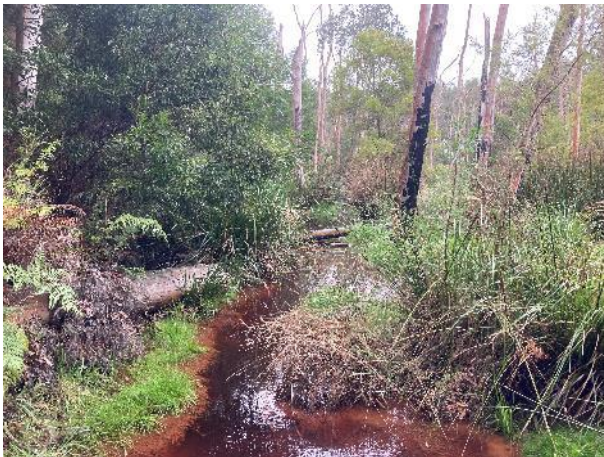
5.15. Site BS1- Big Swamp eastern end

Site BS1 in Big Swamp was added to the current sampling regime to give additional information on the condition of Big Swamp. The water level was shallow and was slowly flowing around the extensive amount of large woody debris and beds of Giant Rush and scattered sedges and rushes such as *Gahnia* and *Cyperus*. There was a high amount of iron floc present on the substrate.

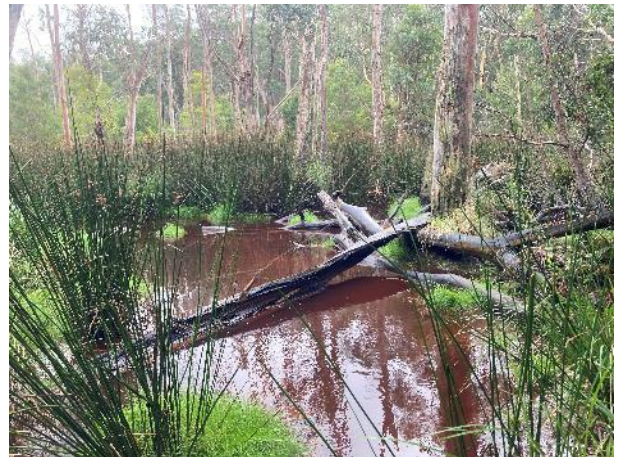
Site BS1: upstream Autumn 2023

Site BS1: downstream Autumn 2023

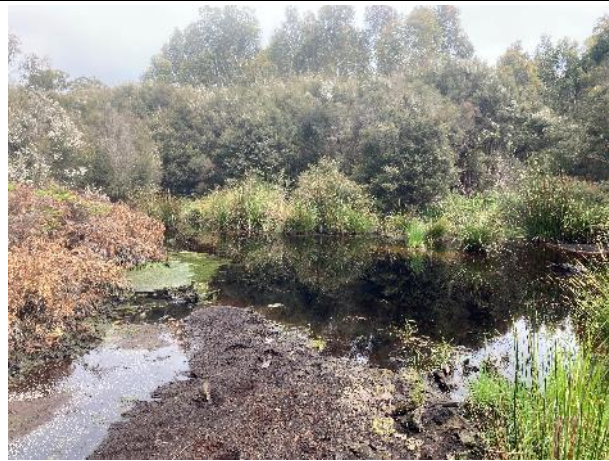
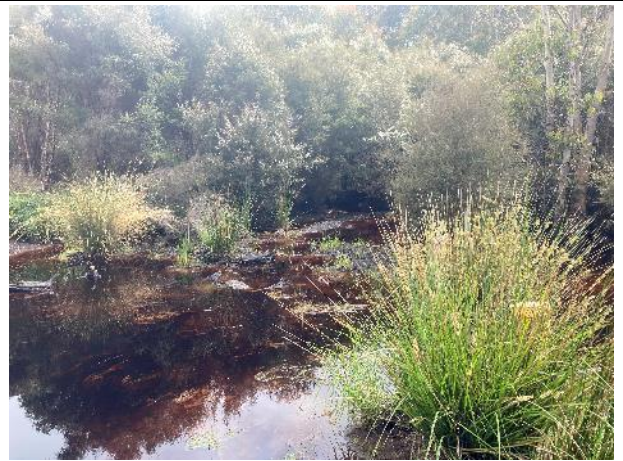
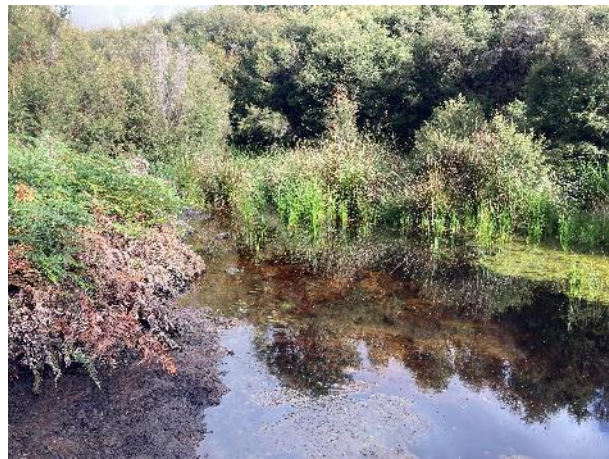
5.16. Site BS2- Big Swamp western end

Site BS2 in Big Swamp was dry in Autumn 2022 and whilst was holding water in Spring 2022 and Autumn 2023, water at this site is primarily standing not flowing as it is at Site BS1. Vegetation appears to be all native with an excellent riparian zone. Vegetation is similar to Site BS1 with beds of Giant Rush and scattered sedges and rushes such as *Gahnia* and *Cyperus* but without the extensive large woody debris. This site also has floating mats and submerged decaying mats of algae amongst the vegetation.

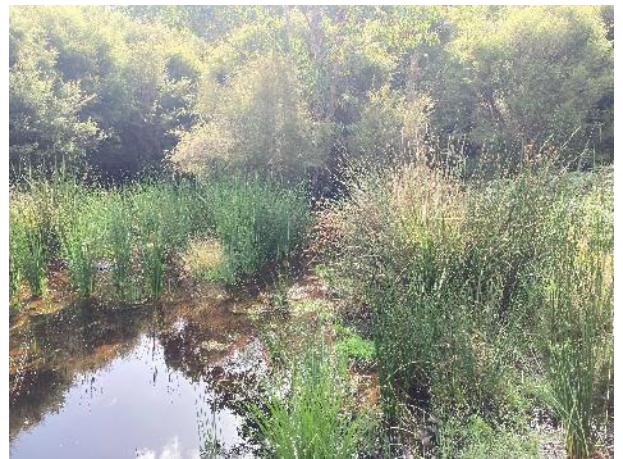
Site BS2: upstream Autumn 2023

Site BS2: downstream Autumn 2023
