# Waterway management in the Upper Barwon

22<sup>nd</sup> October 2022

*alluvium*

# **East Barwon water transfer and remediation project**

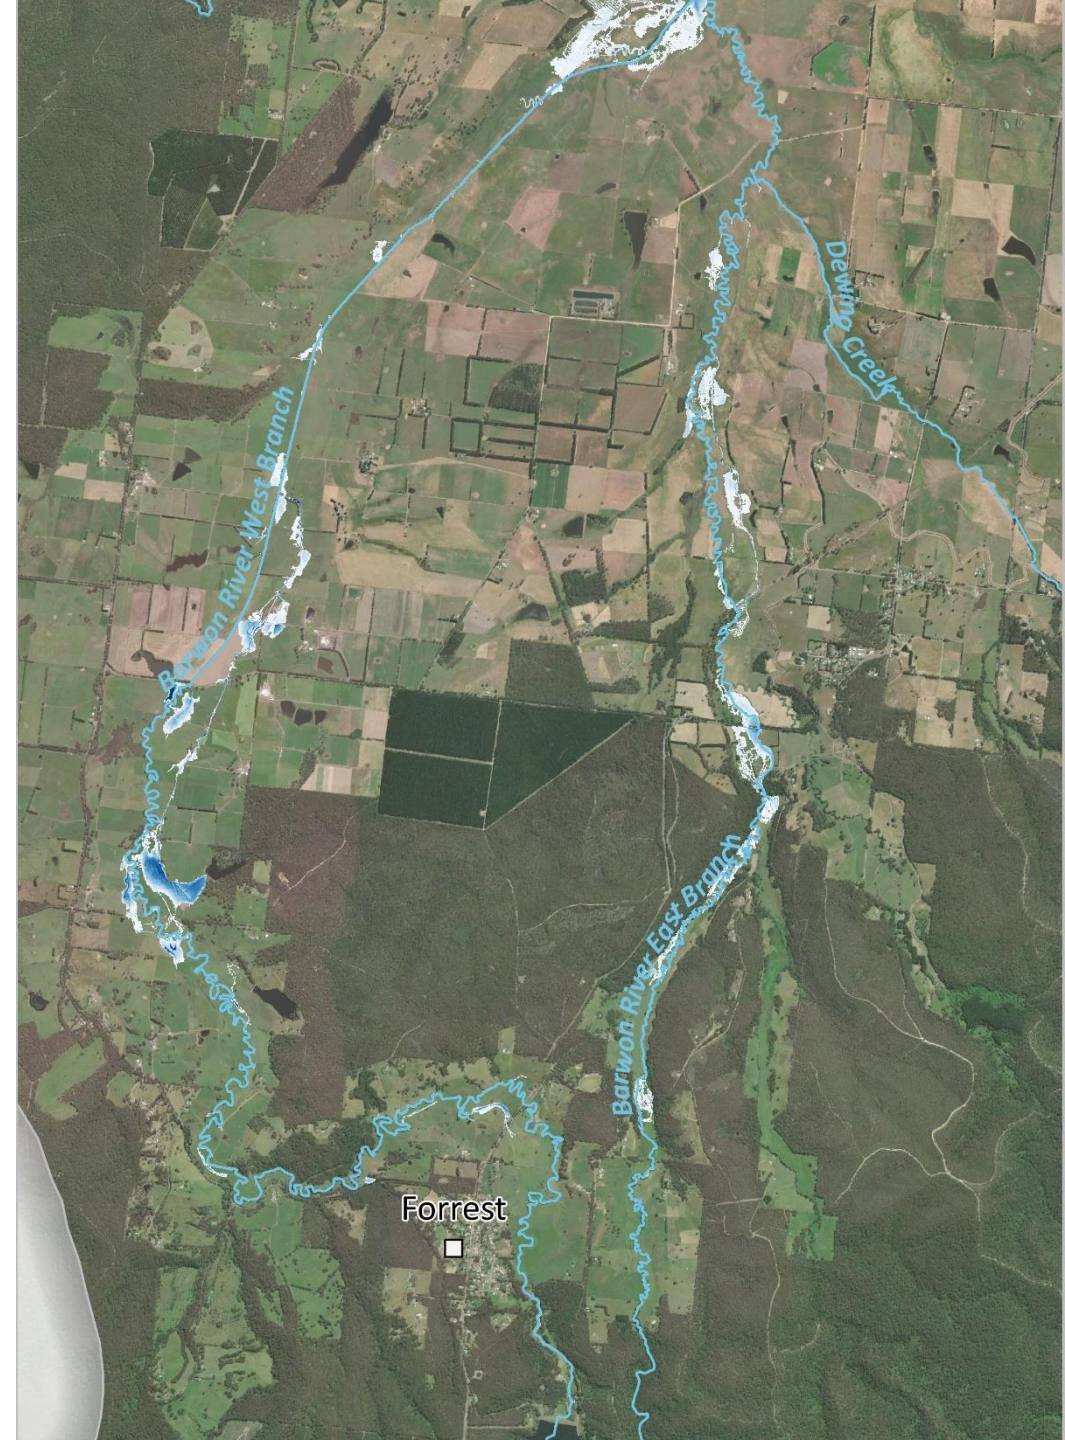
- Modelling identified multiple sites where there are potential constrictions to flow
- These include:
  - Infrastructure
  - Channel diversions and drainage
  - Willow and other vegetation (e.g. Glyceria) encroachment
- Around 50 constriction sites were identified

*Image: Results of the current conditions modelling for the West Barwon at 100ML/d and the East Barwon at 35ML/d*

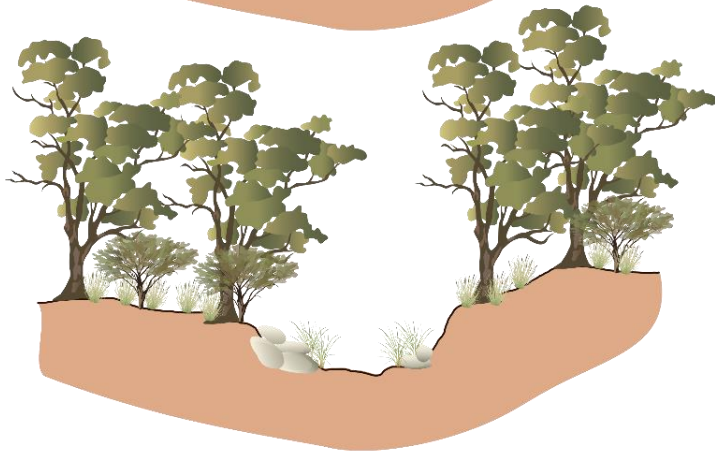
## Previous condition

Willows present along majority of riverbank and channel. Willows are poisoned prior to any physical works to limit the spread of live/viable material.

## Willow removal and bank stabilisation

Willow removal undertaken in a downstream direction, retaining roots on banks to assist with protection of stream banks. Full stump removal for in-channel willows to achieve water delivery objectives. Additional bank protection provided in locations of high erosion risk. Native vegetation planted within 12 months of willow removal.

## Native vegetation establishment

Native vegetation comprises ground cover, shrubs and reeds, and tree cover. Willow removal sites to be maintained in an effective willow free condition over a 20-year program.

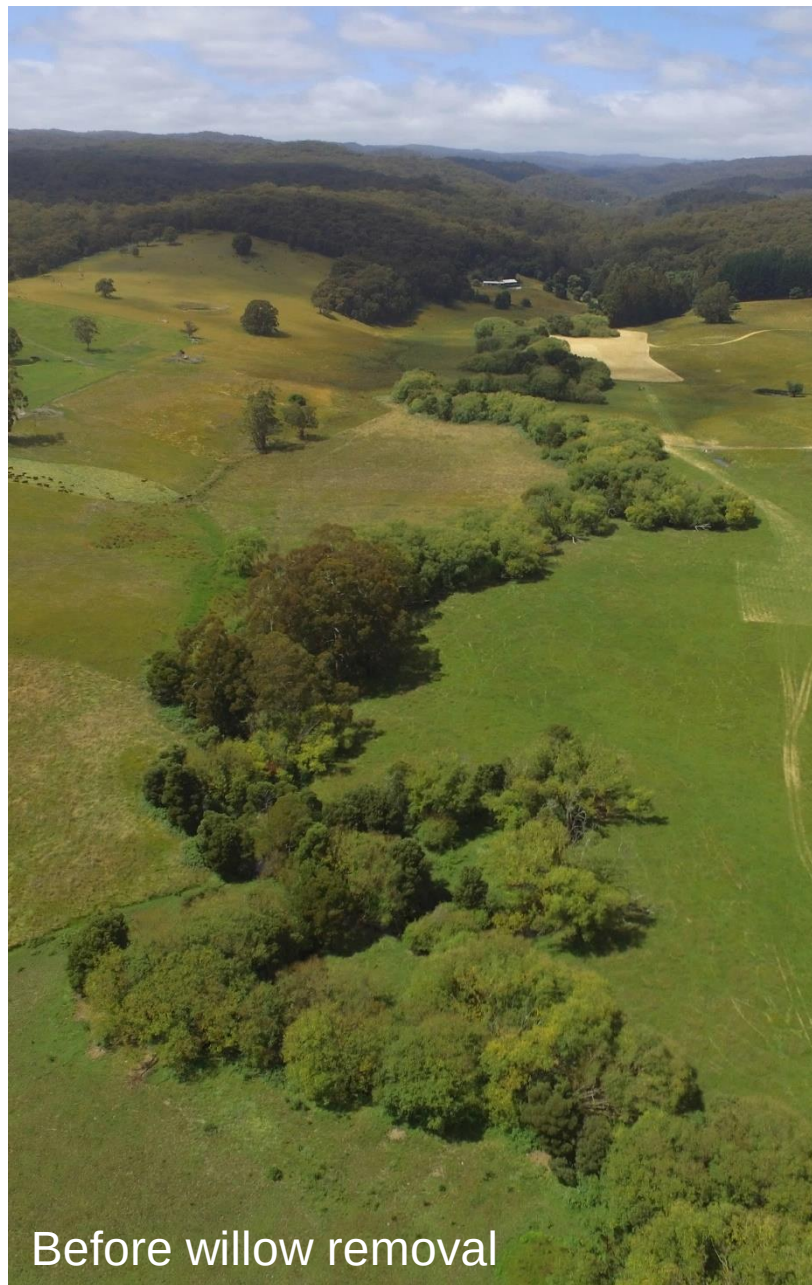
Before willow removal

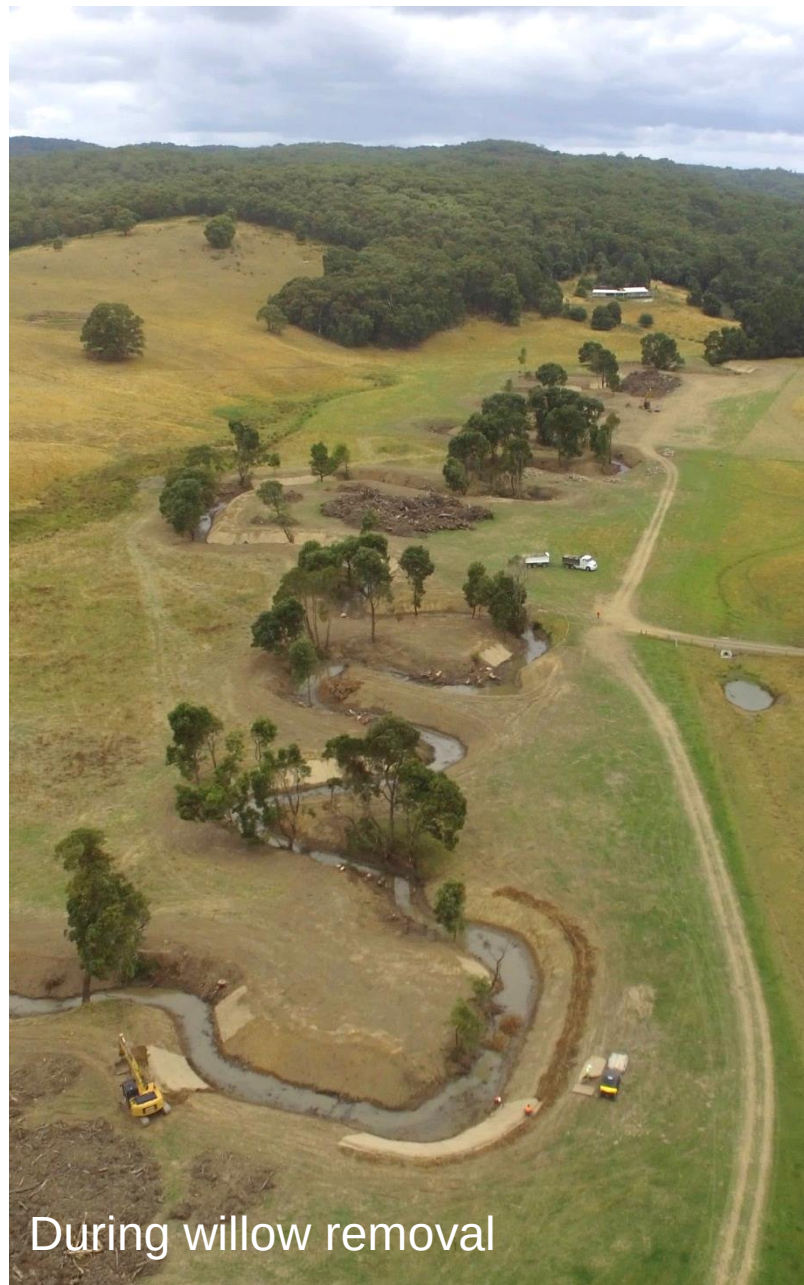
During willow removal

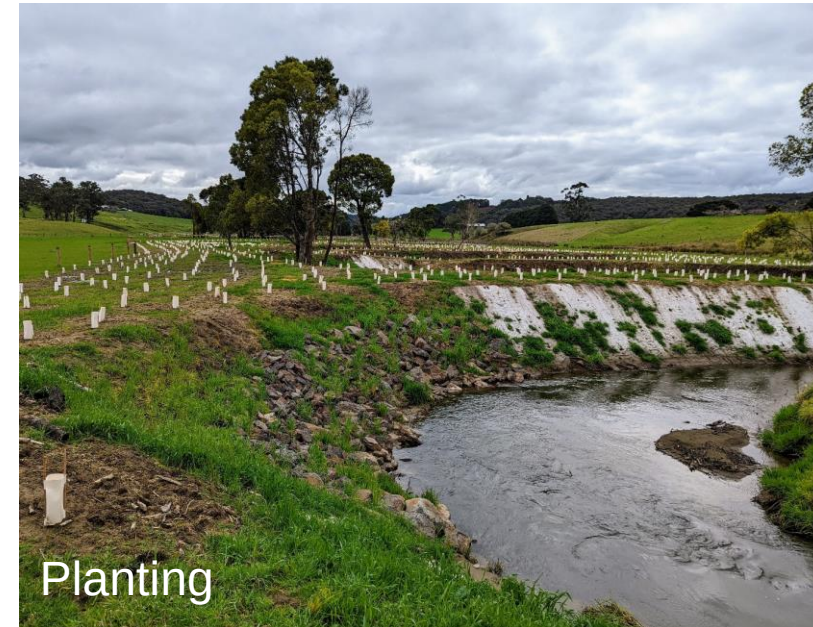
Planting

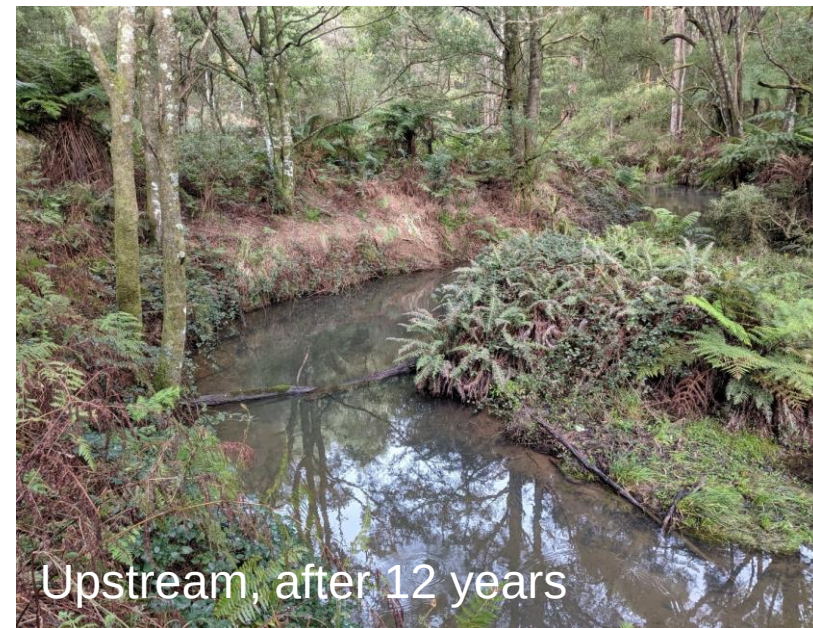
Upstream, after 12 years
