2016 - 2017 Technical Works Program

Barwon Water

Yeodene Swamp Study

IS191000-GW-RP-001 | FINAL

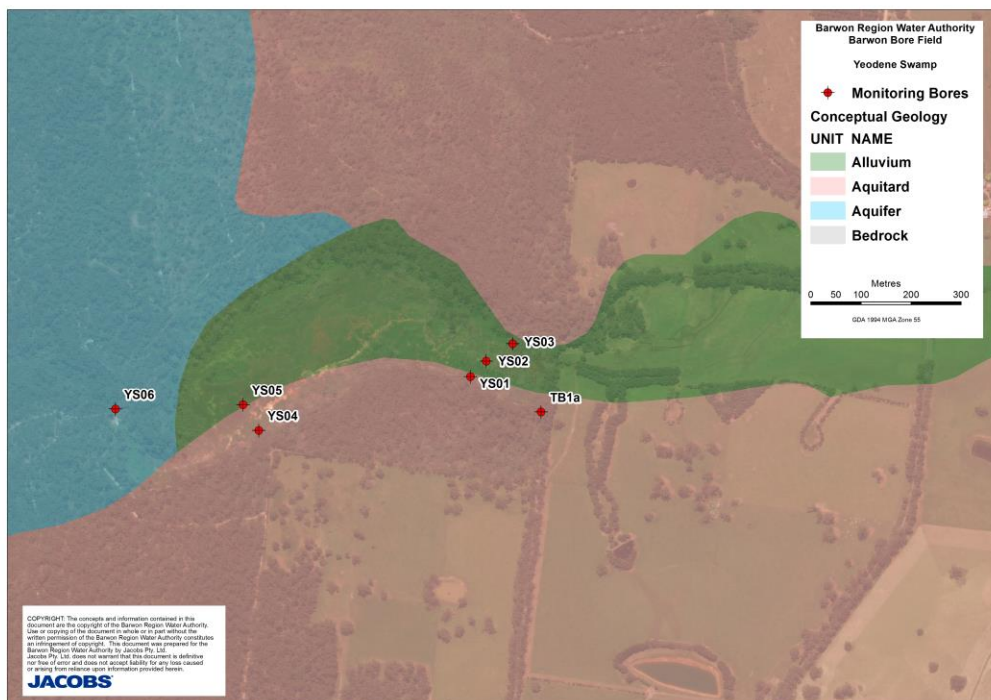
Figure 4-1 Surface geology and monitoring locations (points of lithological analysis)

Lithological logs indicate coarse sands at YS04. While regional mapping suggests the occurrence of outcropping aquitard material in this area (Figure 4-1), it is possible that drilling has penetrated through thin alluvial deposits and into the regional aquifer. Lithological logs at YS05 are consistent with alluvial deposits, while sandy and silty clay deposits at YS06 could be consistent with either shallow alluvial deposits or regional aquifer deposits. Based on these results, it remains unclear as to the exact boundary between outcropping aquifer deposits in the west, and aquitard deposits in the east.

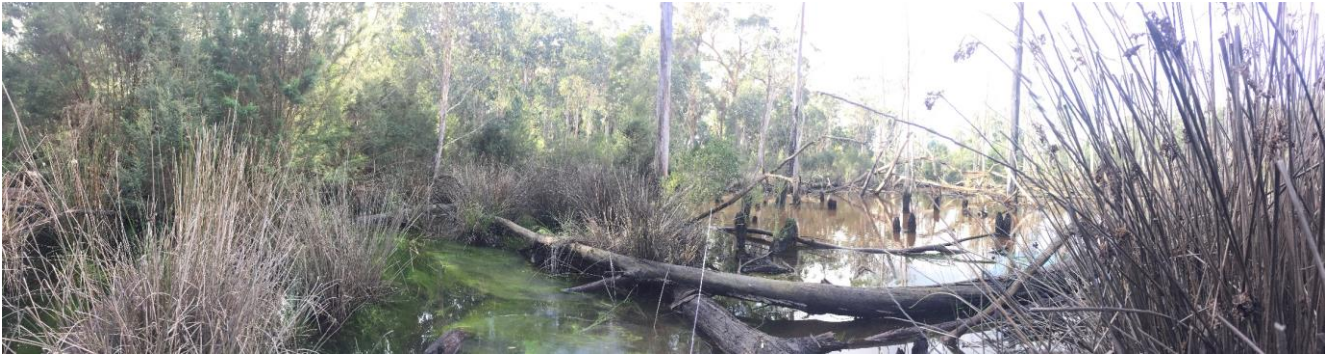
Figure 4-8 : 180 degree photo from centre of transect in Yeodene Swamp.

- This part of Yeodene Swamp was not a permanent swamp historically (i.e. greater than 50 years ago) as the tree ferns and trees would not have established unless there was periodic drying. This could be the result of the construction of agricultural drains in the area.
- The trees and tree ferns are likely to have died as a result of root death caused by permanent inundation.
- Inundated area is un-vegetated as a result of the acidic water which is toxic to most plant species.

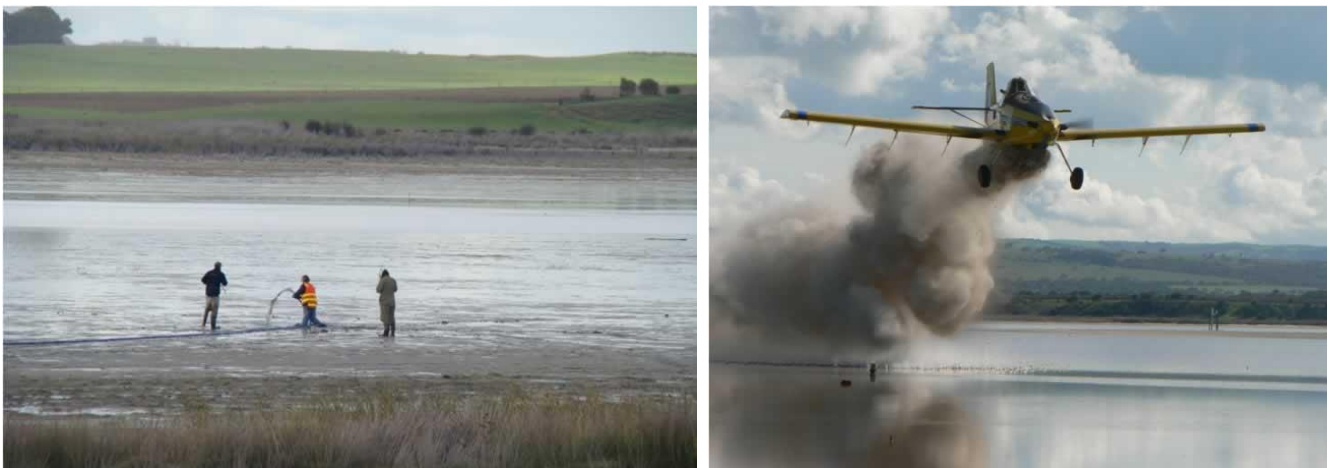
Figure 5-1 Application of slurry to Lower Murray Lakes (left) and aerial application of lime to Currency Creek (right) (EPHC & NRMCC, 2011).

A variety of application methods are also available pending the nature of the site and access limitations. These include the direct application of lime (CaOH) powder, the application of agricultural lime (CaCO₃) slurries via pressure hose, or dusting large areas with agricultural lime from an aircraft (see Figure 5-1).
