# Upper Barwon River Investigation 2019-2021

- Final
- September 2021

| <b>Name of project:</b> | Barwon River/ Boundary Creek Survey |

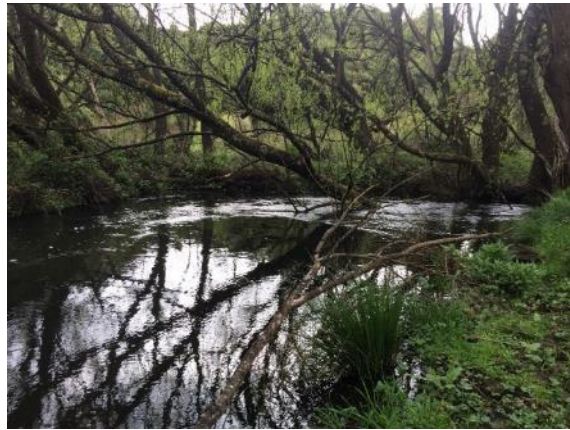
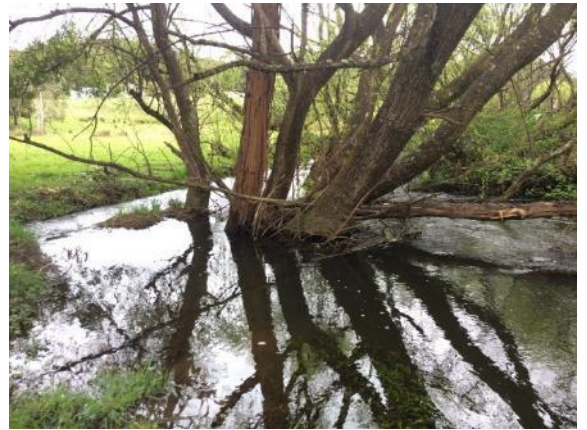
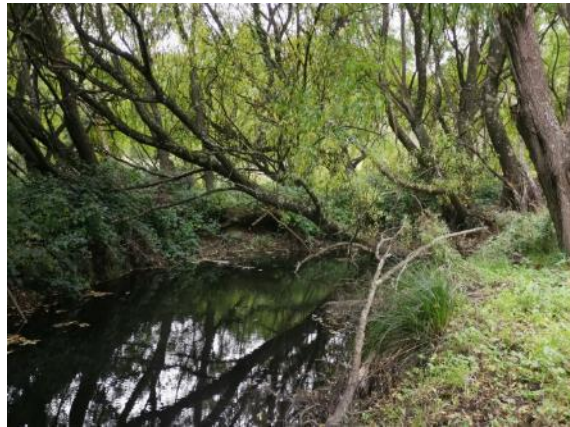
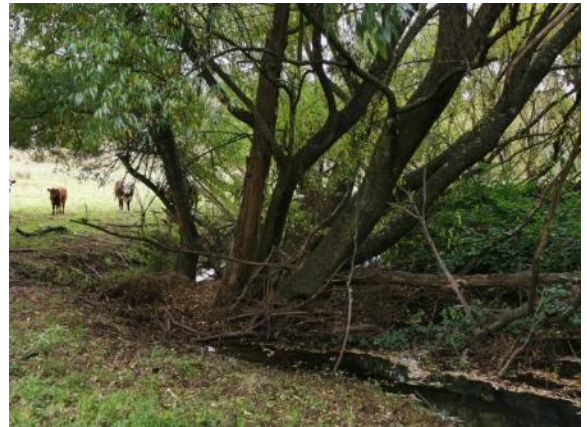
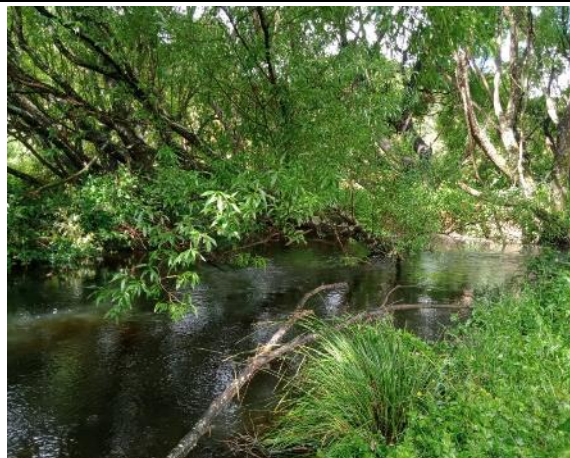
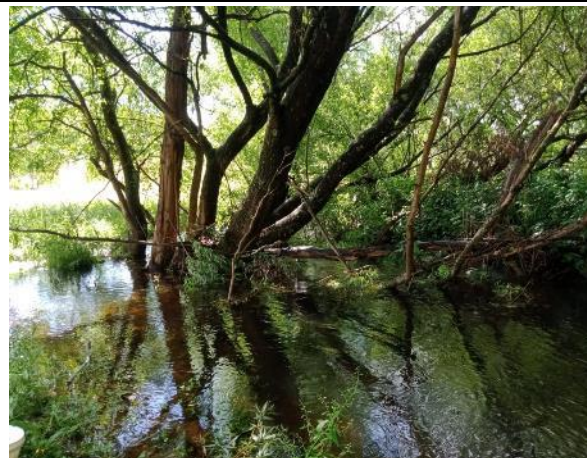
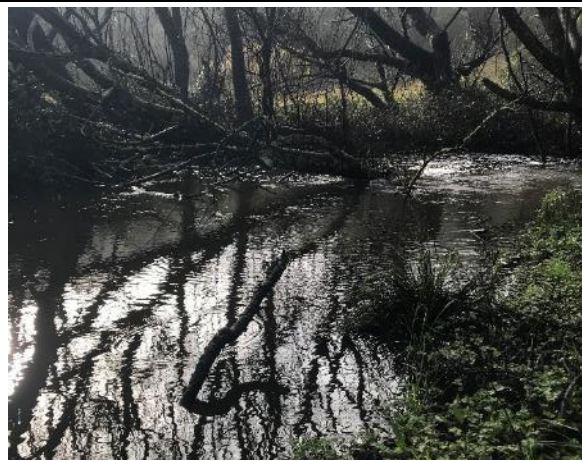
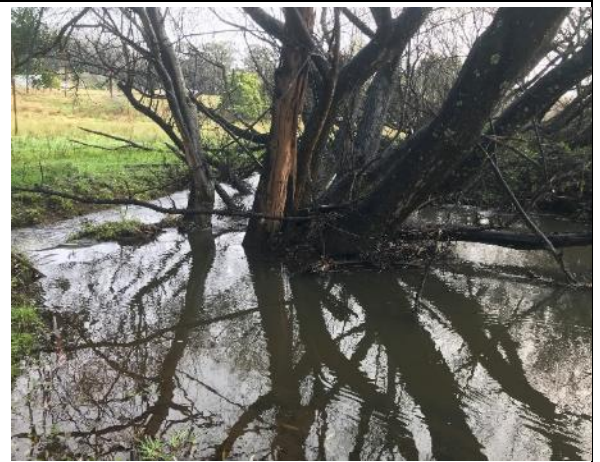
### 4.1. Site 1- East Barwon River @ Kents Road

The East Barwon at Kents Road has diverse habitat with large deep pools and some riffle/run areas. These runs had dried to trickles in Autumn 2020 but were flowing well in Spring and Autumn 2021. The average stream width is eight meters and bank full but had contracted to five meters in Autumn 2020. Willows dominate the riparian zone and are growing within the stream channel. The substrate is a mix of clay and silt with a number of aquatic macrophytes growing in the margins and shallow pool areas. The majority of the riparian zone is exotic vegetation, dominated by blackberries (possibly poisoned in Summer 20/21), willows and pasture grass. One larval fish was collected as bycatch during macroinvertebrate sampling. A concurrent snapshot study by EnviroDNA (2019) found evidence of platypus at this site. Overall analysis of the health of the waterway using EPA habitat parameters for Low Gradient Streams gives this site a score of 74 out of 140.

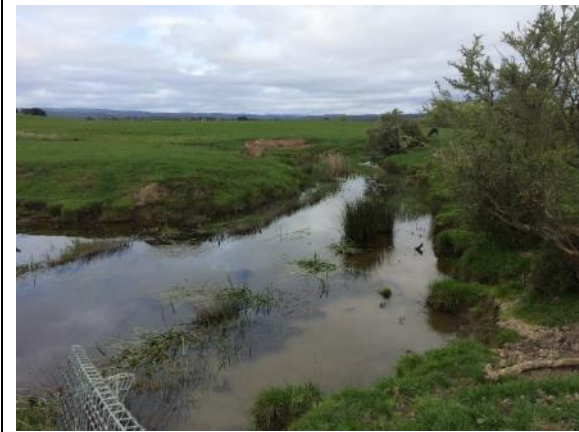
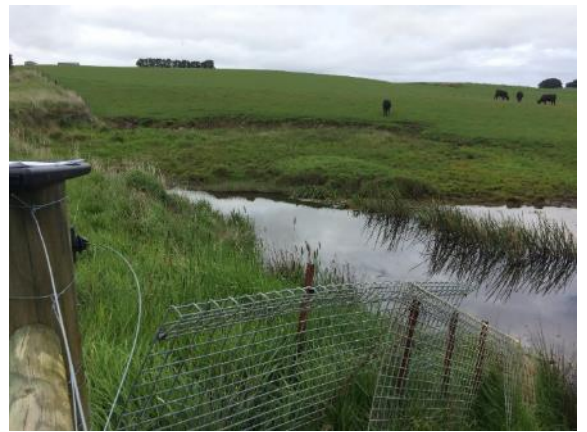
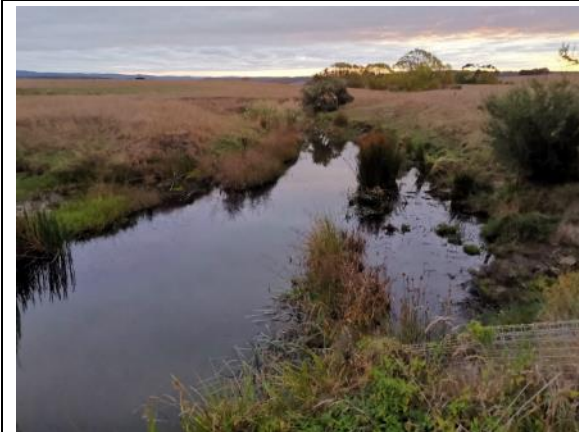
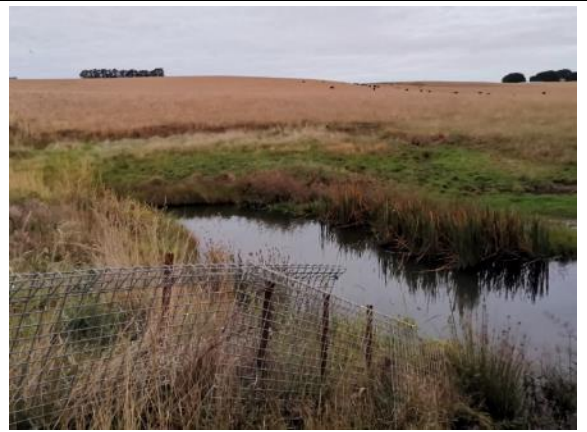
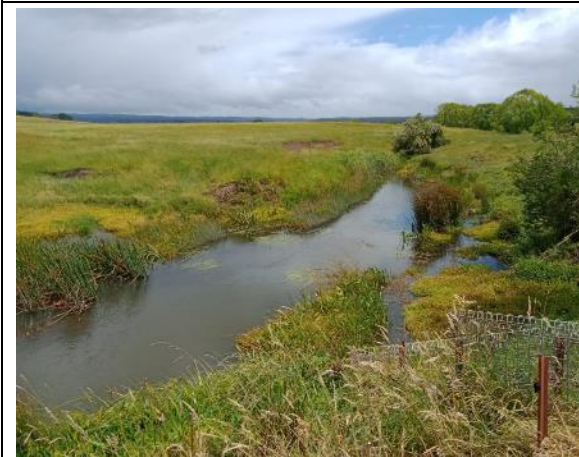
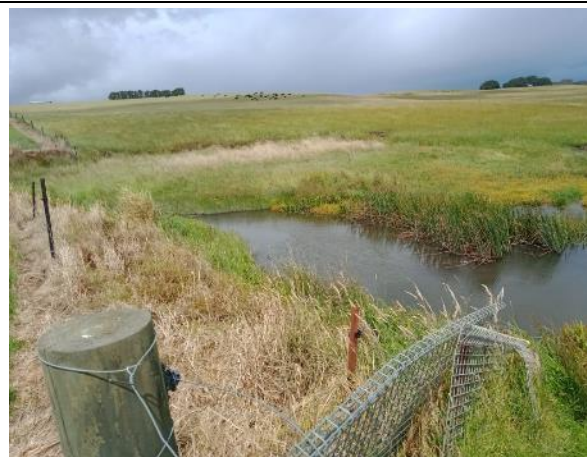
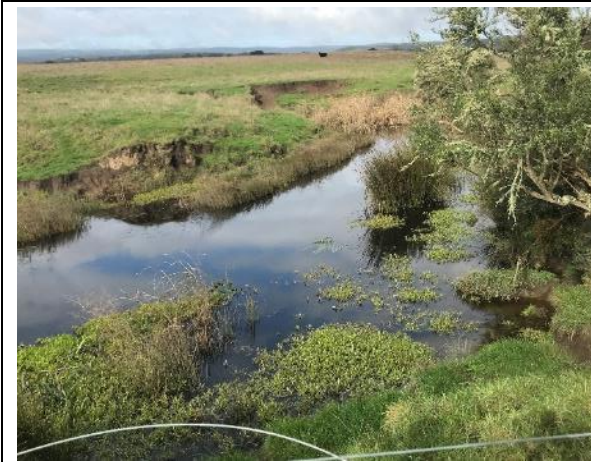
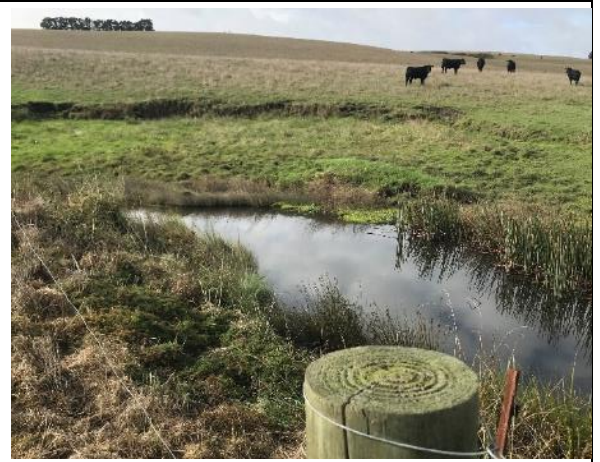
## 4.2. Site 2- East Barwon River @ Dewings Bridge Road

The East Barwon at Dewings Bridge Road consists of a slow flowing channel with extensive backwaters. There is very little riparian zone present but a number of submerged and emergent macrophytes provide good habitat for macroinvertebrates and fish. One larval fish was found in the sample net in Autumn 2020 and three pygmy perch in Spring 2020. The substrate is a mix of clay and silt with some sand. The average stream width at this site was seven meters and was bank full during both Spring and Autumn sampling. The majority of the riparian zone is pasture grass with stock access on both sides. Overall analysis of the health of the waterway using EPA habitat parameters for Low Gradient Streams gives this site a score of 59 out of 140.

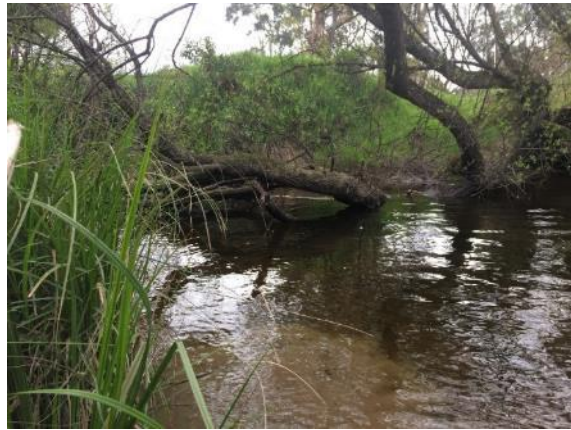
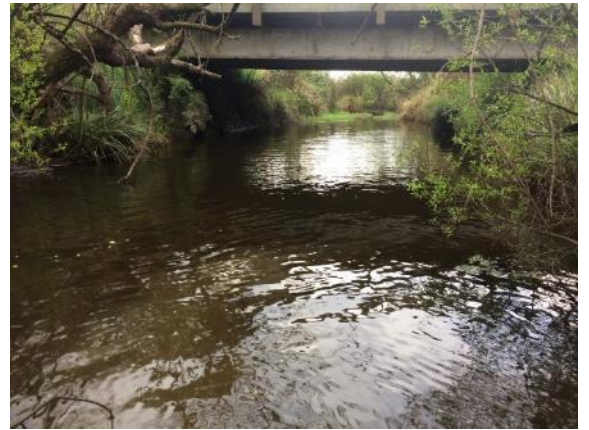
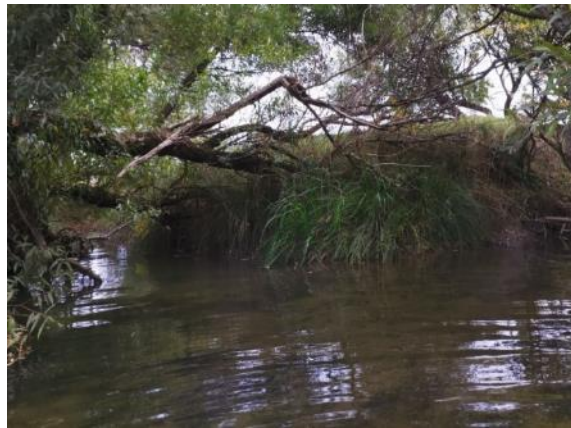
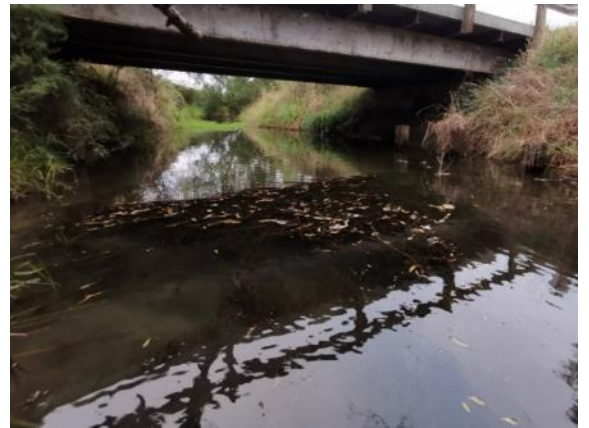
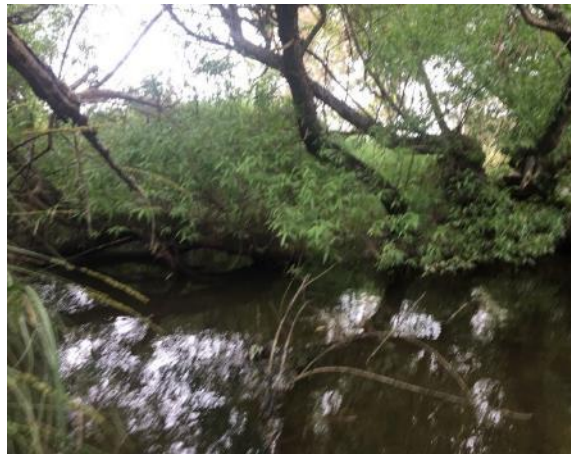
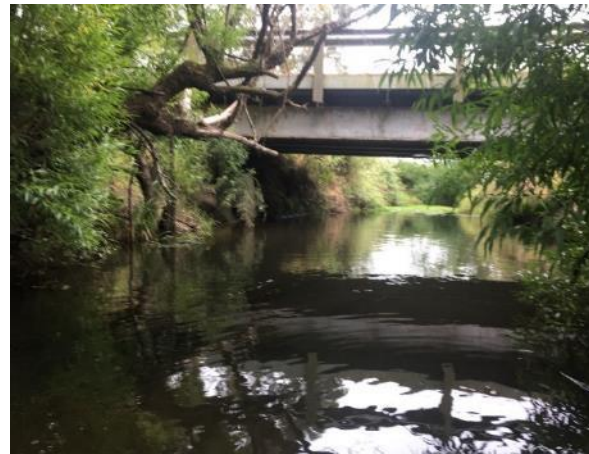
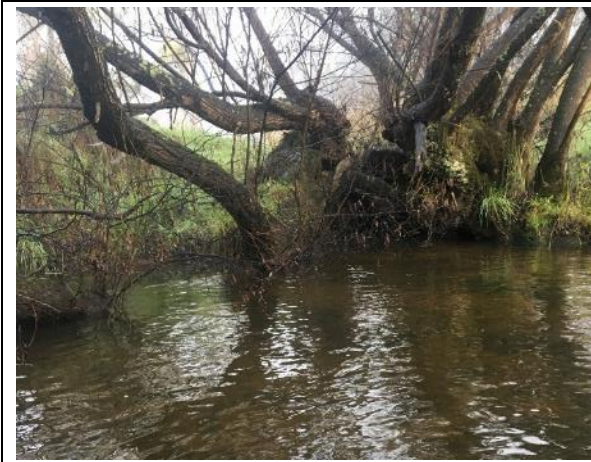
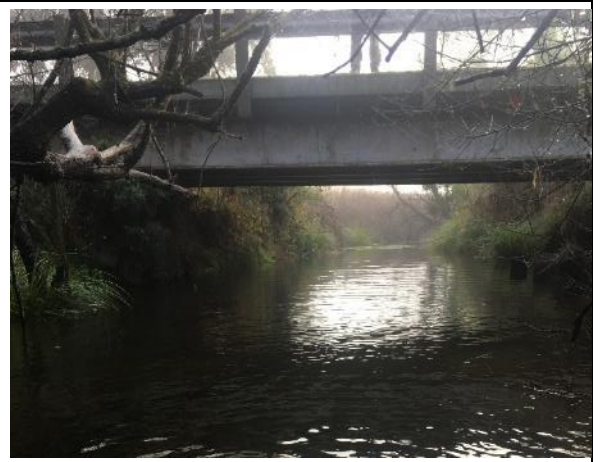
## 4.3. Site 3- West Barwon River@ Seven Bridges Road

The West Barwon River at Seven Bridges Road has large deep pools with a number of large deep backwaters. The average stream width at this site is seven meters, narrow at the top of the surveyed reach and widening into a large pool near the bridge. The substrate is clay and silt mixed with 20% sand. There are some macrophytes present along with trailing bank vegetation, roots and instream large woody debris (primarily willow branches). Willows dominate the riparian zone a mix of shrubs and native and pasture grasses in the understory. Four larval fish were collected as bycatch during macroinvertebrate sampling in Spring 2019. One mountain galaxias, one common galaxias, one pygmy perch and a laval galaxias were collected in Spring 2020. A concurrent snapshot study by EnviroDNA (2019) found evidence of platypus at this site in Spring 2019. Overall analysis of the health of the waterway using EPA habitat parameters for Low Gradient Streams gives this site a score of 85 out of 140.

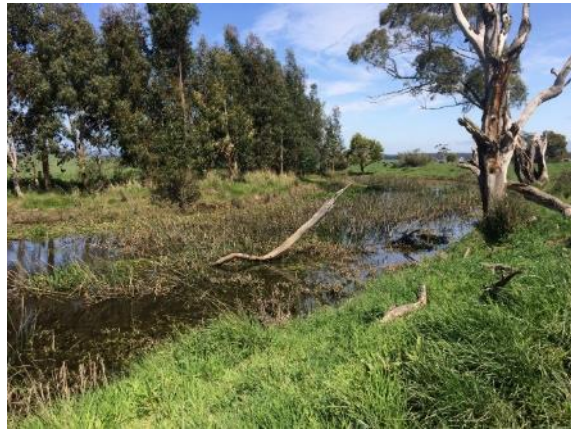
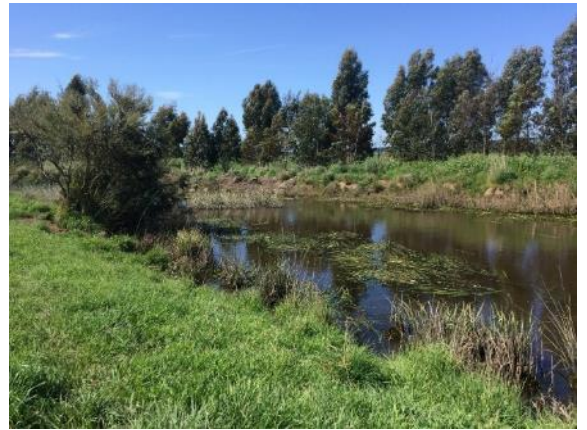
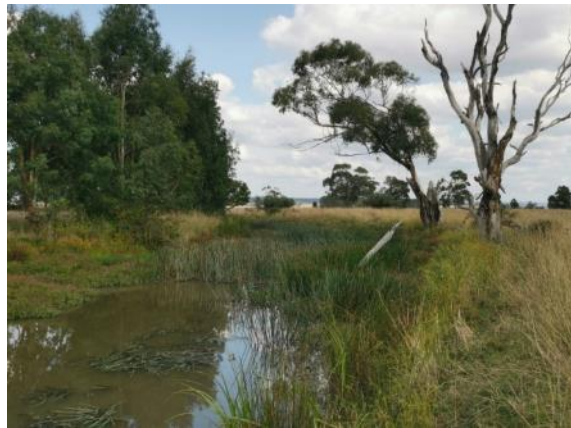
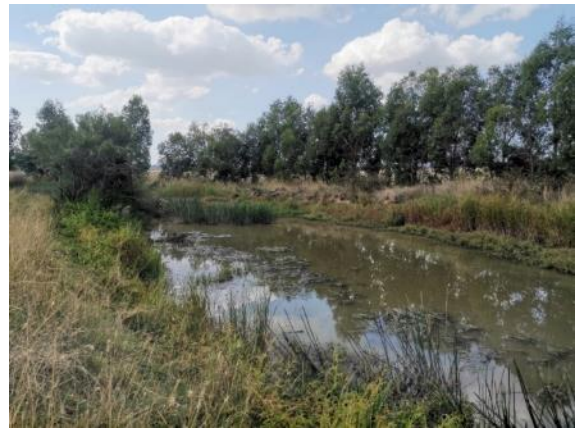
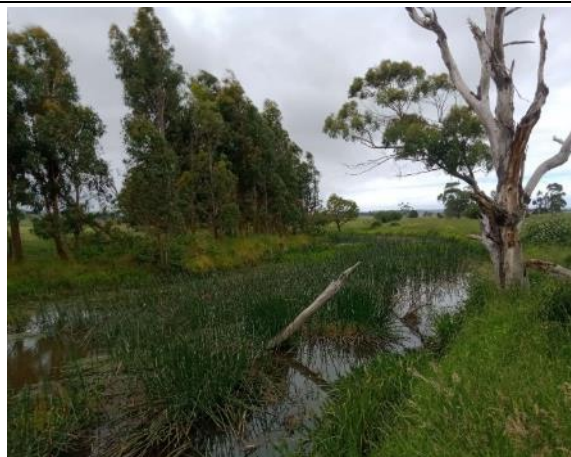
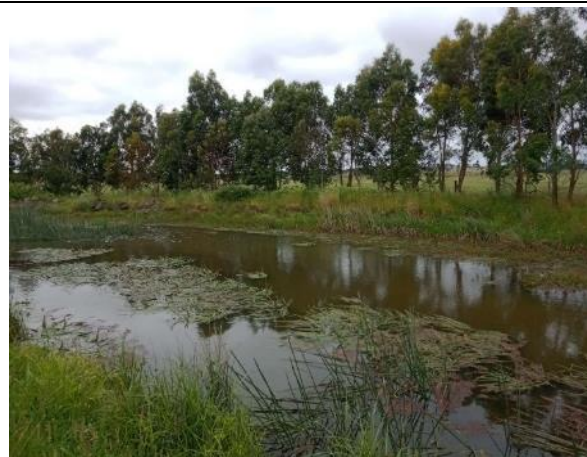
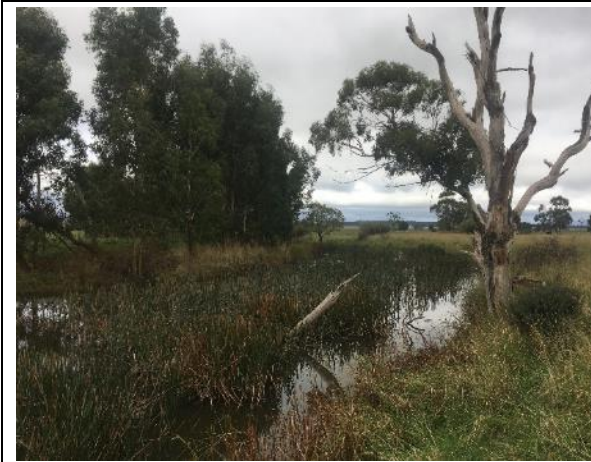
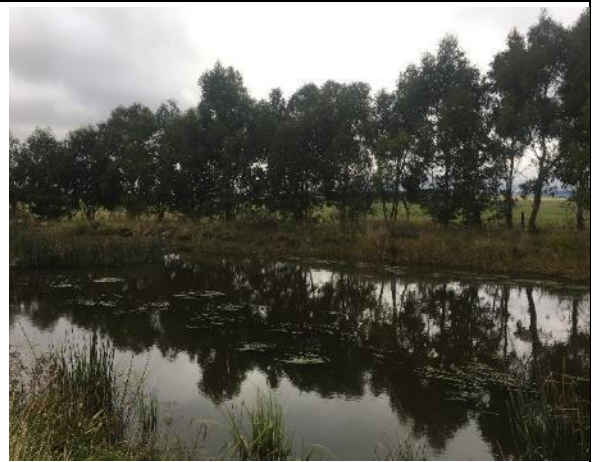
## 4.4. Site 4- Barwon River upstream of Boundary Creek confluence

The Barwon River immediately upstream of the Boundary Creek confluence is a large slow flowing channel with shallow side sections that support a number of macrophyte beds. The average stream width at this site is nine meters. The substrate is clay and black silt with some large woody debris and filamentous algae present in addition to the macrophytes. *Juncus*, *Typha*, *Triglochin* and *Polygonum* species are all present instream though riparian vegetation is limited to some isolated trees, a narrow native plantation and pasture grass with stock access. The introduced *Gambusia* (mosquito fish) were collected as bycatch during macroinvertebrate sampling in Spring 2019 and in Autumn 2021. Overall analysis of the health of the waterway using EPA habitat parameters for Low Gradient Streams gives this site a score of 79 out of 140.

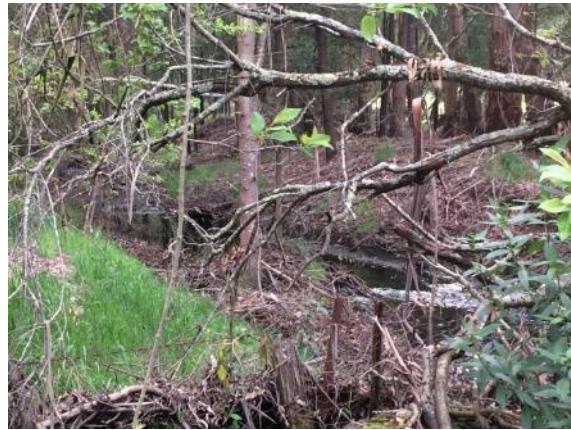
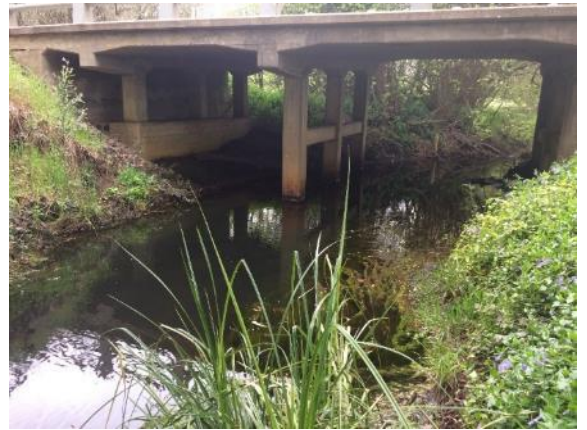
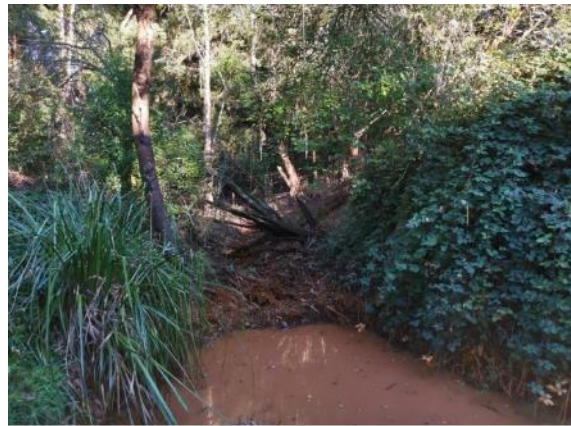
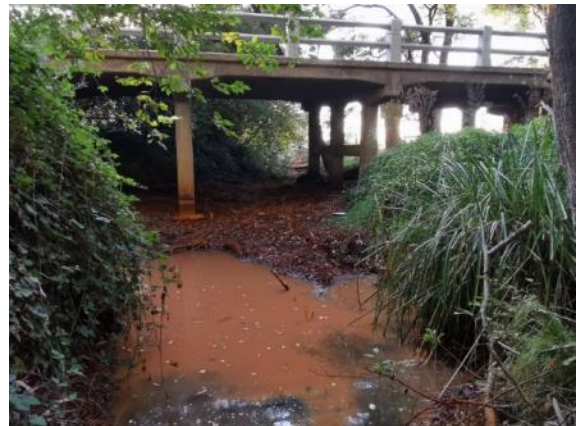
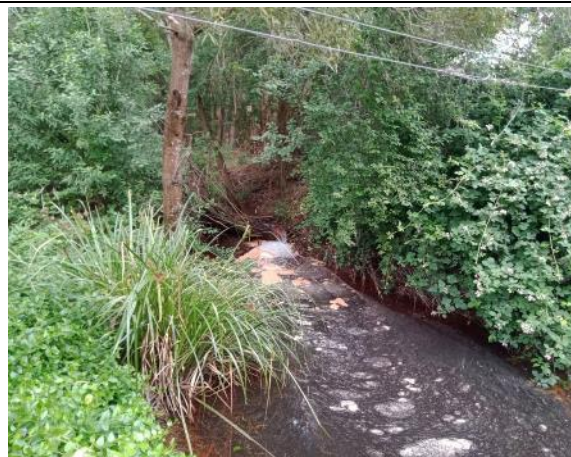
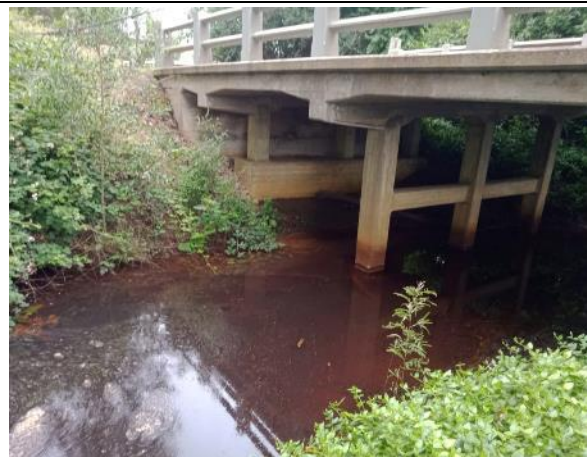
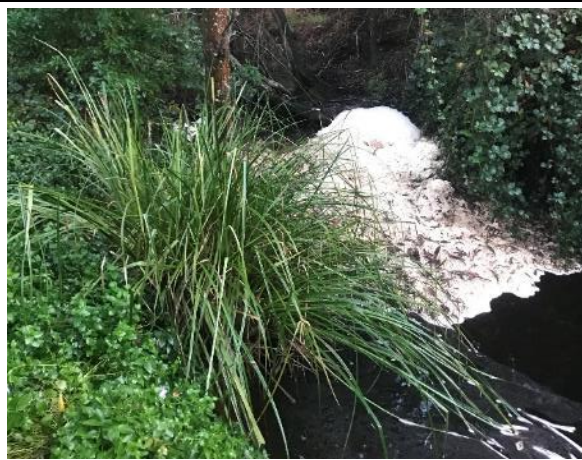
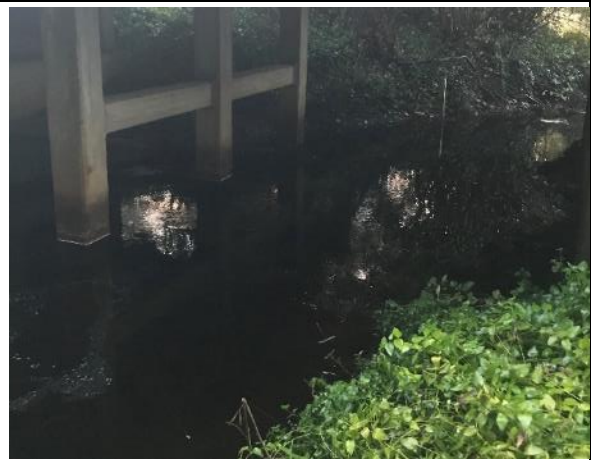
## 4.5. Site 5- Boundary Creek @ Colac- Forrest Road

Boundary Creek at Colac- Forrest Road has a mix of large deep pools, a large shallow pool at the bridge and shallow runs. It has been bankfull with an average stream width of four meters, narrow at the top of the surveyed reach and widening into a large pool upstream of the bridge during each sampling event excepting during Autumn 2020 sampling when the creek had contracted to a pool approximately 4 meters long by 2.5 meters wide. During this time the pooled water was stagnant, with low oxygen concentrations and very high turbidity. The substrate is a mix of cobble, pebble, gravel, sand, clay and silt. There are no macrophytes but there was some filamentous algae in Spring 2019, (absent since) and trailing bank vegetation present. Foam was present at the top of the reach in Spring 2020 and Autumn 2021. The riparian zone is wide and a mix of native and exotic vegetation except the ground cover which is dominated by *Convolvulus* sp. and pasture grasses. Overall analysis of the health of the waterway using EPA habitat parameters for Low Gradient Streams gives this site a score of 81 out of 140.

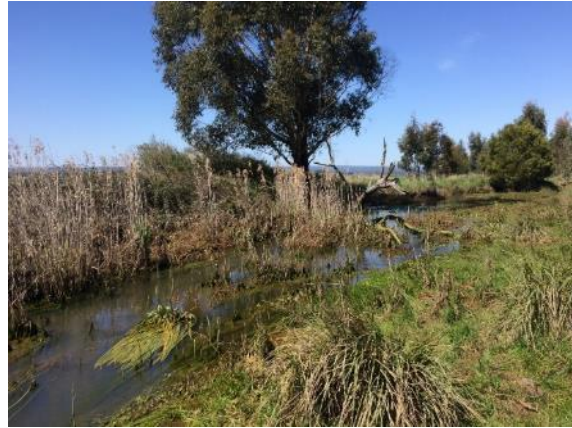
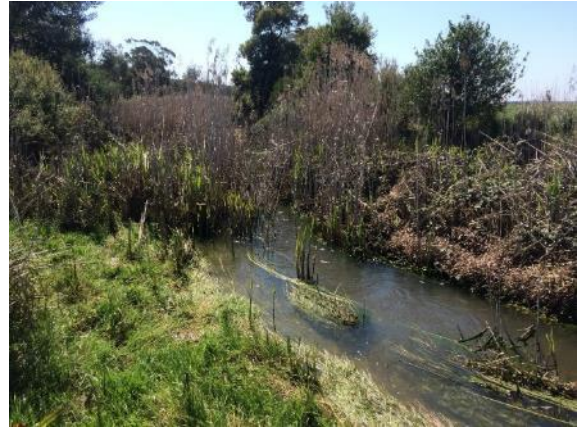
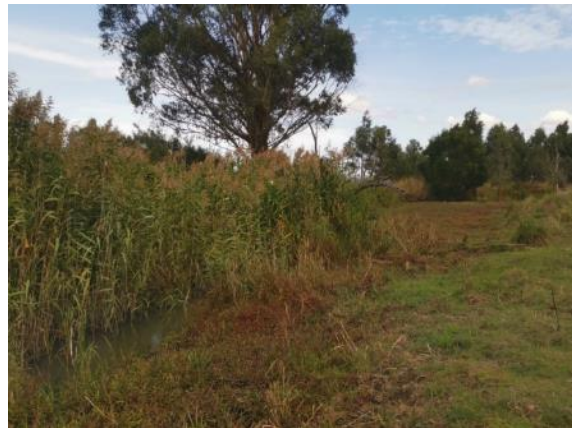
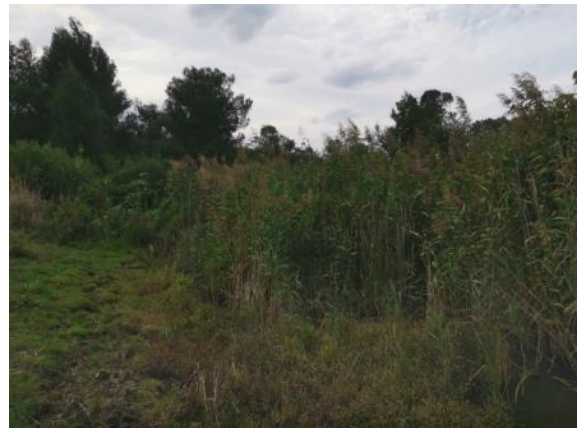
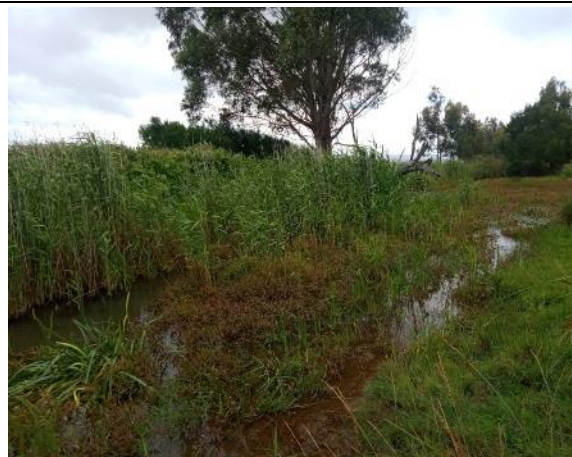
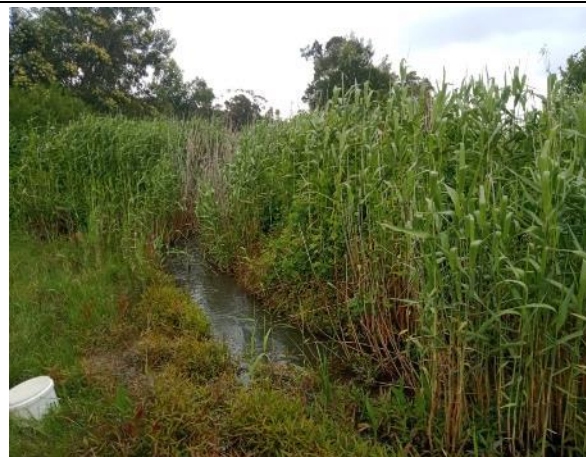
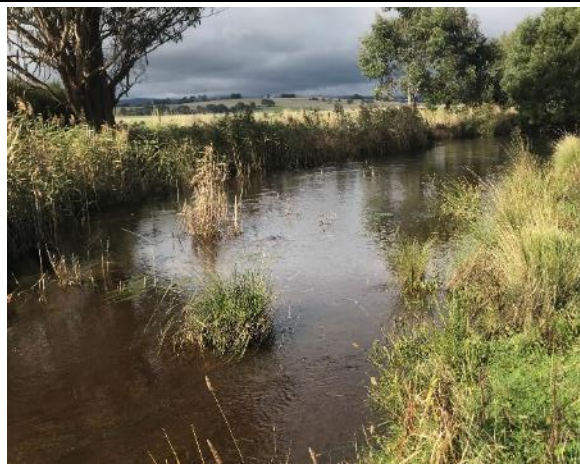
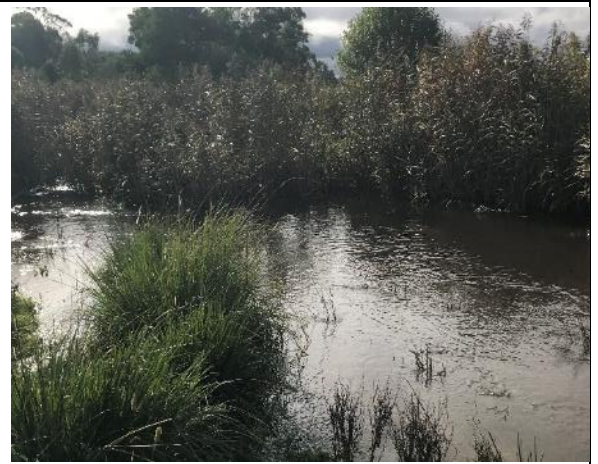
## 4.6. Site 6- Barwon River downstream of Boundary Creek confluence

The Barwon River immediately downstream of the Boundary Creek confluence is a narrow deep channel with wide shallow edges dominated by grasses and aquatic macrophytes. The average stream width at this site is five meters and was bank full in Spring 2019, Spring 2020 and Autumn 2021. There is a narrow channel at the top of the surveyed reach, narrowing to a confined channel downstream. The river had contracted to the main channel but remained flowing, leaving the fringes to dry out in Autumn 2020. The substrate consists of clay and silt usually with filamentous algae tangled through the macrophyte beds but in Autumn 2021 the macrophyte beds were covered in a smothering floc was easily disturbed, forming a thick plume (see photos above). Macrophyte species are varied with *Triglochin*, *Polygonum*, *Phragmites*, and *Juncus* species all present in addition to trailing grasses. Three different fish species were collected at this site as bycatch; southern pygmy perch, smelt and a galaxid in Autumn 2020, and gambusia and southern pygmy perch in Spring 2020. The riparian zone is limited to grasses and scattered native trees and shrubs with stock access to the site. Overall analysis of the health of the waterway using EPA habitat parameters for Low Gradient Streams gives this site a score of 70 out of 140.

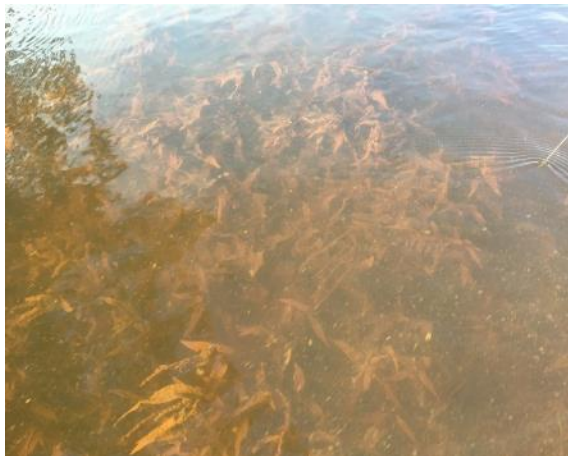
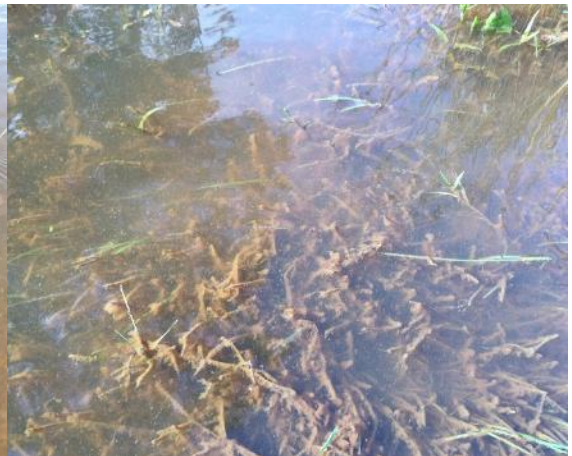
Floc on aquatic vegetation in Autumn 2021

During the Autumn 2021 survey an iron oxyhydroxide floc was observed on vegetation at Site 6 (see photos in Appendix 1). The filterable iron concentration at the site was also elevated (Table 3). Such flocs can be associated with respiration in iron bacteria which convert iron (II) to iron (III) - which is then converted to the red hydrous oxide ("rust"). Often this happens at an anoxic/oxic interface such as where groundwater enters a stream. As catchments "wet up" in autumn and water tables rise, inflows of groundwater into streams increase before appreciable surface runoff. At Site 6 it is likely iron (II) in the water is being oxidised by iron bacteria on the vegetation – taking advantage of the oxygen produced by the plants during photosynthesis. This leads to a build up of  $\text{Fe}(\text{OH})_3$  on the plants. This could be a regular seasonal effect at this site given its proximity to Boundary Creek. (Site 5). Higher flows will dislodge the iron floc.

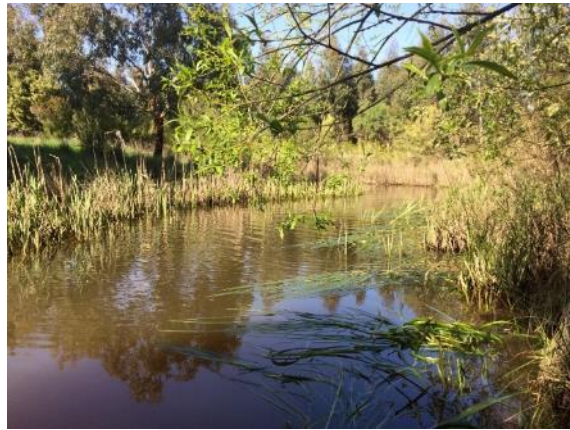
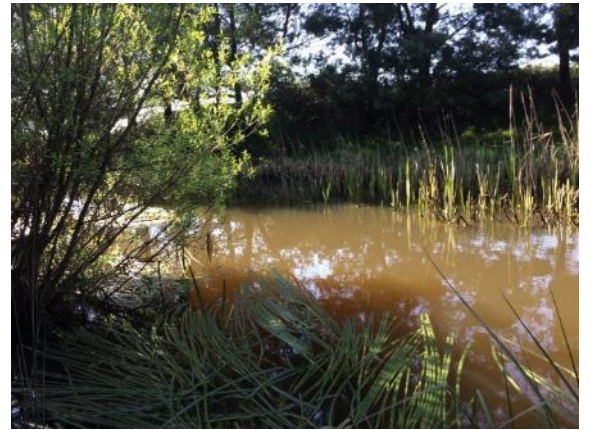
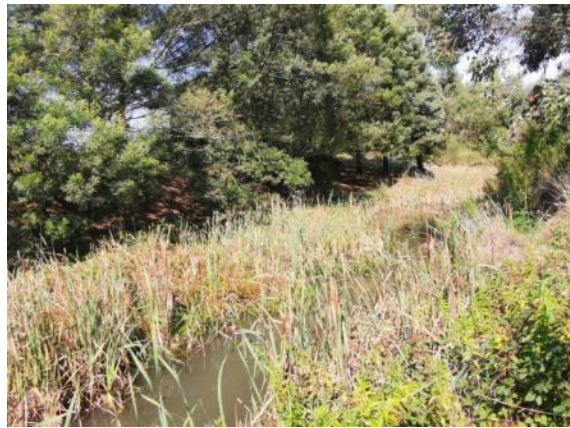
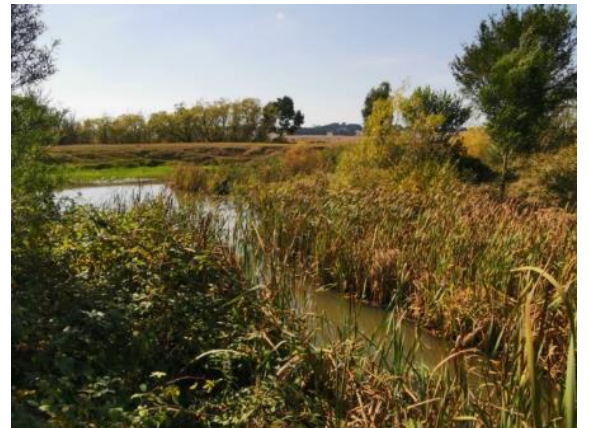
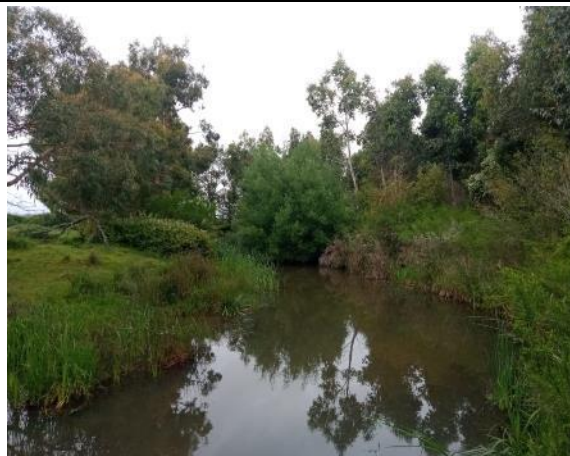
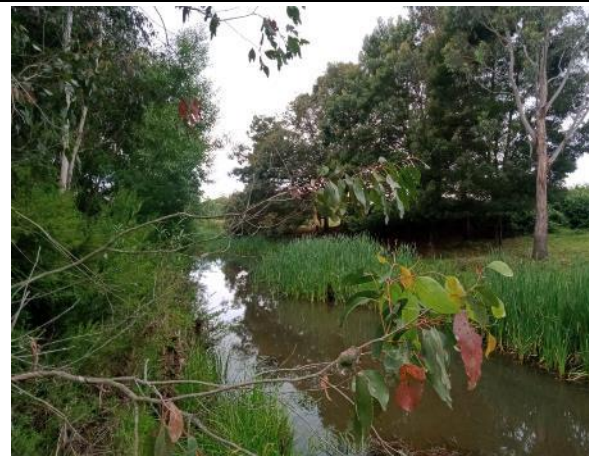
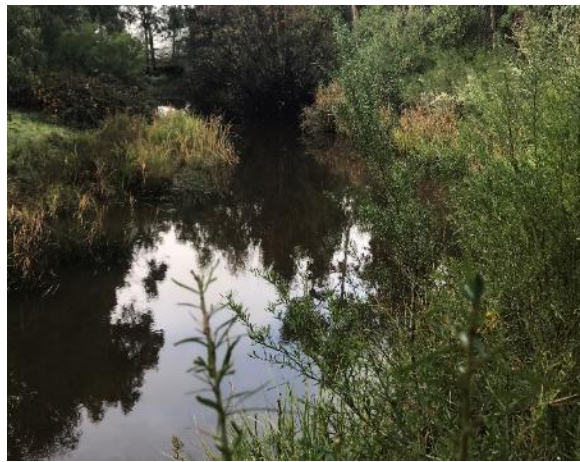
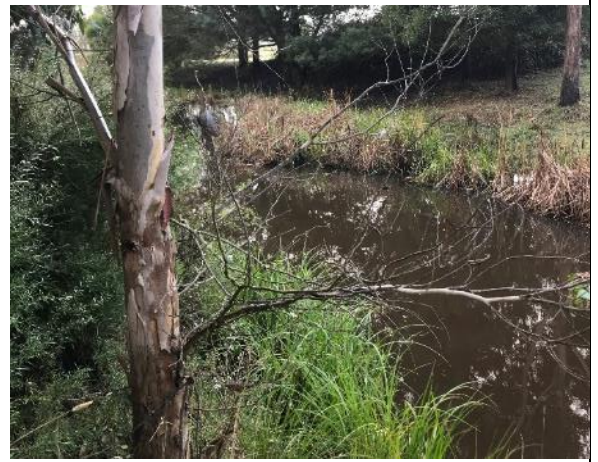
## 4.7. Site 7- Barwon River upstream of CO\_BAR16

The Barwon River upstream of CO\_BAR16 adjacent to the northern boundary of the pine plantation has a large deep channel with any shallow areas dominated by beds of *Phragmites*. The average stream width at this site is seven meters. The substrate is clay and silt. In addition to the *Phragmites* beds there are beds of *Triglochin*, and scattered *Polygonum*, *Juncus* and other grasses. The riparian zone has a good mix of trees, shrubs and understory with a majority of native trees and shrubs. Overall analysis of the health of the waterway using EPA habitat parameters for Low Gradient Streams gives this site a score of 90 out of 140.

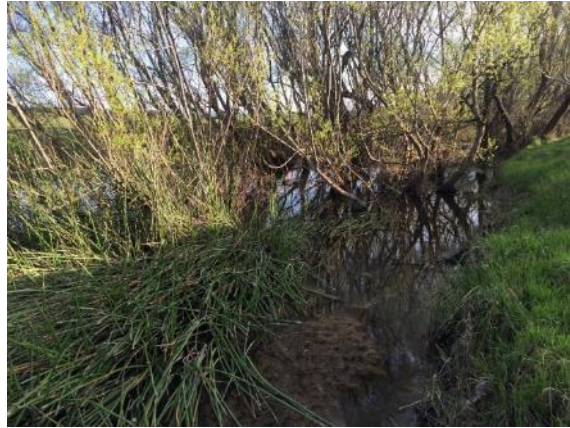
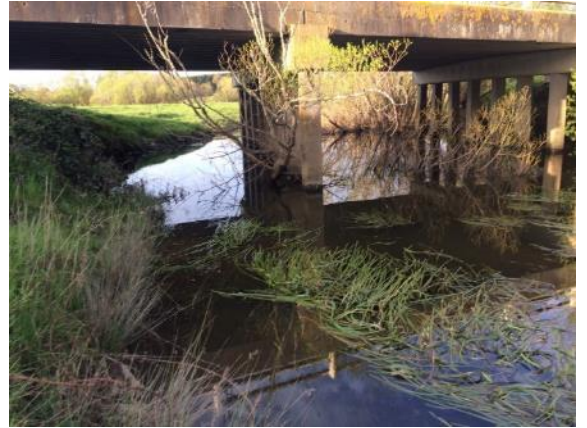
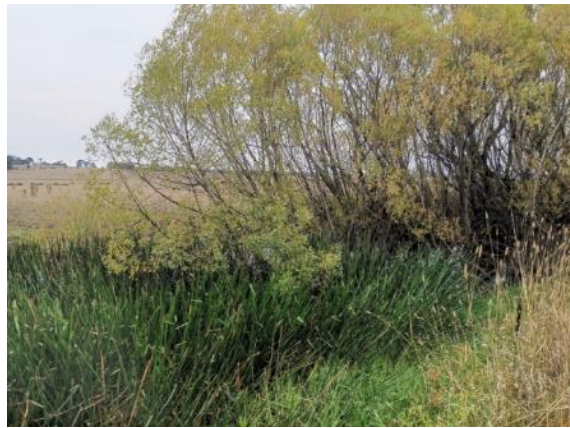
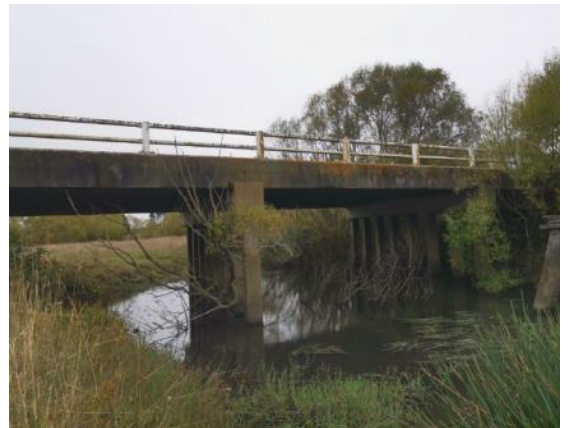
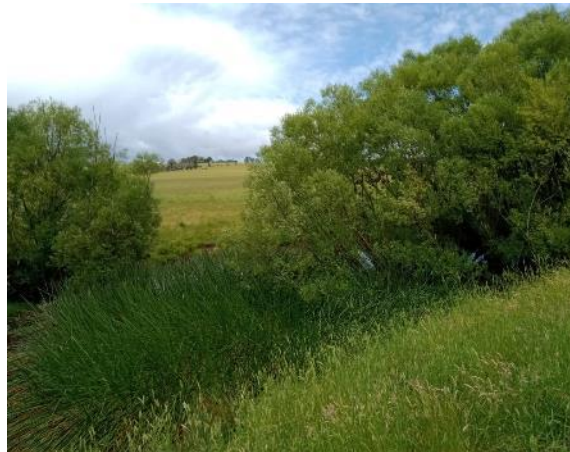
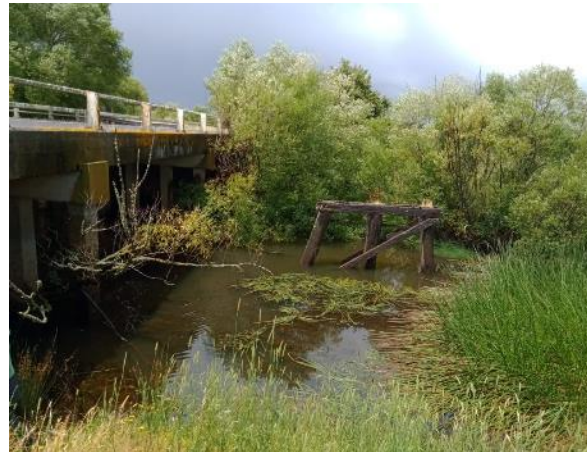
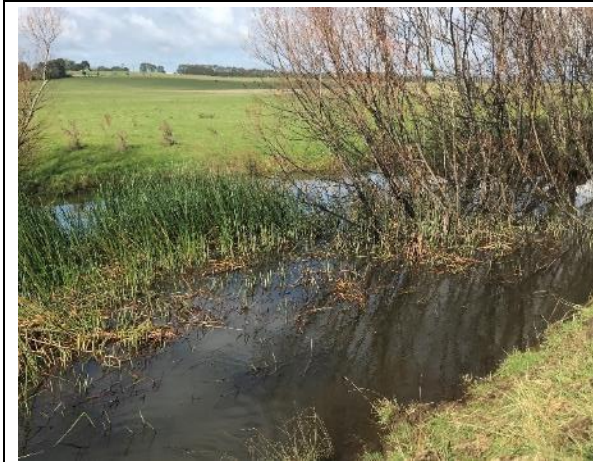
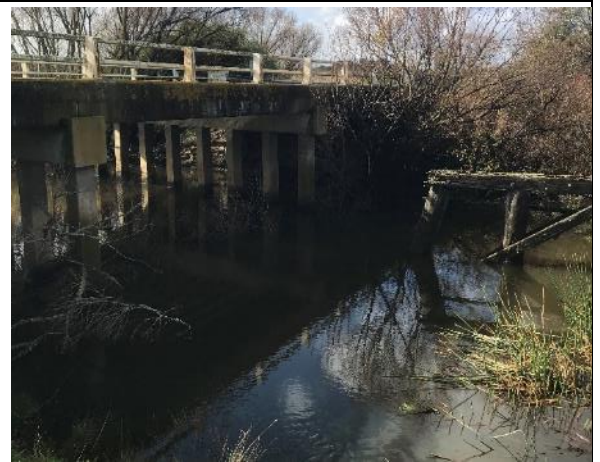
## 4.8. Site 8- Barwon River @ Colac- Lorne Road

The Barwon River at Colac- Lorne Road has large deep pools with a shallow areas at the sides and willow trees growing in the channel and some substrate exposed. The average stream width at this site is eight meters with a predominantly clay and silt substrate mixed with some sand. There are beds of *Triglochin* and *Phragmites* in addition to trailing grasses and large willows. The riparian zone consists of willow trees, pasture grasses and blackberries and allows stock access. Overall analysis of the health of the waterway using EPA habitat parameters for Low Gradient Streams gives this site a score of 69 out of 140.

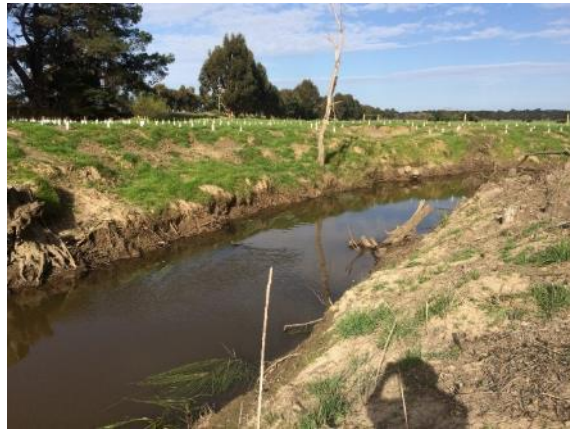
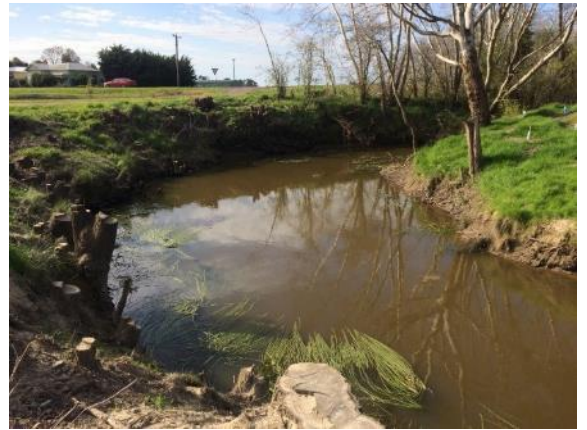
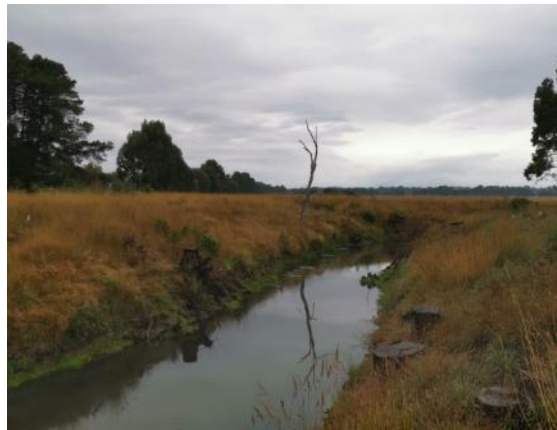
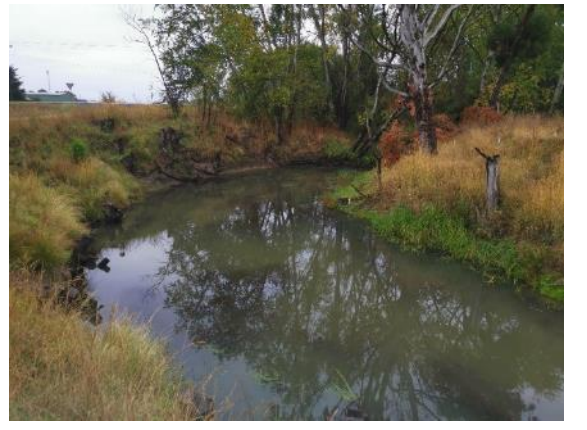
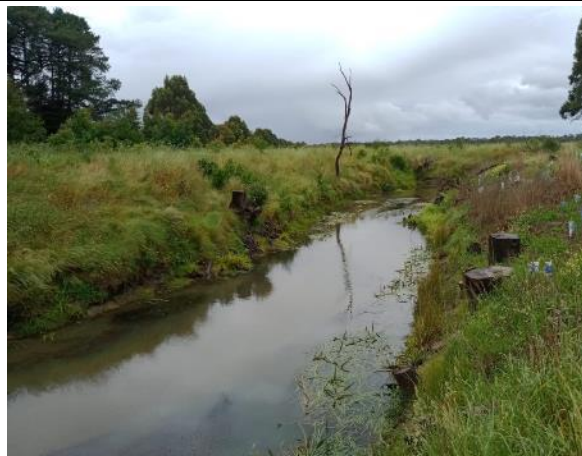
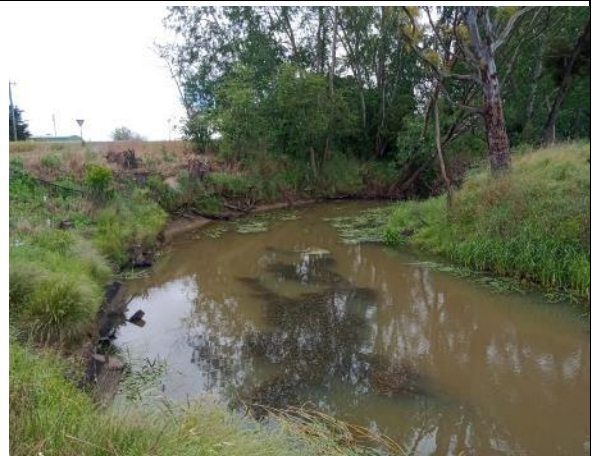
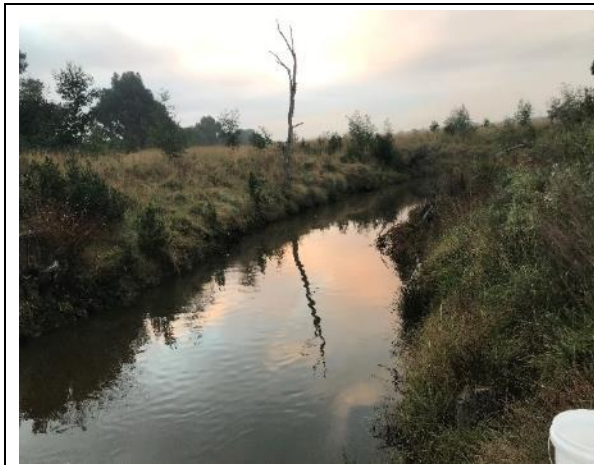
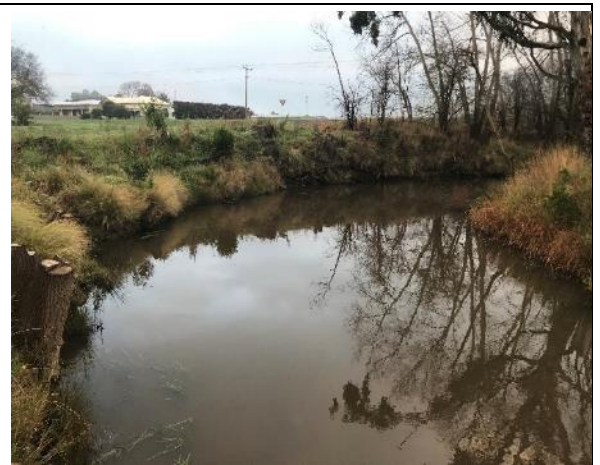
## 4.9. Site 9- Barwon River @ Birregurra

The Barwon River at Birregurra consists of a large deep slow flowing pool. The average stream width at this site is five meters with steep clay banks. The substrate is clay and silt with willow roots, some snags and *Triglochin* beds scattered along the edges of the channel. There were recent willow removal works and replanting of the riparian zone in Spring 2019 amongst the pasture grass and blackberry groundcover. The riparian zone is now growing well (Autumn 2021) although follow up ground cover weed management may be required. Rakali footprints were evident in the soft sediment edge in Spring 2019. Overall analysis of the health of the waterway using EPA habitat parameters for Low Gradient Streams gives this site a score of 67 out of 140.
