# Upper Barwon River Investigation 2019-2021

- Final
- September 2021

| <b>Name of project:</b> | Barwon River/ Boundary Creek Survey |

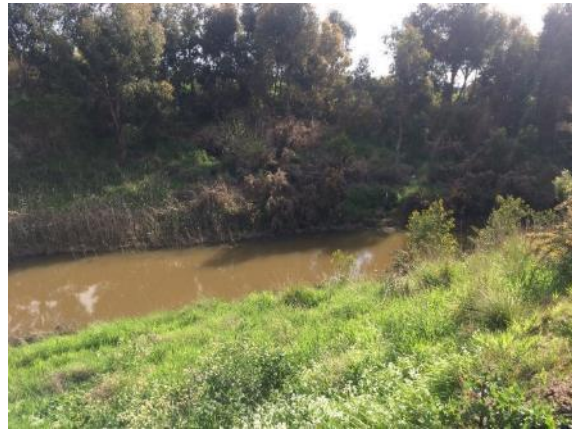
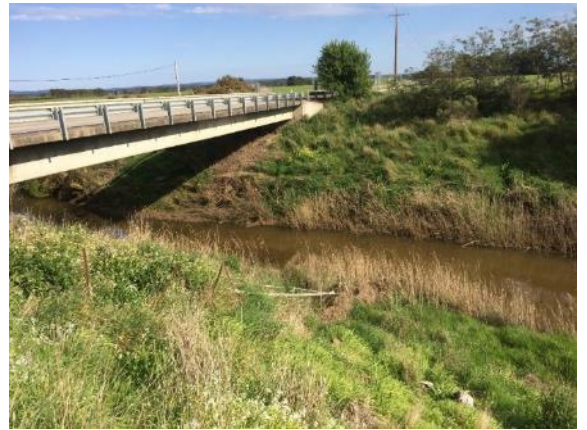
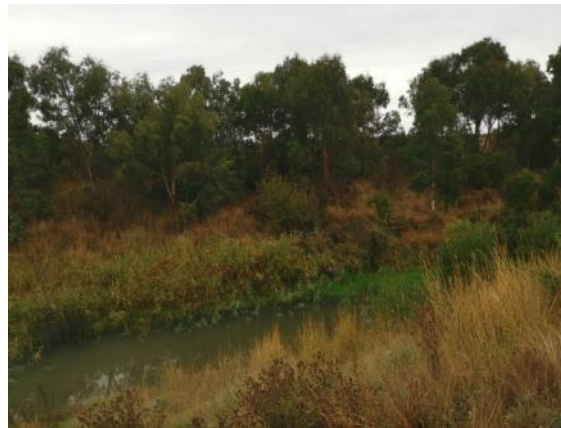
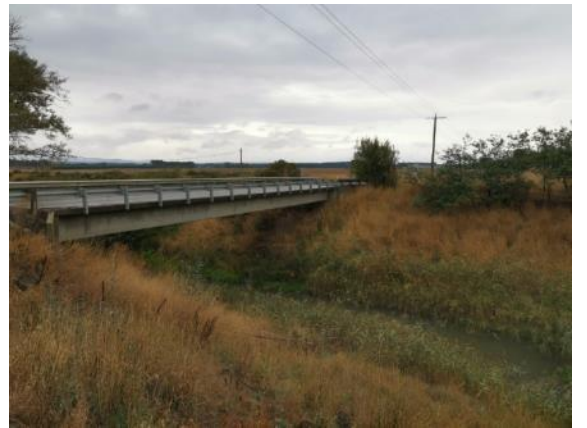
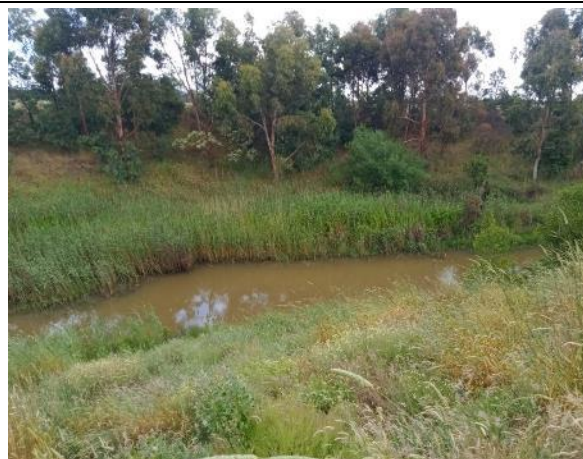
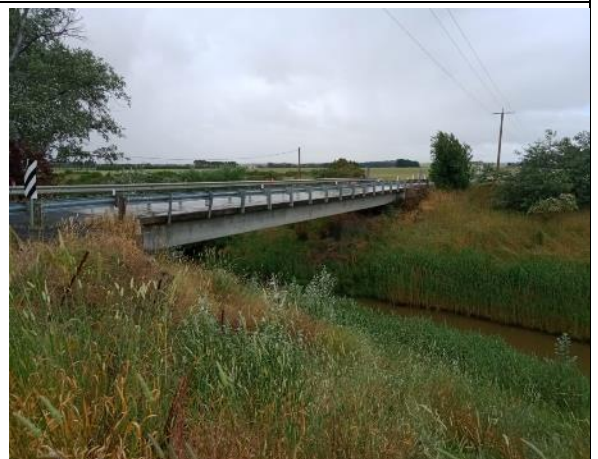
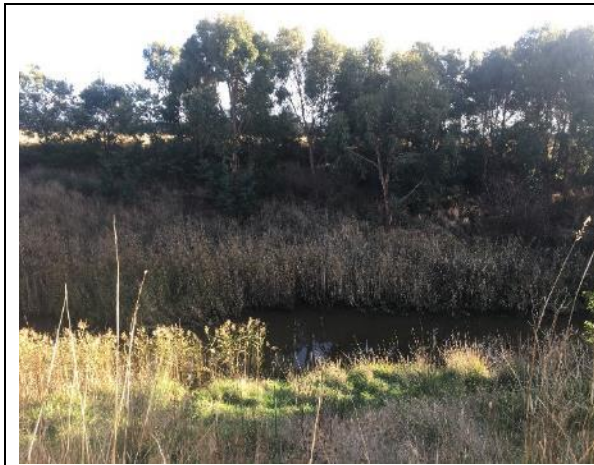
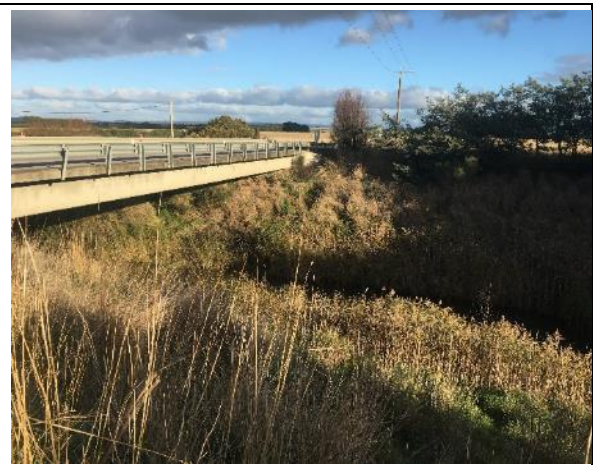
## 4.10. Site 10- Barwon River @ Conns Lane

The Barwon River at Conns Lane has large deep pools with some small deep backwaters and a narrow deep run at the top of the reach. The average stream width at this site is six meters. The substrate is clay and silt mixed with some sand and gravel. Phragmites beds line the channel and there are isolated patches of *Triglochin* in addition to *Polygonum* and trailing grasses along the waters edge. The trailing and shallow vegetation contained filamentous algae in Autumn 2021. Larval fish and gambusia were collected in the macroinvertebrate net in Spring 2020 and gambusia were plentiful in Autumn 2021. The riparian zone consists of relatively new and older native revegetation with pasture grass understory. Overall analysis of the health of the waterway using EPA habitat parameters for Low Gradient Streams gives this site a score of 98 out of 140.

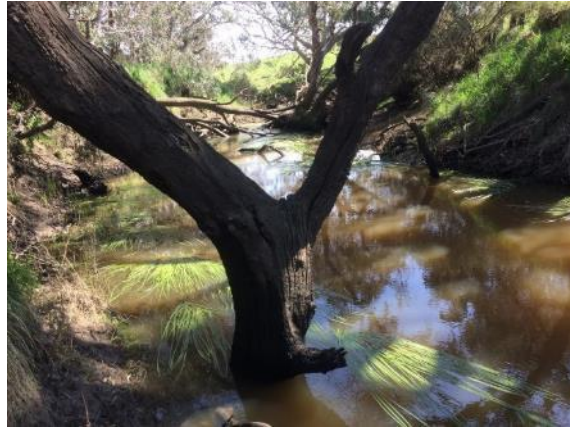
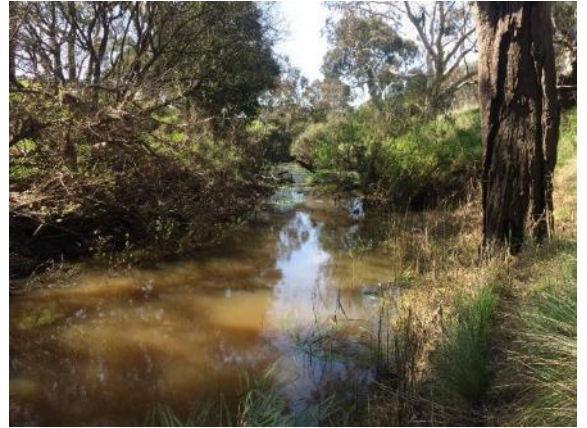
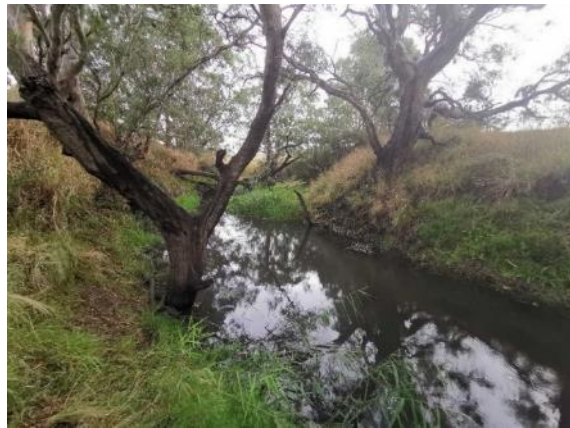
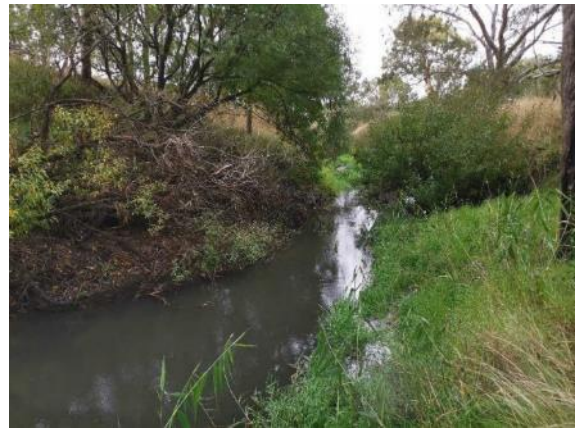
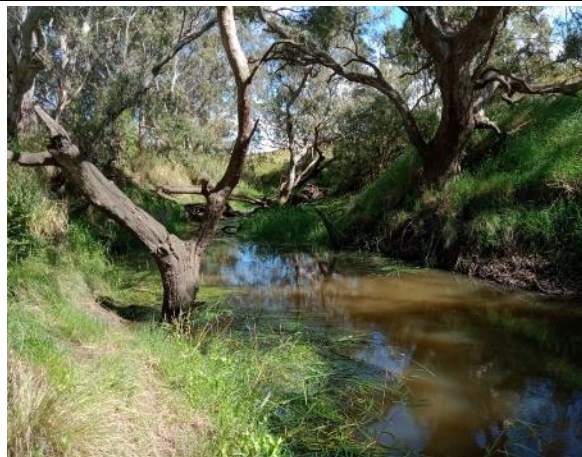
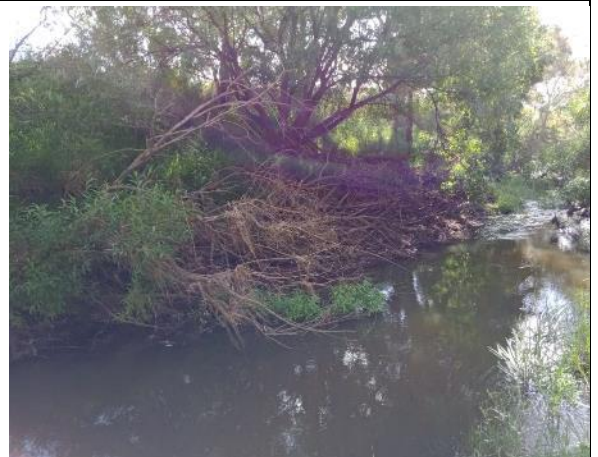
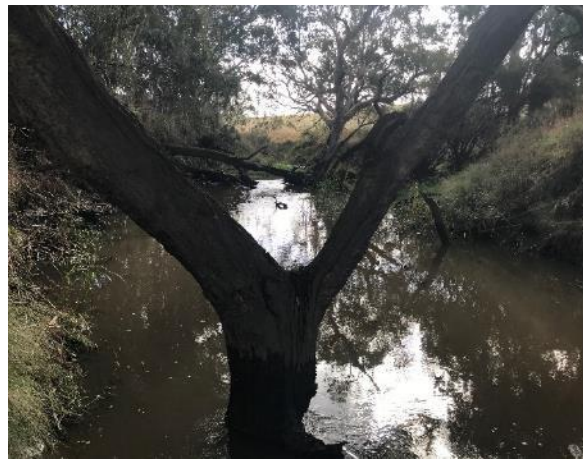
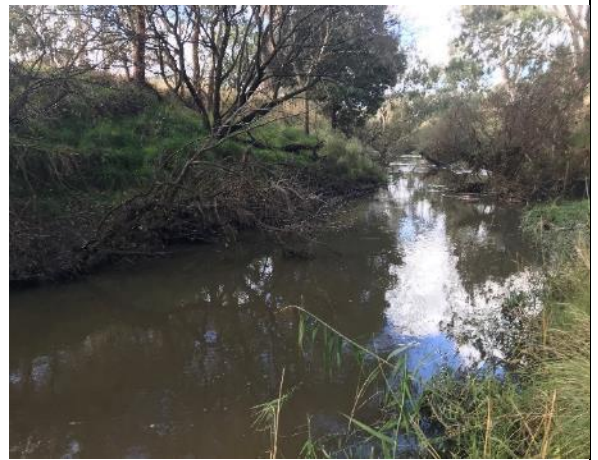
The Barwon River at Winchelsea- Deans Marsh Road has large deep pools with a shallow run at the top of the reach. The average stream width at this site is five meters and the substrate is clay and silt mixed with some sand and gravel. *Triglochin* is growing in the shallow areas of the channel and there are roots, large woody debris and trailing grasses. The riparian zone is predominately native trees and understory with a mix of grasses as groundcover. Rakali footprints were spotted at the waters edge in Spring 2019. Overall analysis of the health of the waterway using EPA habitat parameters for Low Gradient Streams gives this site a score of 90 out of 140.

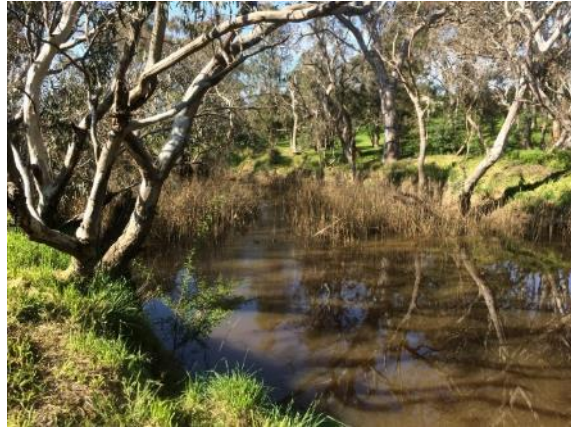
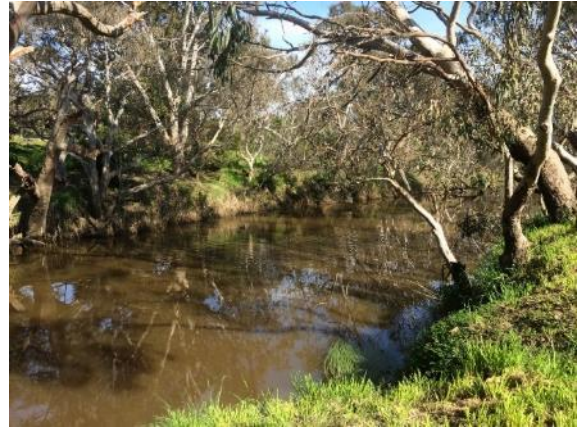
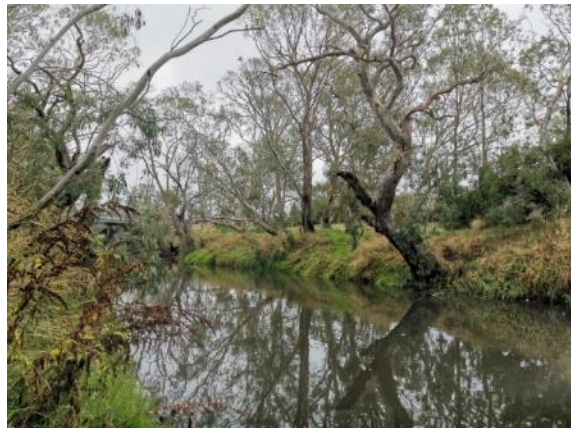
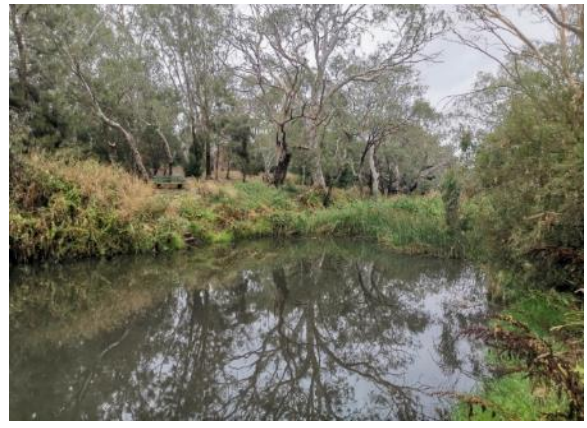
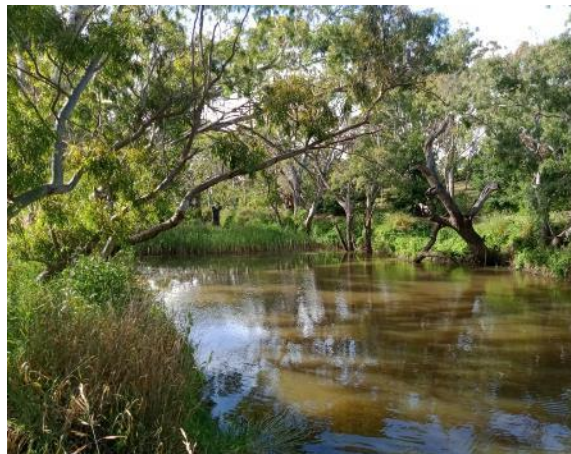
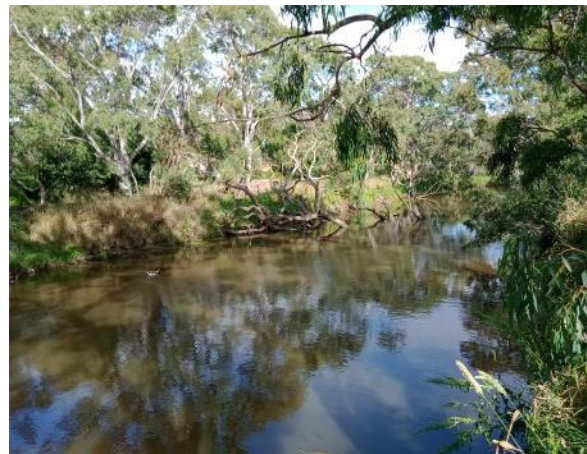
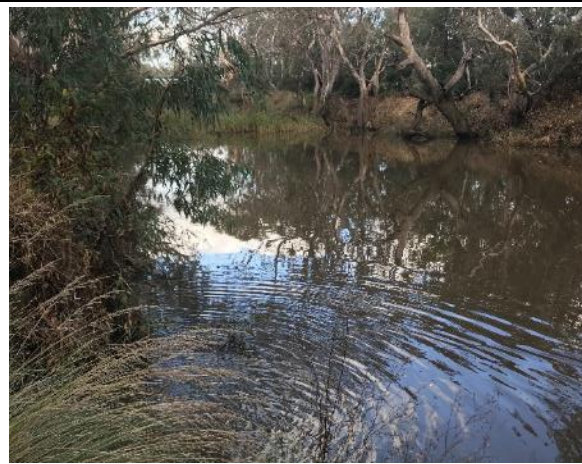
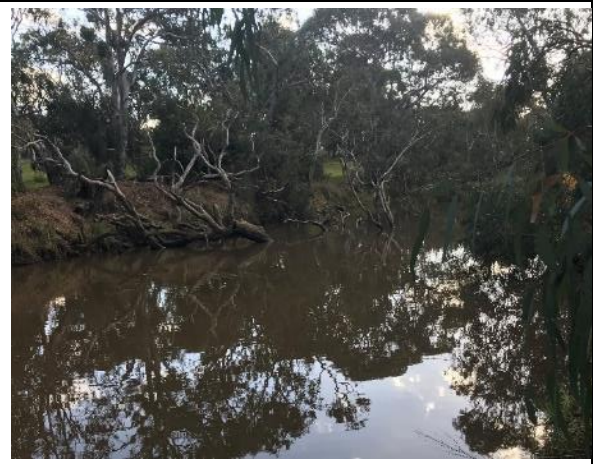
The Barwon River at Winchelsea has large deep pools with a large shallow pool at the top of the reach. The average stream width at this site is twelve meters. The substrate is clay and silt mixed with sand and some gravel. In addition to the *Phragmites* beds at the top of the reach and along some edges there are also patches of *Triglochin*. Large woody debris, trailing grasses and emergent vegetation such as *Polygonum* are also present. Riparian vegetation is predominantly native with many established eucalypts and groundcover is pasture grass. A concurrent snapshot study by EnviroDNA (2019) in Spring found evidence of platypus at this site. Overall analysis of the health of the waterway using EPA habitat parameters for Low Gradient Streams gives this site a score of 88 out of 140.
