Upper Barwon River Macroinvertebrate Sampling Report 2019-2022

- Final
- June 2022

Austral Research and Consulting
ABN 73 007 840 779
15 Buntings Rd
Kirkstall Vic 3283 Australia
Web: www.austral.net.au

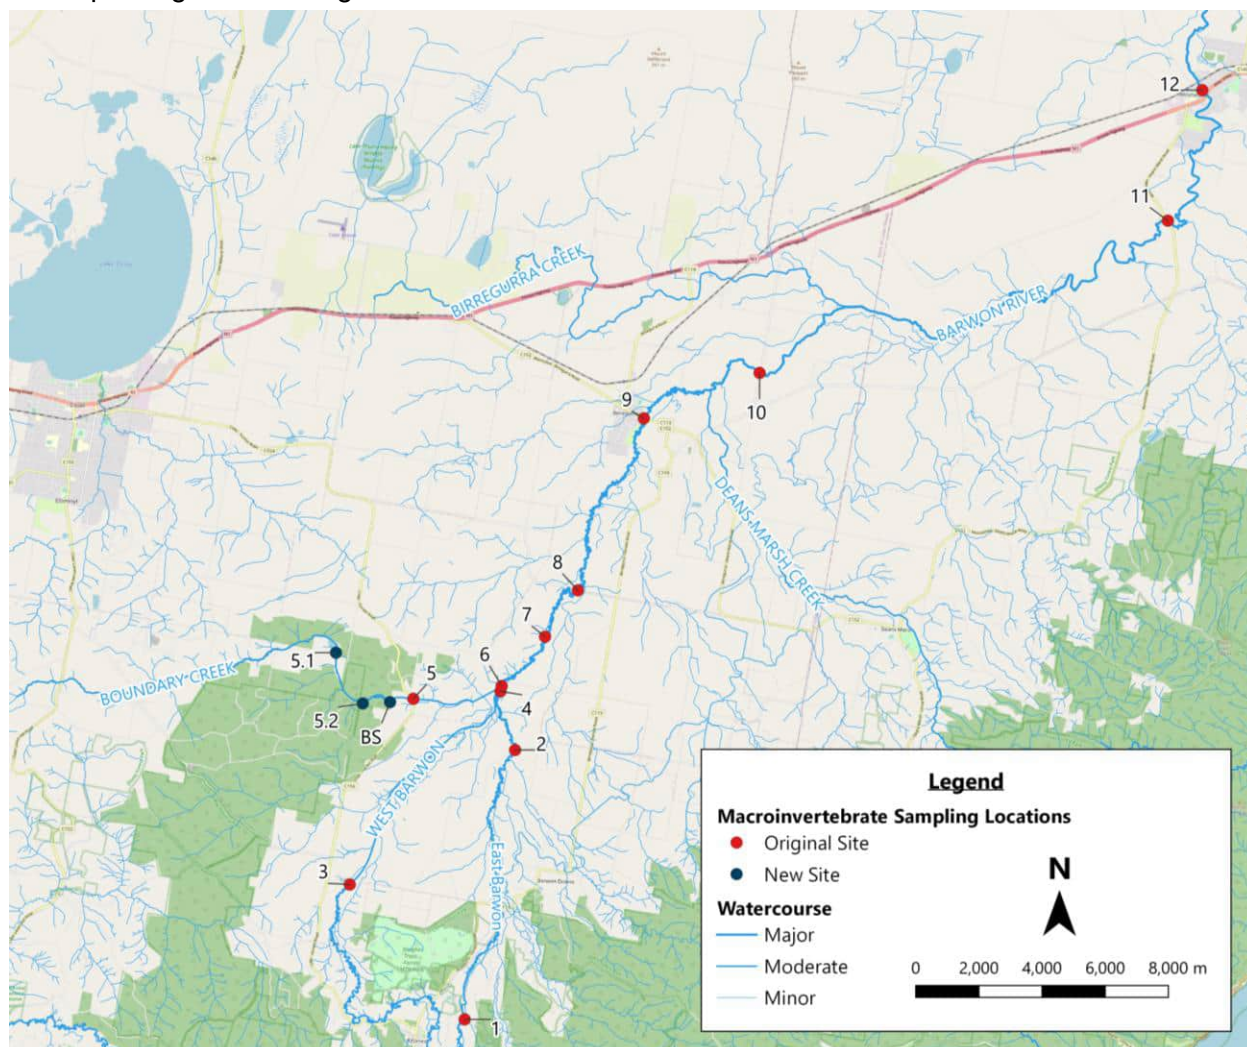
A total of twelve sites were surveyed along East Barwon, West Barwon, and Barwon Rivers in addition to Boundary Creek (Figure 1) in Spring 2019, Autumn 2020, Spring 2020, Autumn 2021, Spring 2021 and Autumn 2022. A further 3 sites were surveyed on Boundary Creek and in Big Swamp along with the original twelve in Autumn 2022.

■ **Figure 1: Barwon River and Boundary Creek (base map from Open Street Map). Red markers are original sites, blue are new sites added in Autumn 2022.**

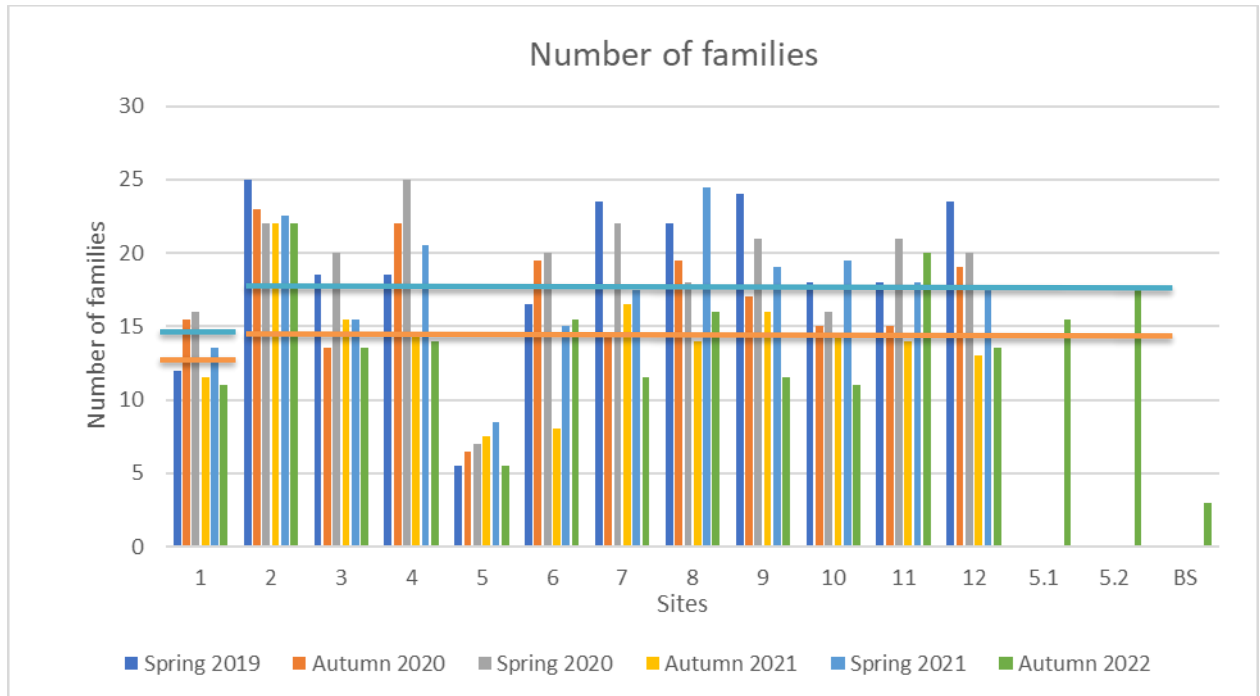
■ **Figure 2: Number of families found in edge habitats in the Barwon River and Boundary Creek. Blue line denotes Spring objective and orange line denotes Autumn objective.**

Figure 2 shows that the East Barwon River at Dewings Bridge Road (Site 2) is the only site to consistently meet the objectives for Number of Families. In addition, the new site, Site 5.2 on Boundary Creek immediately above Big Swamp, and Site 11 were the only other sites to meet the Number of Families objective in Autumn 2022. There are no consistent patterns along the waterways over time but it is interesting to note that Boundary Creek above Big Swamp (Sites 5.1 and 5.2) have comparable numbers of families present to sites on the Barwon River.

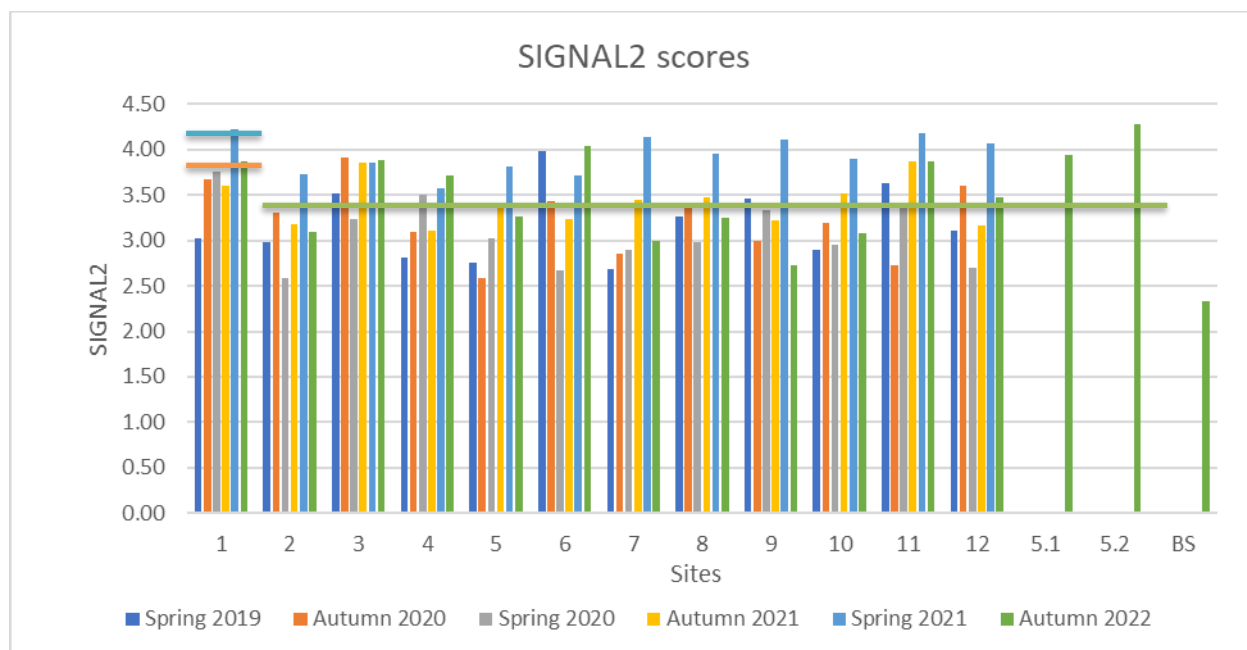
- **Figure 3: SIGNAL2 index scores from edge habitats in the Barwon River and Boundary Creek. Blue line denotes Spring objective and orange line denotes Autumn objective for Uplands B objectives and green line denotes both Spring and Autumn objective for Central Hills and Coastal Plains objective.**

Figure 3 shows that whilst none of the sites consistently meet the objectives for SIGNAL2, Site 3 on the West Barwon River at Seven Bridges Road and Site 11 on the Barwon River upstream of Winchelsea have met objectives during five of the six sampling events. Boundary Creek at Colac-Forrest Road (Site 5) met the SIGNAL2 objectives during the Spring 2021 sampling event when pH was at its most neutral (6.05 pH units). The two Boundary Creek sites upstream of Big Swamp recorded amongst the highest SIGNAL2 scores of the study.

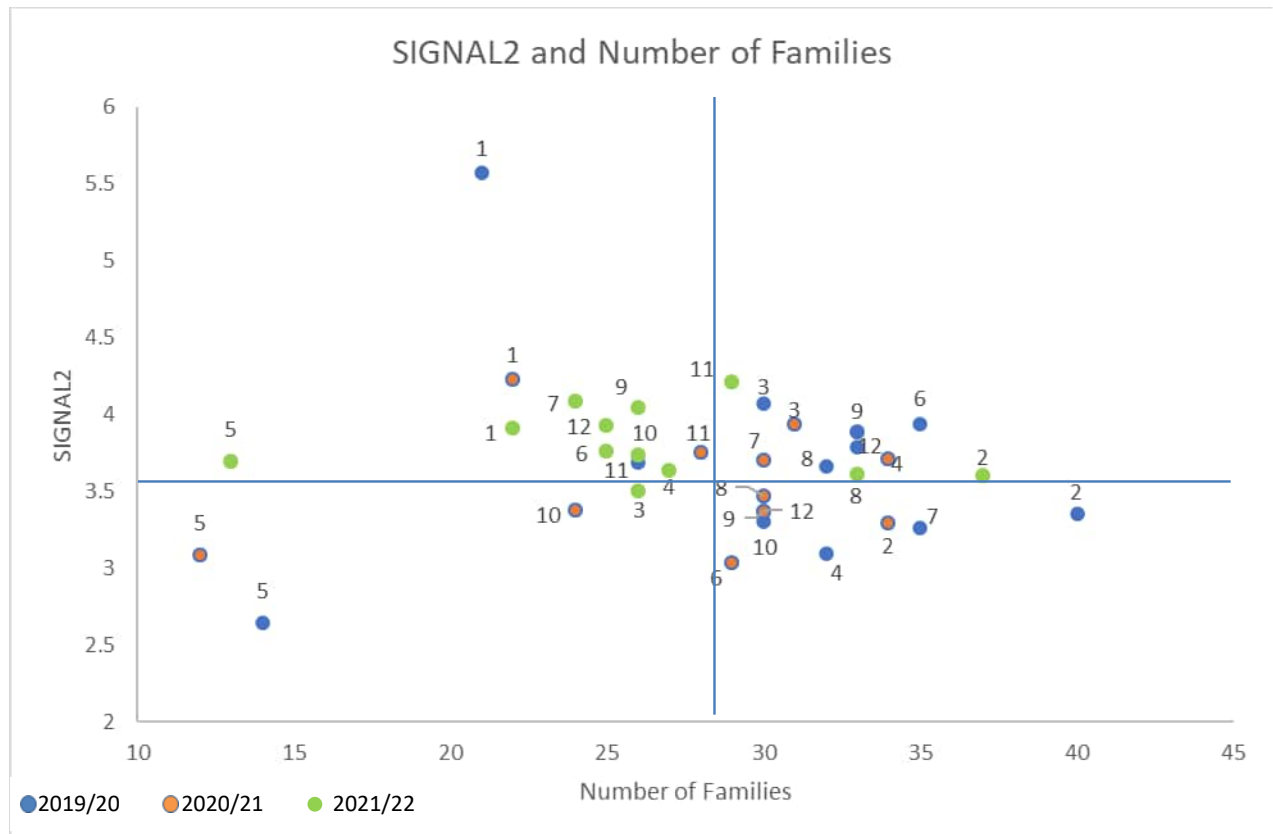
■ **Figure 4: SIGNAL2 index plotted against number of families recorded for each site combined over season for three years.**

Figure 4 above shows that for most sites, above and below the Boundary Creek/ Barwon River confluence, there was a shift to the upper left quadrant with fewer families being present but not a corresponding shift to fewer pollution sensitive taxa. Sites in this quadrant are often subject to toxic pollution such as heavy metals or low pH or harsh physical conditions (Chessman, 2003). The cause of the shift is not clear but is unlikely to be due to Boundary Creek impacts as sites above and below the confluence were affected.

The two uppermost sites on the Barwon River tributaries, Site 1 (East Barwon at Kents Road) and Site 3 (West Barwon at Seven Bridges Road) show different patterns to the majority of the sites. The river has been extensively modified during willow removal works at Site 1 during the 2021/22 summer with the number of families remaining stable but the SIGNAL2 score has declined over the study period. The SIGNAL2 score has also declined over time at Site 3 and the number of families present has reduced by five families between 2020/21 and 2021/22.

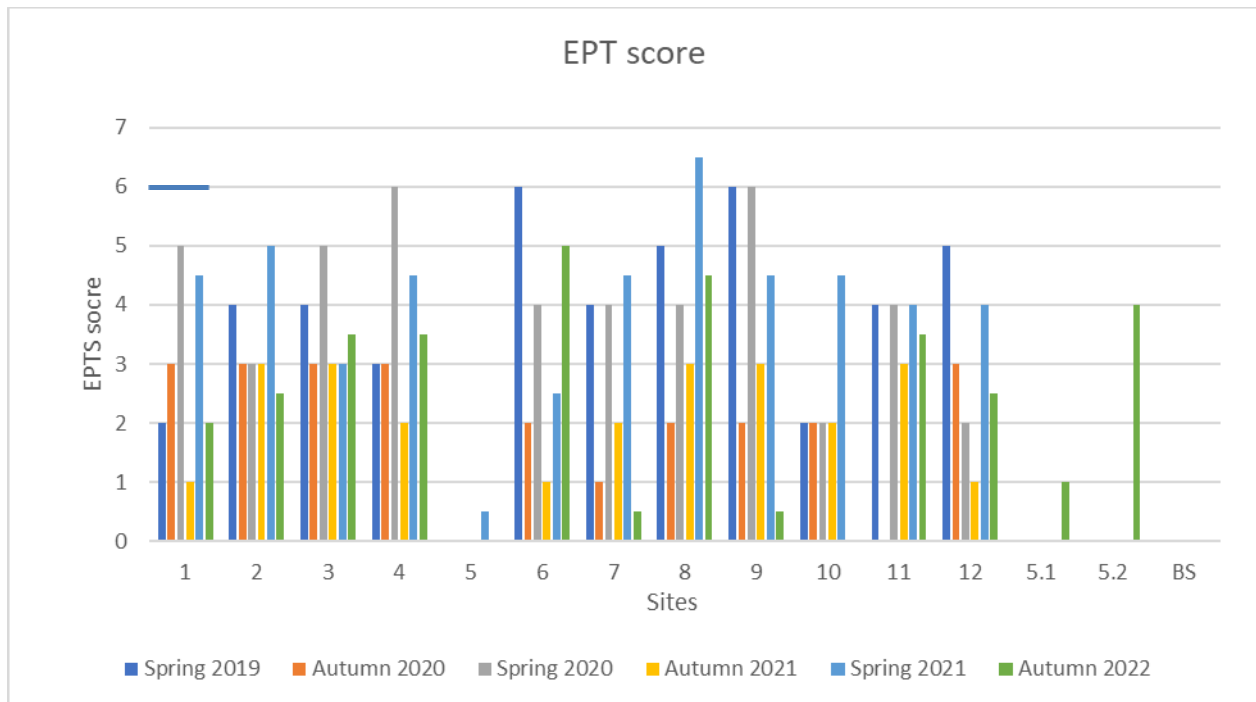
■ **Figure 5: EPT (Ephemoptera, Plecoptera, Tricoptera families) index scores from edge habitats in the Barwon River and Boundary Creek. There is only a Spring objective for Uplands B region (blue line).**

Whilst the number of pollution sensitive taxa present (EPT score) does not have an objective for many of the sites in this study, Figure 5 shows that sites such as Site 9 at Birregurra have good numbers of these taxa present in Spring and that in Spring 2021, Site 8 at Colac-Lorne Road had the highest number of EPT taxa present over the three years.

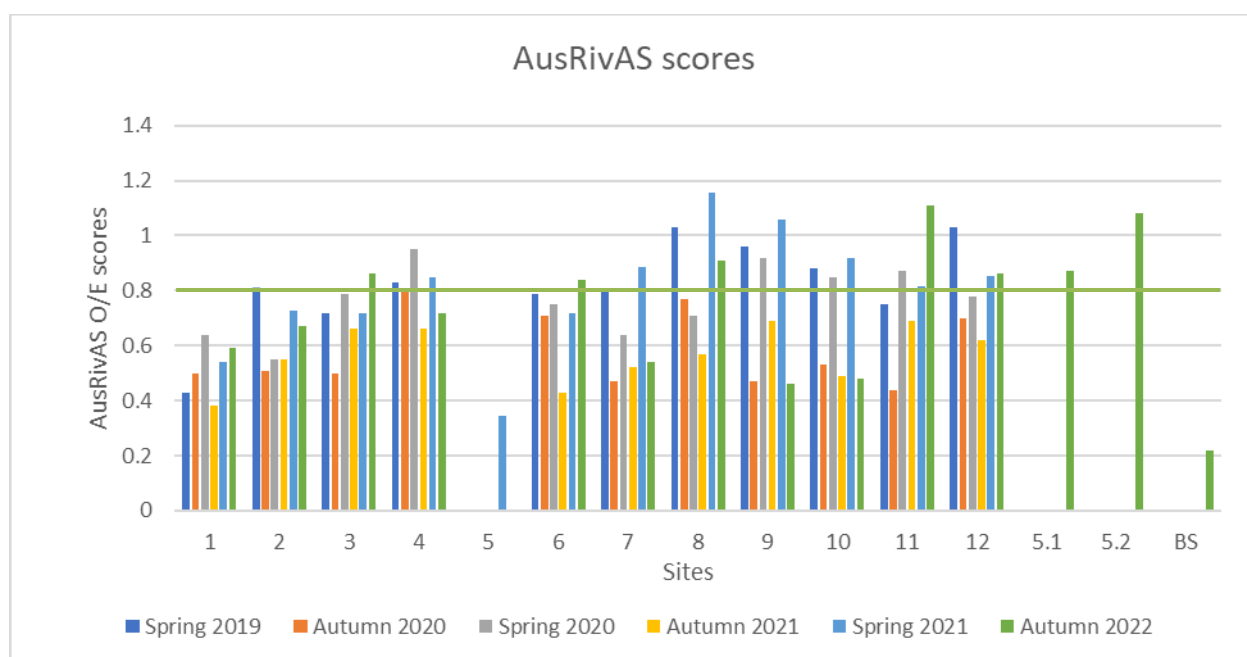
■ **Figure 6: AusRivAS observed vs expected (O/E) scores from edge habitats in the Barwon River, Boundary Creek and Big Swamp. Green line denotes both Spring and Autumn objective (Band A).**

Sites 4 (upstream of Boundary confluence), 9 (Birregurra) and 10 (Conns Lane) meet AusRivAS objectives during every Spring sampling events over the three years. AusRivAS objectives were met in both the latest Spring and Autumn sampling events at Sites 8 (Colac-Lorne Road), 11 (Winchelsea-Deans Marsh Road), and 12 (Winchelsea). The two new sites on Boundary Creek above Big Swamp (Site 5.1 and 5.2) both met objectives and the site in Big Swamp recorded the lowest score whilst Site 5 was once again outside the experience of the model in Autumn, presumably due to the low alkalinity at this site.

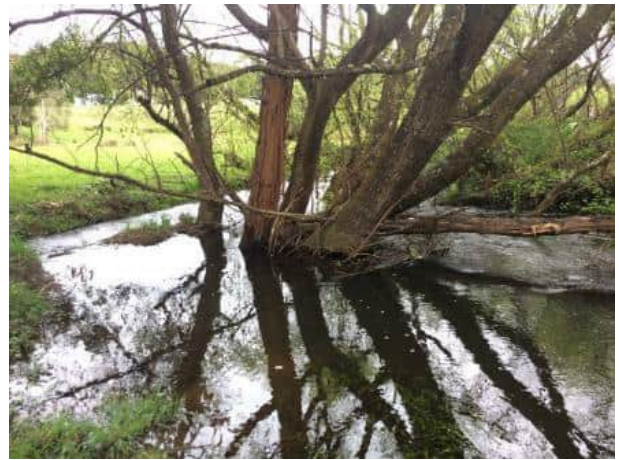
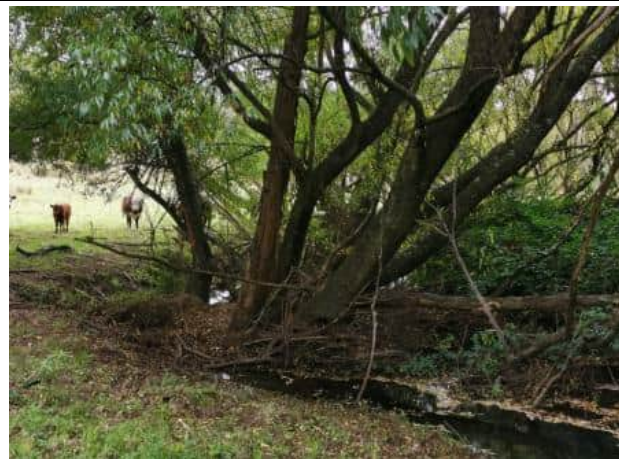
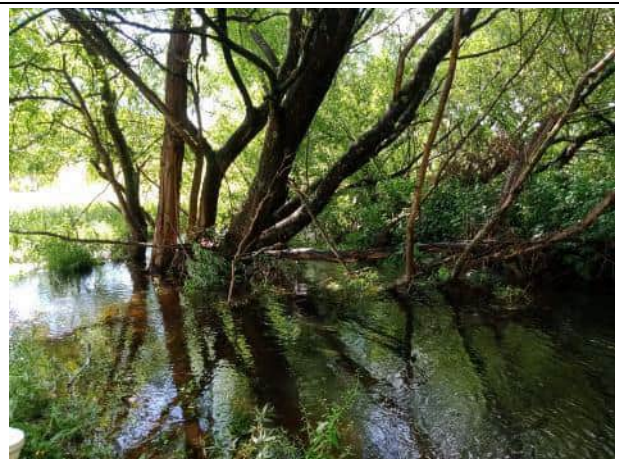
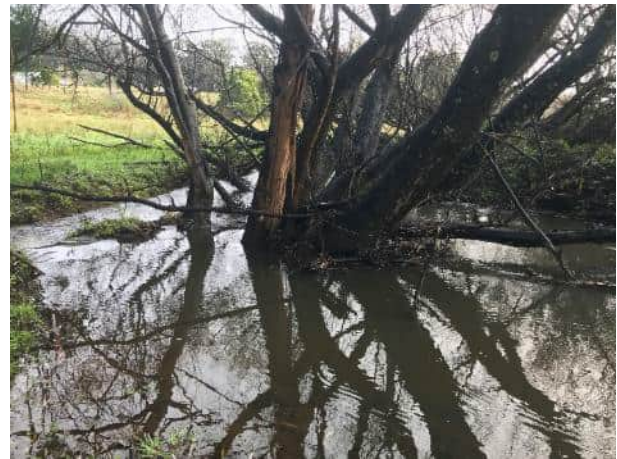
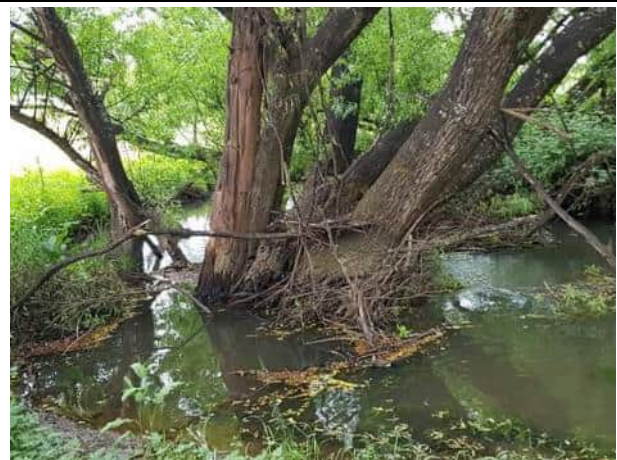
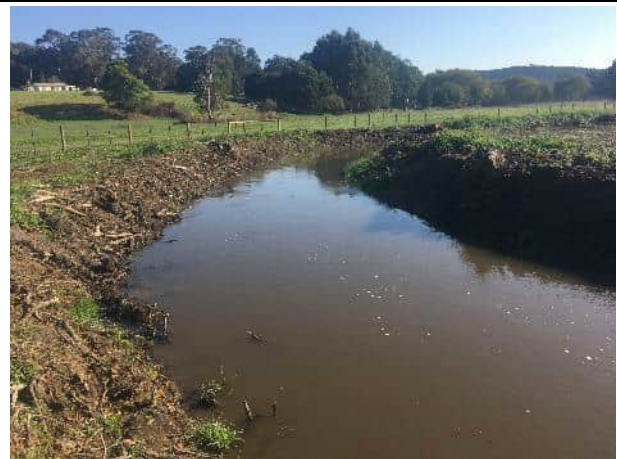
Prior to the willow removal and river realignment in early 2022, the East Barwon River at Kents Road had diverse habitat with large deep pools and some riffle/ run areas. These runs had dried to trickles in Autumn 2020 but were flowing well in Spring and Autumn 2021. The average stream width was eight meters and bank full but had contracted to five meters in Autumn 2020. Willows dominate the riparian zone and are growing within the stream channel. The substrate was a mix of clay and silt with a number of aquatic macrophytes growing in the margins and shallow pool areas. The majority of the riparian zone was exotic vegetation, dominated by blackberries (possibly poisoned in Summer 20/21), willows and pasture grass. One larval fish has been collected as bycatch during macroinvertebrate sampling. A concurrent snapshot study by EnviroDNA (2019) found evidence of platypus at this site.

Following the works in January to April 2022 (Barwon Water, 2022), the East Barwon River at Kents Road is a homogenous channel with very little riparian zone and submerged macrophytes. The banks were either disturbed bare earth with some grasses beginning to establish or rip rap and not unexpectedly for such extensive and recent works, the river was more turbid than previously observed. Stock now appear excluded from the waterway and all woody weeds have been removed within the vicinity of the site.

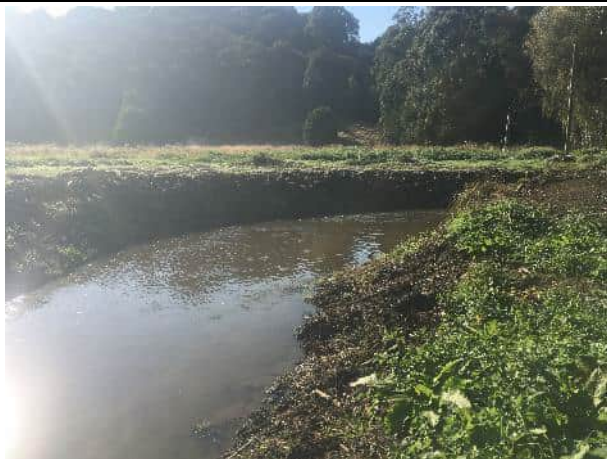
Site 1: upstream Autumn 2022

Overall analysis of the health of the waterway using EPA habitat parameters for Low Gradient Streams gives this site a score of 74 out of 140 in 2019 and a downgraded score of 57 out of 140 in 2022 due to the recent works. It is expected that this score will improve following the planned revegetation works and ongoing stock exclusion.

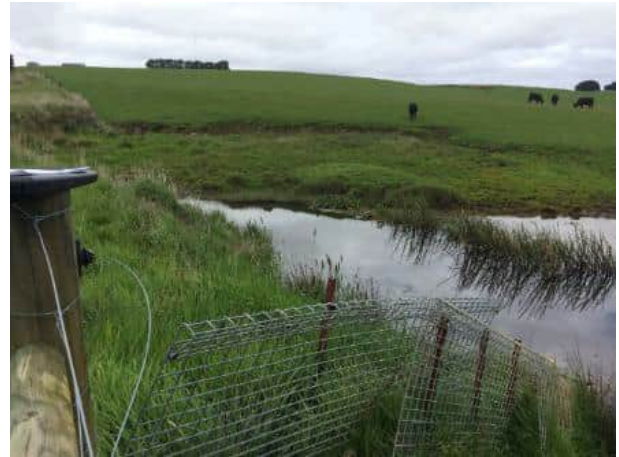
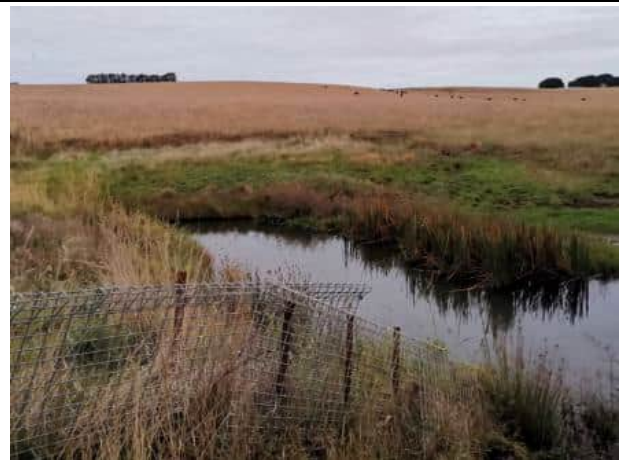
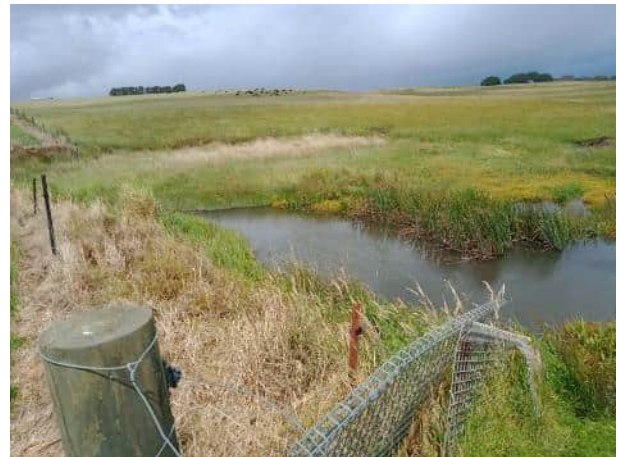
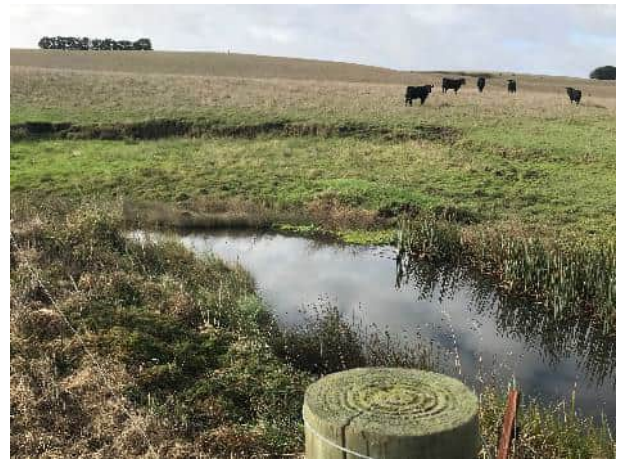
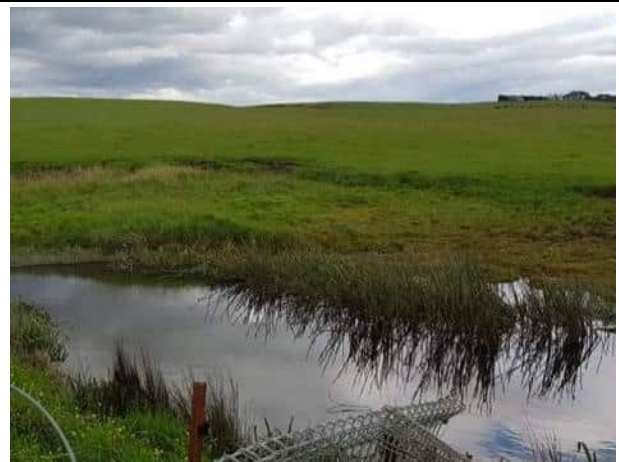
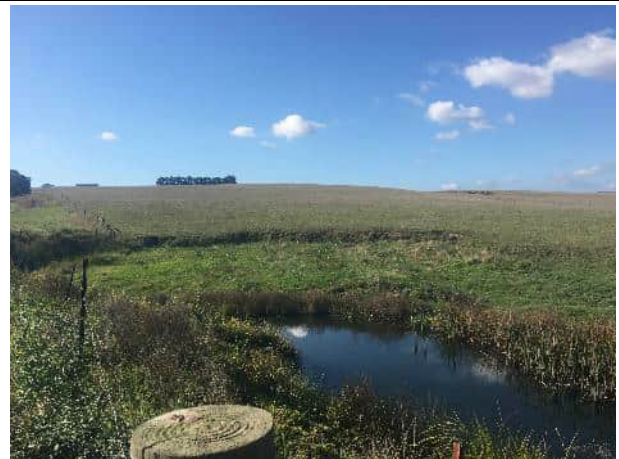
The East Barwon at Dewings Bridge Road consists of a slow flowing channel with extensive backwaters. There is very little riparian zone present but a number of submerged and emergent macrophytes provide good habitat for macroinvertebrates and fish. One larval fish was found in the sample net in Autumn 2020, three pygmy perch in Spring 2020 and a pygmy perch in Spring 2021. The substrate is a mix of clay and silt with some sand. The average stream width at this site was seven meters and was bank full during both Spring and Autumn sampling. The majority of the riparian zone is pasture grass with stock access on both sides. Overall analysis of the health of the waterway using EPA habitat parameters for Low Gradient Streams gave this site a score of 59 out of 140 and increased to 70 out of 140, primarily due to the gradual reduction in erosional scars and the increase in submerged and emergent macrophyte beds, despite the constant stock access. Removing stock access and establishing riparian vegetation will improve the health of this site significantly.

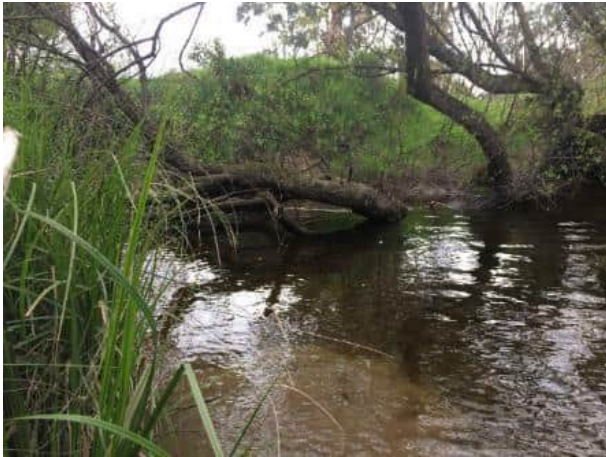
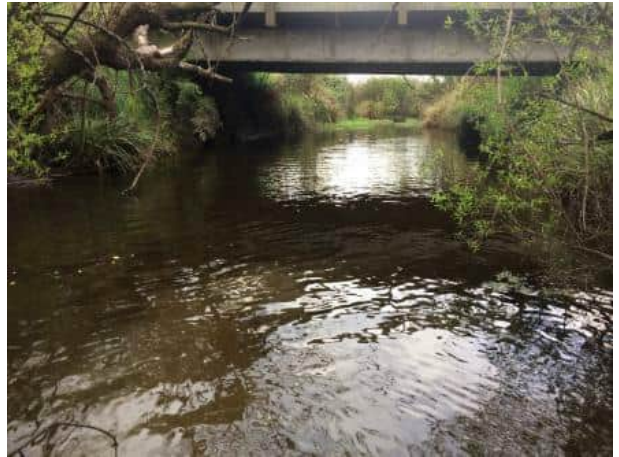
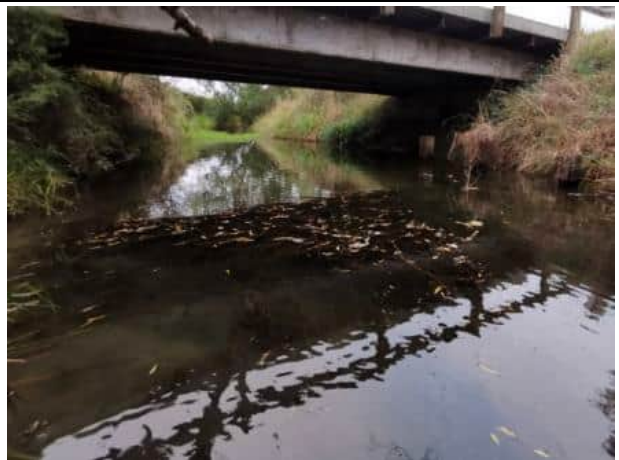
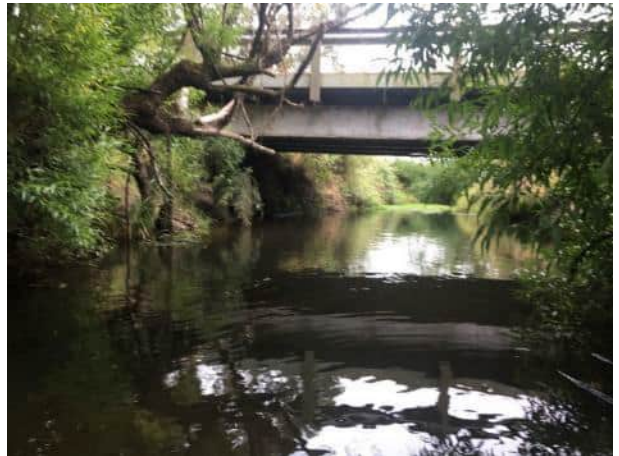
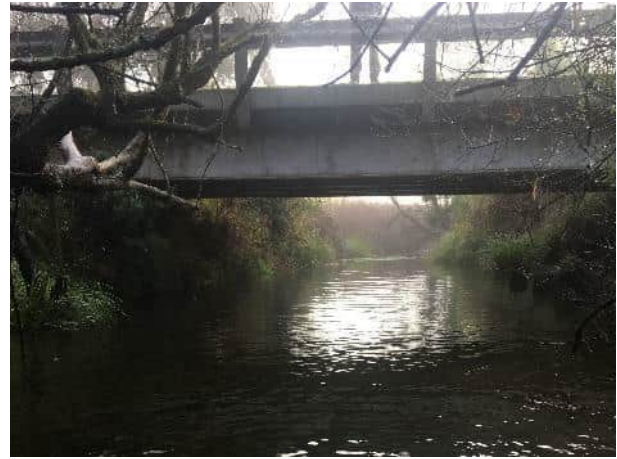
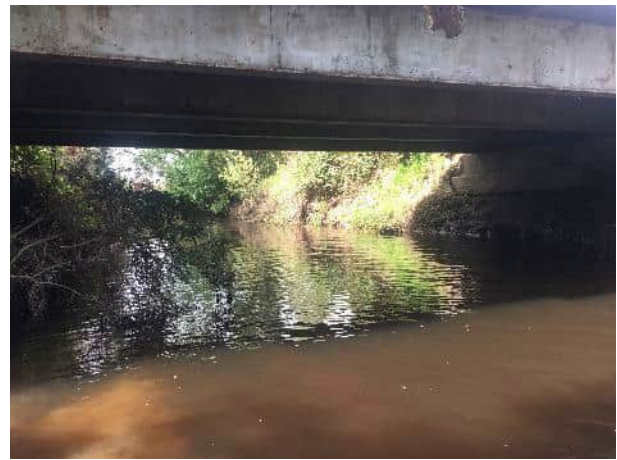
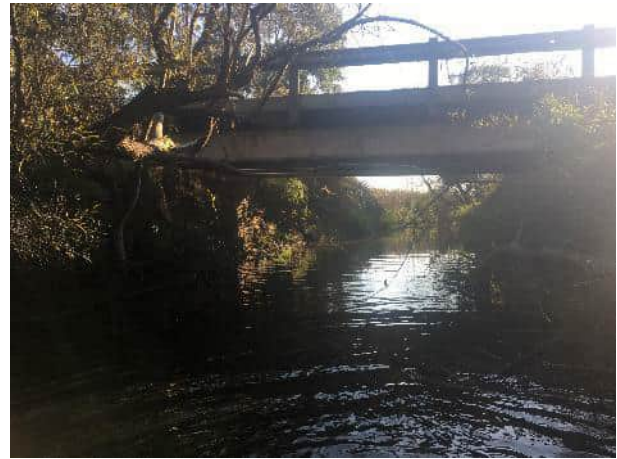
5.3. Site 3- West Barwon River@ Seven Bridges Road

The West Barwon River at Seven Bridges Road has large deep pools with a number of backwaters. The average stream width at this site is seven meters, narrow at the top of the surveyed reach and widening into a large pool near the bridge. The substrate is clay and silt mixed with 20% sand. There are some macrophytes present along with trailing bank vegetation, roots and instream large woody debris (primarily willow branches). Willows dominate the riparian zone a mix of shrubs and native and pasture grasses in the understory. Four larval fish were collected as bycatch during macroinvertebrate sampling in Spring 2019. One mountain galaxias, one common galaxias, one pygmy perch and a laval galaxias were collected in Spring 2020 and another galaxias in Spring 2021. A number of pygmy perch were collected in Autumn 2022. A concurrent snapshot study by EnviroDNA (2019) found evidence of platypus at this site in Spring 2019. Overall analysis of the health of the waterway using EPA habitat parameters for Low Gradient Streams gave this site a score of 85 out of 140 in 2019 and this has remained steady over the three years of the study.

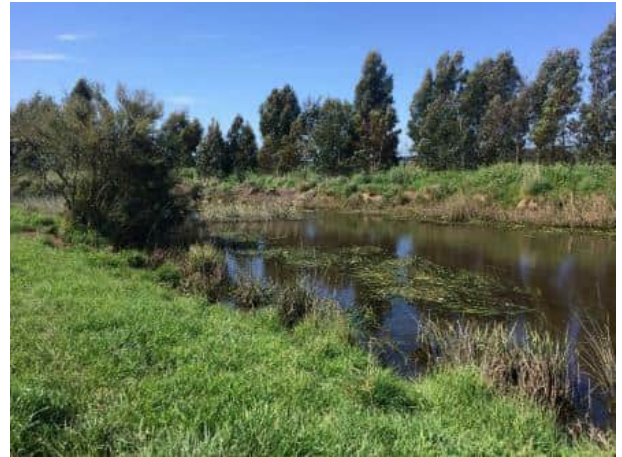
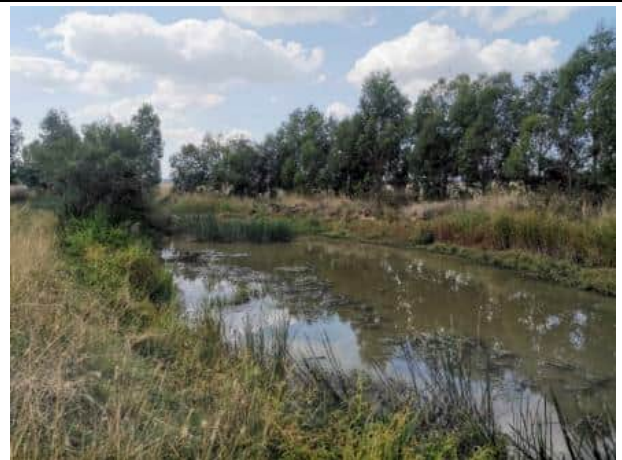
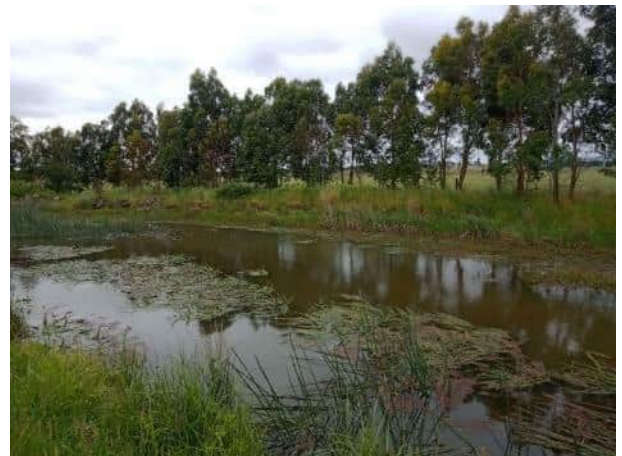
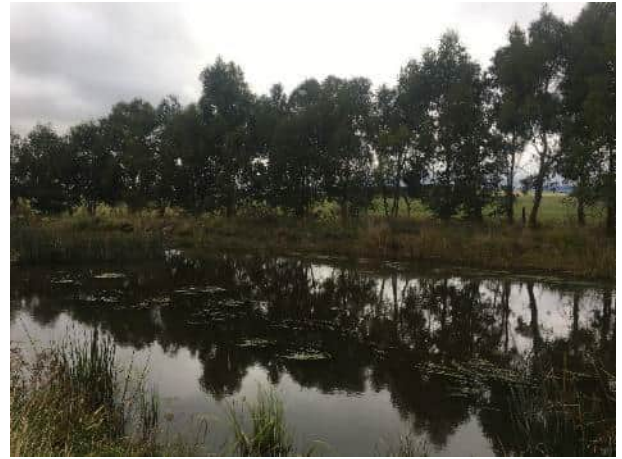
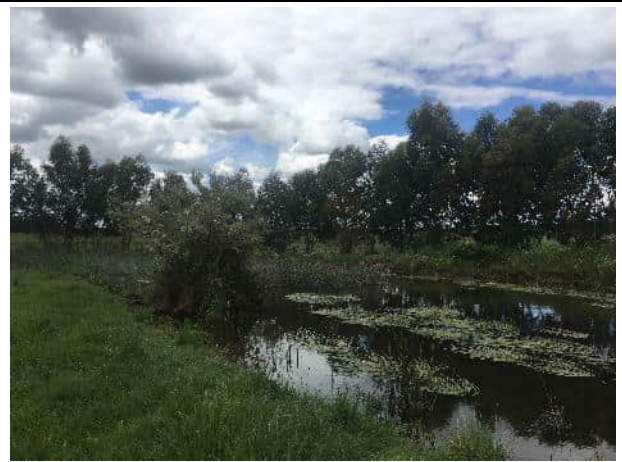
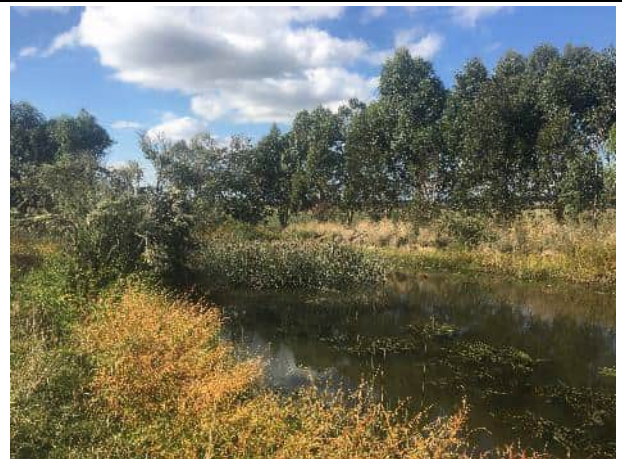
The Barwon River 100 meters upstream of the Boundary Creek confluence is a large slow flowing channel with shallow side sections that support a number of macrophyte beds. The average stream width at this site is nine meters. The substrate is clay and black silt with some large woody debris and filamentous algae present in addition to the macrophytes. *Juncus*, *Typha*, *Triglochin* and *Polygonum* species are all present instream though riparian vegetation is limited to some isolated trees, a narrow native plantation and pasture grass with stock access. The introduced *Gambusia* (mosquito fish) were collected as bycatch during macroinvertebrate sampling in Spring 2019, Autumn 2021 and Autumn 2022 and a pygmy perch sampled in Spring 2021. Overall analysis of the health of the waterway using EPA habitat parameters for Low Gradient Streams gave this site a score of 79 out of 140 in 2019 and an increased score of 99 due to the establishment of more aquatic macrophytes and healed erosion. Fencing and revegetation of the left side of the river to a similar standard as the right side would see further improvements to the health of the river.

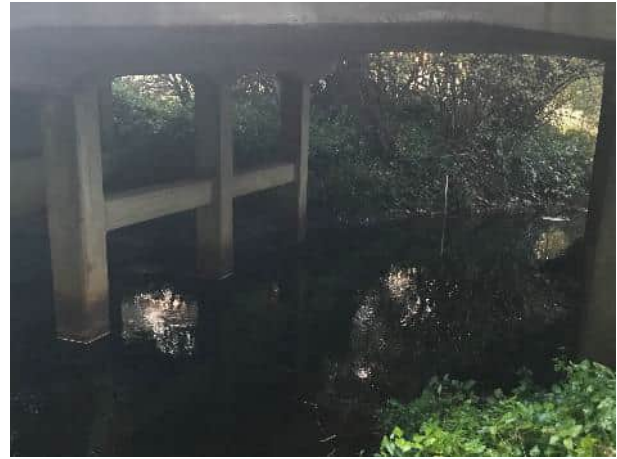
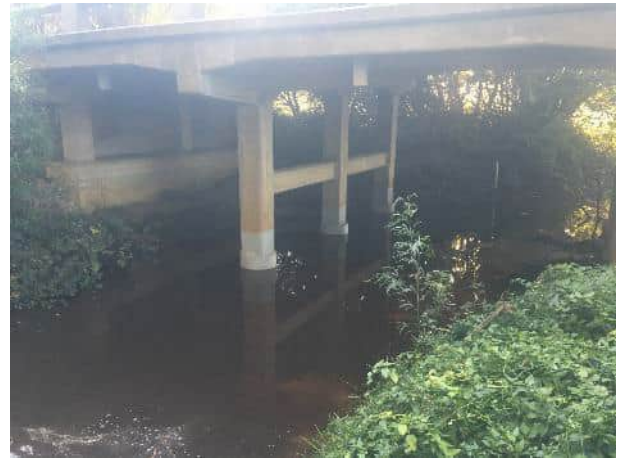
Boundary Creek at Colac- Forrest Road has a mix of large deep pools, a large shallow pool at the bridge and shallow runs. It has been bank full with an average stream width of four meters, narrow at the top of the surveyed reach and widening into a large pool upstream of the bridge during each sampling event excepting during Autumn 2020 sampling when the creek had contracted to a pool approximately 4 meters long by 2.5 meters wide. During this time the pooled water was stagnant, with low oxygen concentrations and very high turbidity. The substrate is a mix of cobble, pebble, gravel, sand, clay and silt. There are no macrophytes but there was some filamentous algae in Spring 2019, (absent since) and trailing bank vegetation present. Foam was present at the top of the reach in Spring 2020, Autumn 2021, Spring 2021 and Autumn 2022. The riparian zone is wide and a mix of native and exotic vegetation except the ground cover which is dominated by *Convolvulus* sp. and pasture grasses. Overall analysis of the health of the waterway using EPA habitat parameters for Low Gradient Streams has remained steady at 81 out of 140 between 2019 and 2022 and is likely to remain so until conditions allow aquatic vegetation to establish and the riparian vegetation is improved.

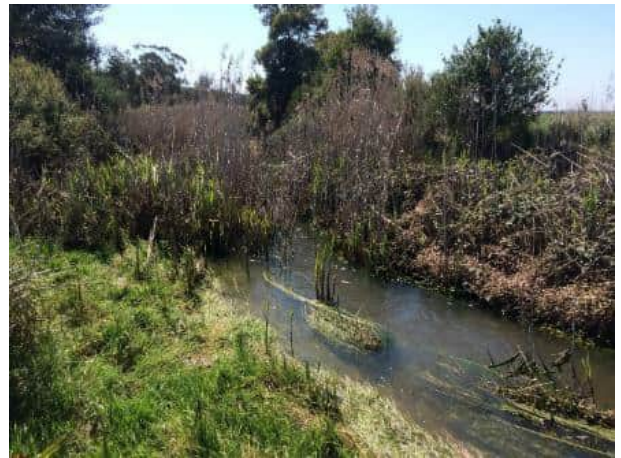
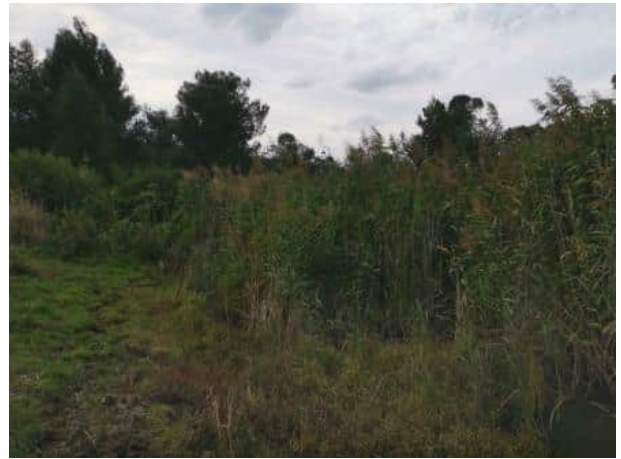
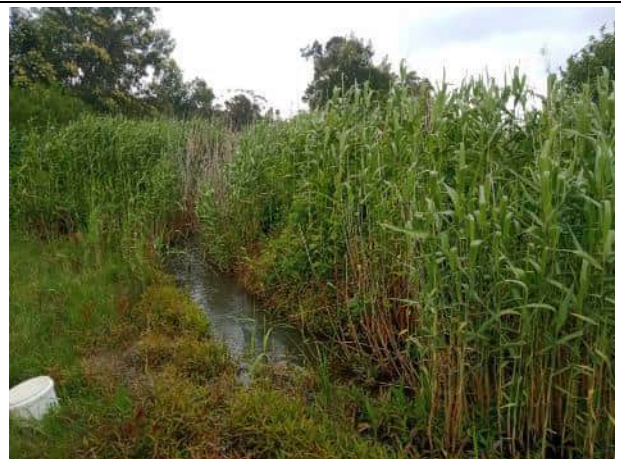
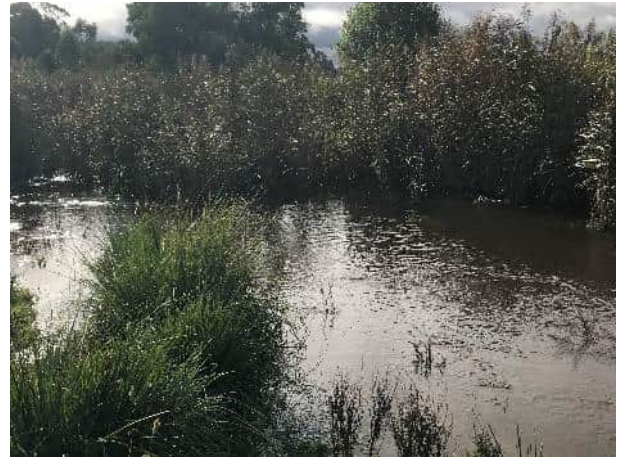
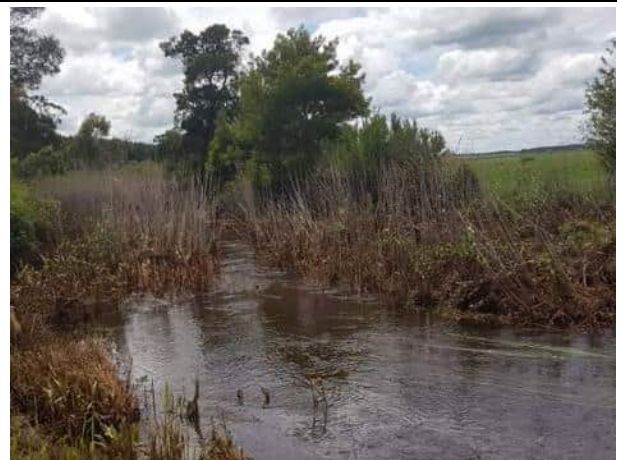
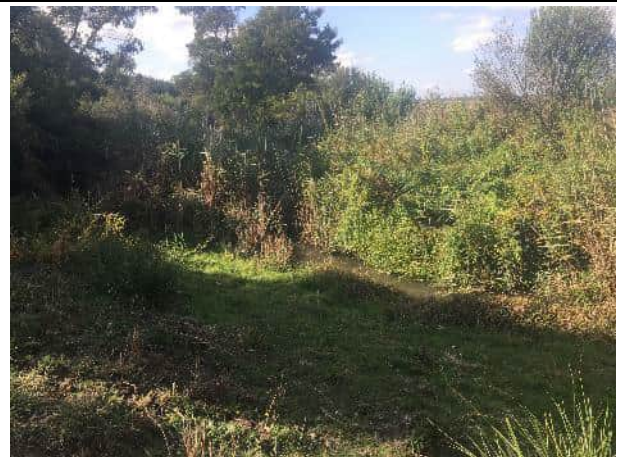
The Barwon River 100 meters downstream of the Boundary Creek confluence is a narrow deep channel with wide shallow edges dominated by grasses and aquatic macrophytes. The average stream width at this site is five meters and was bank full in Spring 2019, Spring 2020, Autumn 2021 and Spring 2021 and had contracted to a narrow (1-2 meter) channel in Autumn 2020 and Autumn 2022. There is a narrow channel at the top of the surveyed reach, narrowing to a confined channel downstream. The river had contracted to the main channel but remained flowing, leaving the fringes to dry out in Autumn 2020 and Autumn 2022. The substrate consists of clay and silt usually with filamentous algae tangled through the macrophyte beds but in Autumn 2021 and Spring 2021 the macrophyte beds were covered in a smothering floc that was easily disturbed, forming a thick plume. This plume appeared to be absent in Autumn 2022 but this could have been due to the absence of slow flowing areas where floc would be able to settle. Macrophyte species are varied with *Triglochin*, *Polygonum*, *Phragmites*, and *Juncus* species all present in addition to trailing grasses. Four different fish species have been collected at this site as bycatch; southern pygmy perch, smelt and a galaxid in Autumn 2020, gambusia and southern

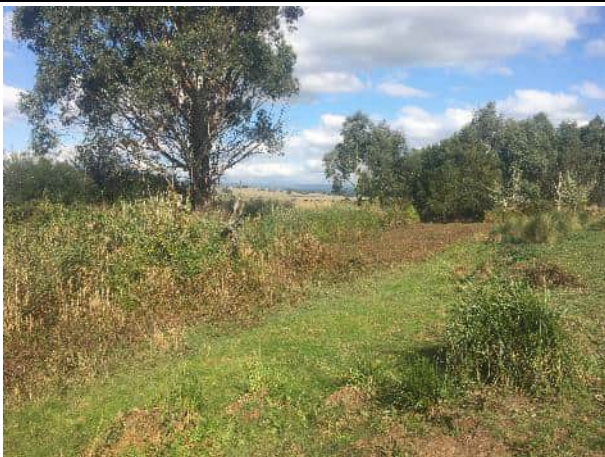
Site 6: upstream Autumn 2022

pygmy perch in Spring 2020. The riparian zone is limited to grasses and scattered native trees and shrubs with stock access to the site. Overall analysis of the health of the waterway using EPA habitat parameters for Low Gradient Streams gave this site a score of 70 out of 140 in 2019 and a very similar score of 71 in 2022. As with all sites that have unrestricted stock access, the health of this site would be improved by fencing and revegetating the river on both sides.

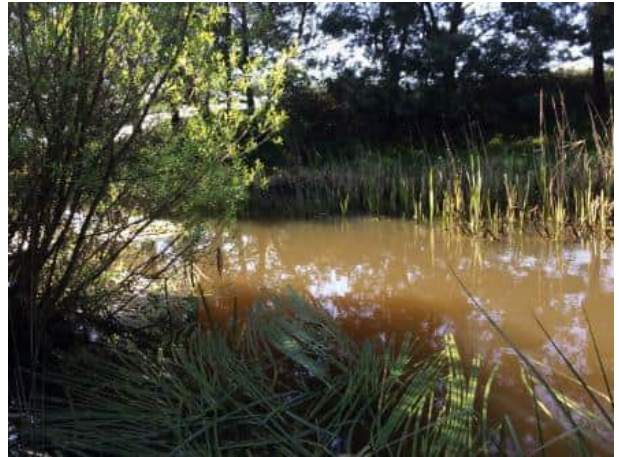
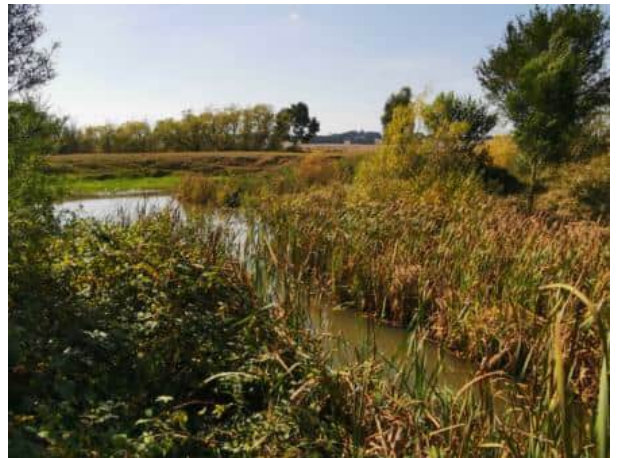
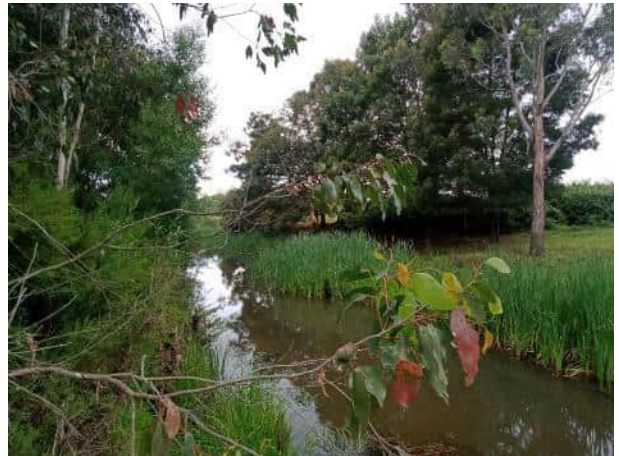
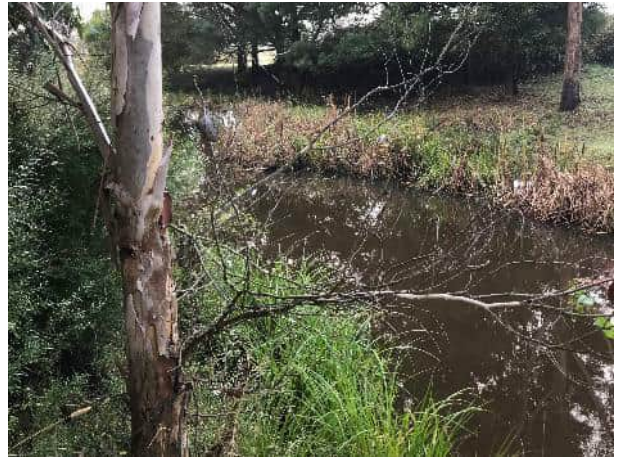
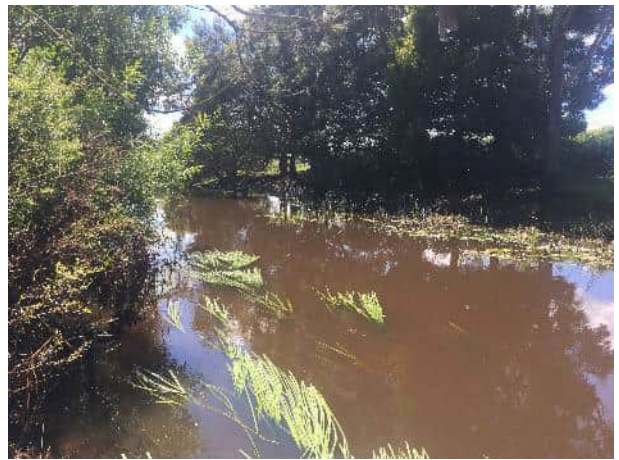
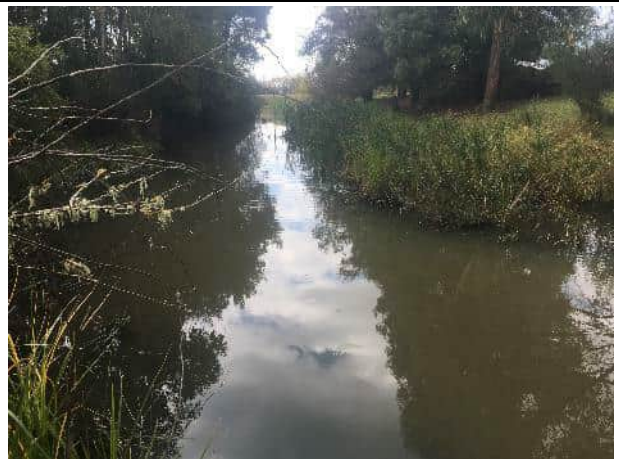
The Barwon River adjacent to the northern boundary of the pine plantation has a large deep channel with any shallow areas dominated by beds of *Phragmites*. The average stream width at this site is seven meters. The substrate is clay and silt. In addition to the *Phragmites* beds there are beds of *Triglochin*, and scattered *Polygonum*, *Juncus* and other grasses. The riparian zone has a good mix of trees, shrubs and understory with a majority of native trees and shrubs. Overall analysis of the health of the waterway using EPA habitat parameters for Low Gradient Streams gave this site a score of 90 out of 140 in 2019 and increased to 104 in 2022 primarily due to continued improvements in riparian and instream macrophyte condition.
