Upper Barwon River Macroinvertebrate Sampling Report 2019-2022

- Final
- June 2022

Austral Research and Consulting
ABN 73 007 840 779
15 Buntings Rd
Kirkstall Vic 3283 Australia
Web: www.austral.net.au

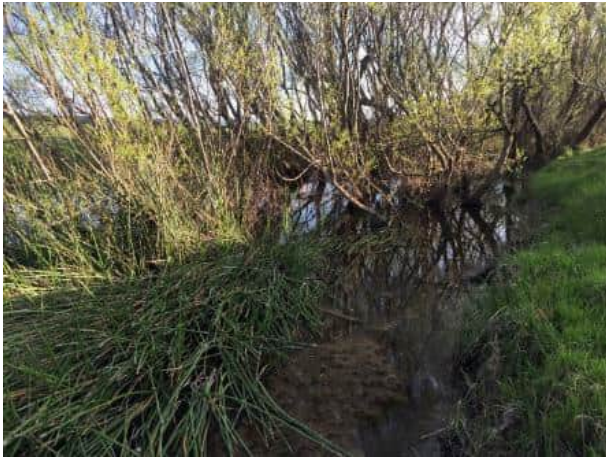
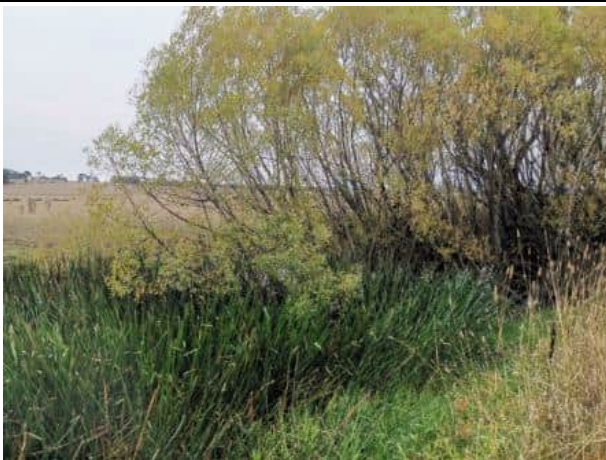
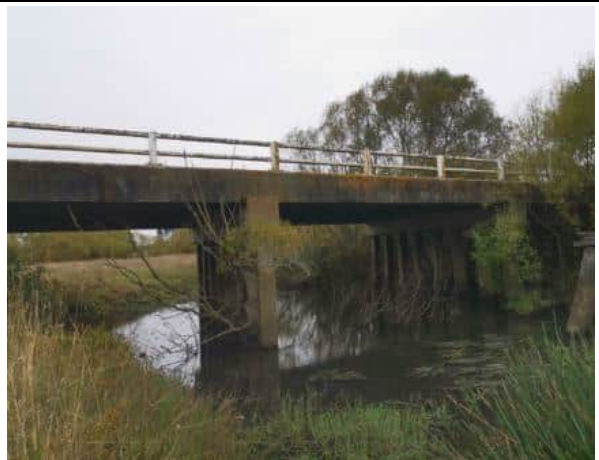
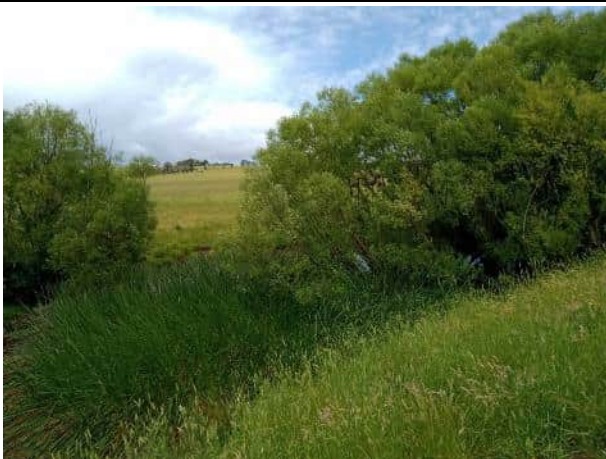
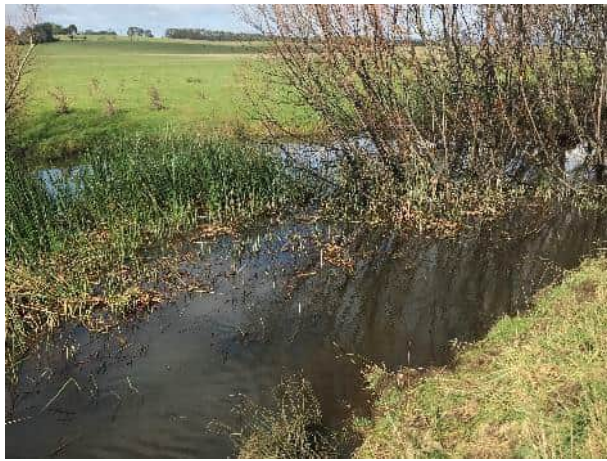
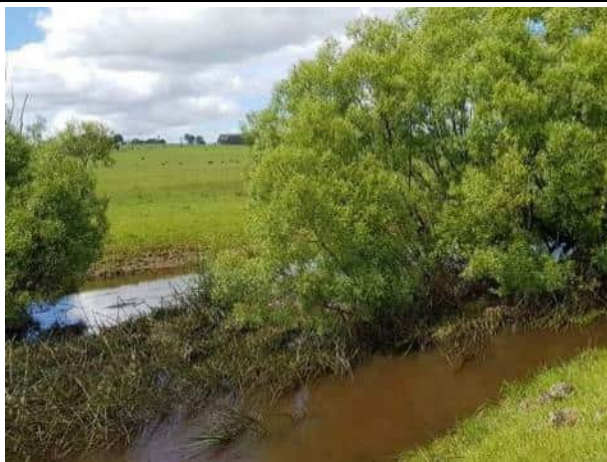
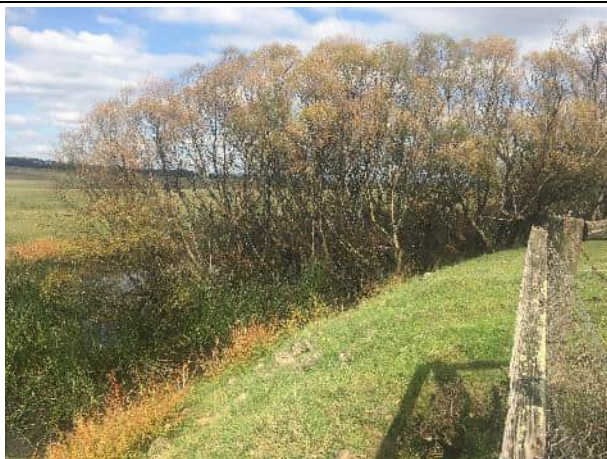
5.8. Site 8- Barwon River @ Colac- Lorne Road

The Barwon River at Colac- Lorne Road has large deep pools with a shallow areas at the sides and willow trees growing in the channel with some substrate exposed when the river level is low. The average stream width at this site is eight meters with a predominantly clay and silt substrate mixed with some sand. There are beds of *Triglochin* and *Phragmites* in addition to trailing grasses and large willows. The riparian zone consists of willow trees, pasture grasses and blackberries and allows stock access. Overall analysis of the health of the waterway using EPA habitat parameters for Low Gradient Streams gives this site a score of 69 out of 140 in 2019 and a similar score of 73 in 2022.

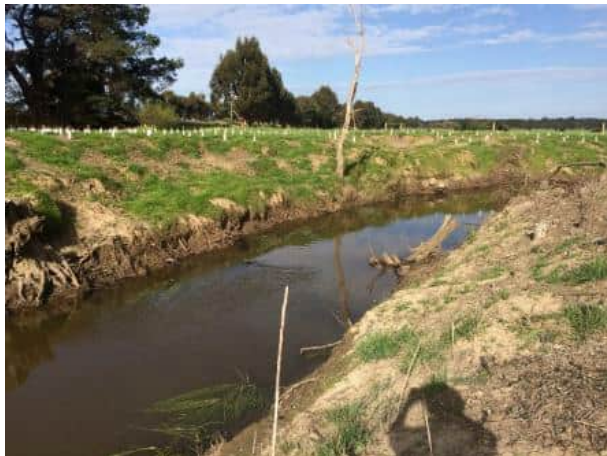
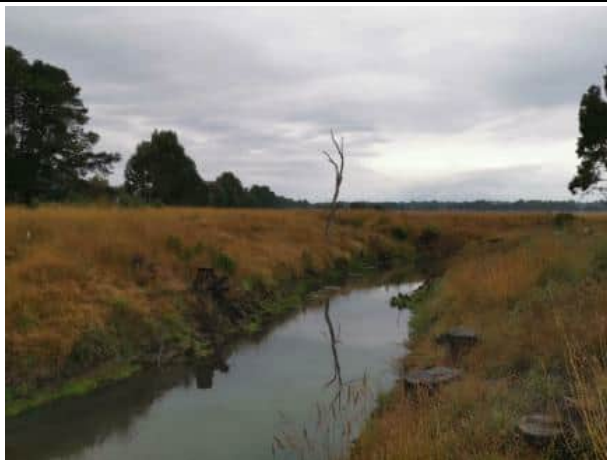
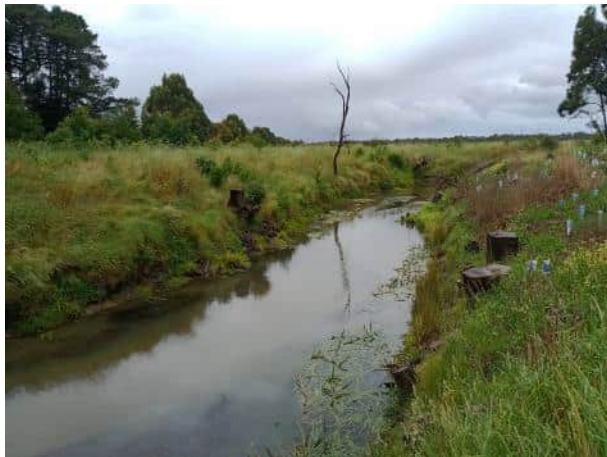
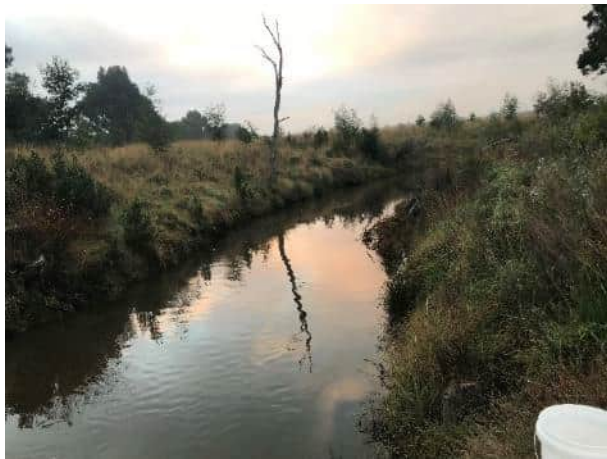
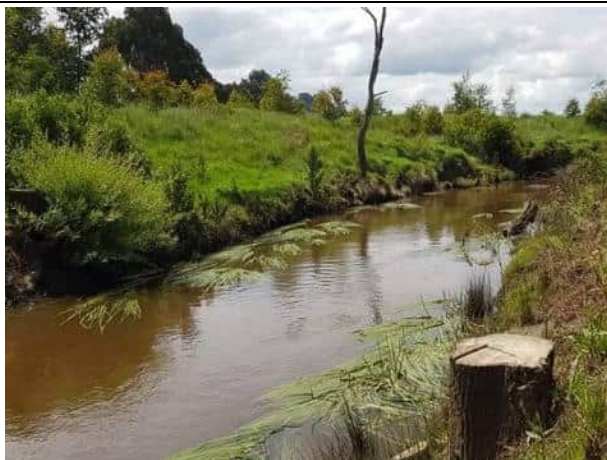
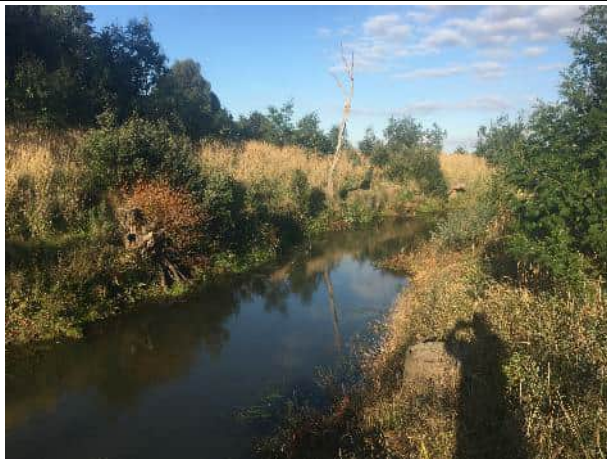
5.9. Site 9- Barwon River @ Birregurra

The Barwon River at Birregurra consists of a large deep slow flowing pool. The average stream width at this site is five meters with steep clay banks. The substrate is clay and silt with willow roots, some snags and *Triglochin* beds scattered along the edges of the channel and establishing well over time. There were willow removal works and replanting of the riparian zone in Spring 2019 in amongst the pasture grass and blackberry groundcover. The riparian zone is established and growing well although follow up ground cover weed management may be required. Rakali footprints are evident in the soft sediment edge during many of the sampling events. Introduced mosquitofish (*Gambusia sp.*) were bycatch in Autumn 2022. Overall analysis of the health of the waterway using EPA habitat parameters for Low Gradient Streams gave this site a score of 67 out of 140 in 2019 but has increased to 98 in 2022, primarily due to the successful reintroduction of the riparian zone following large scale willow removal.

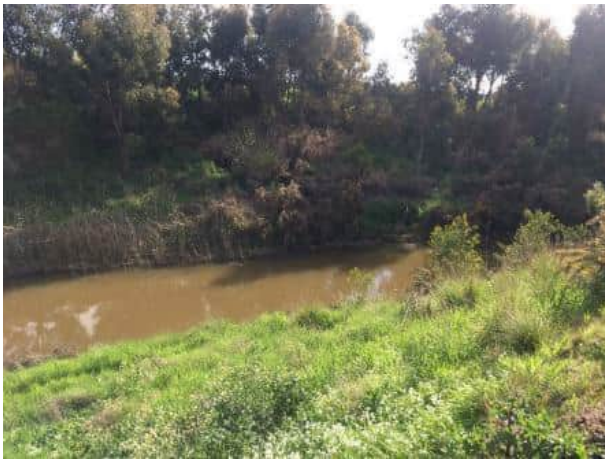
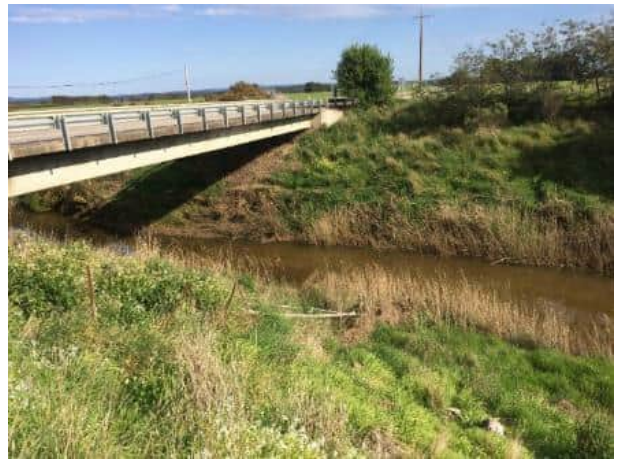
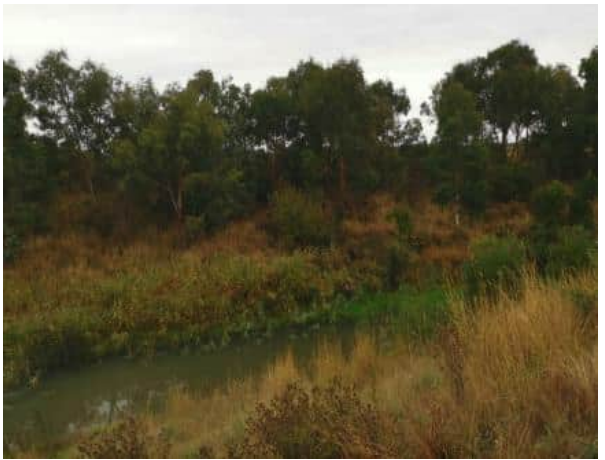
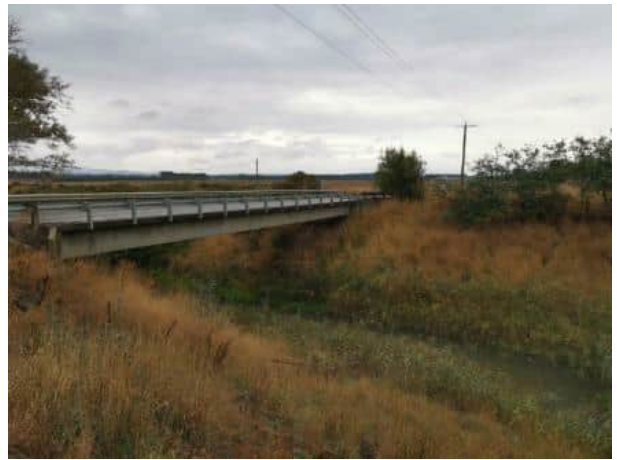
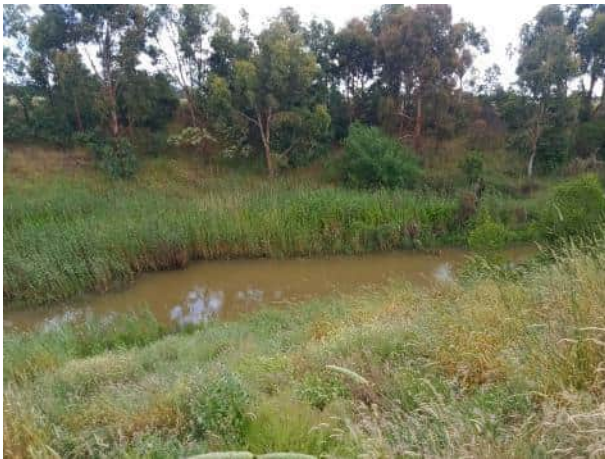
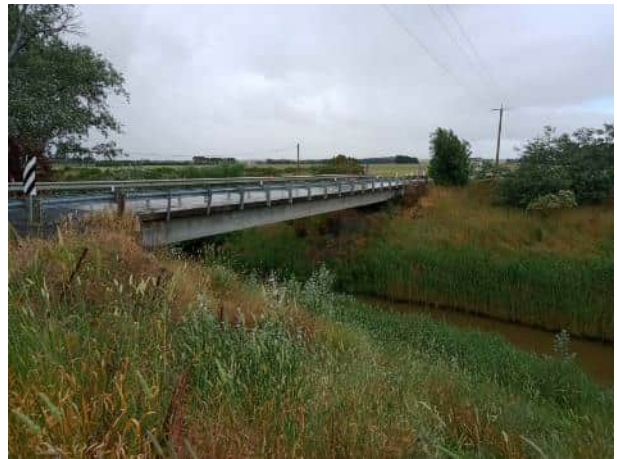
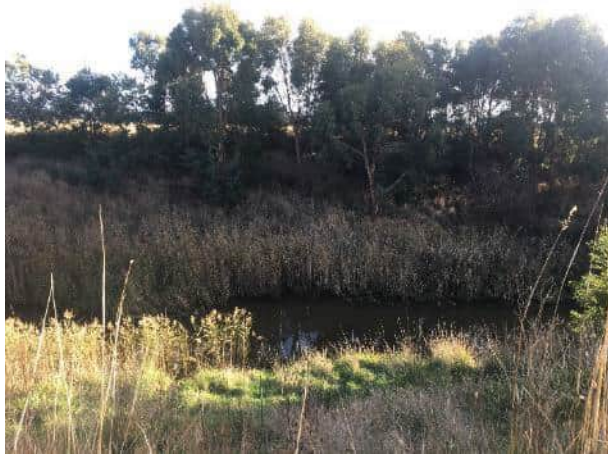
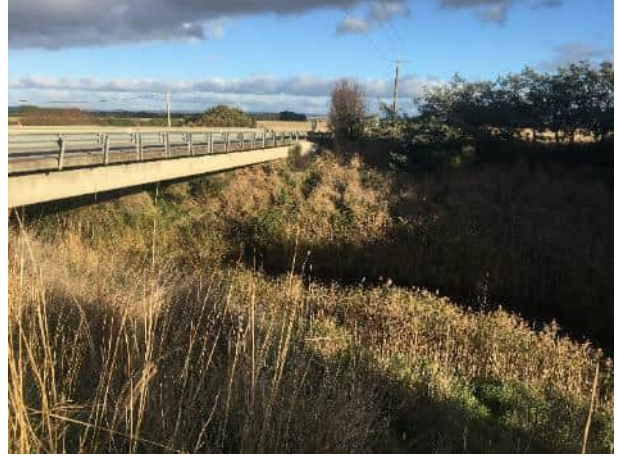
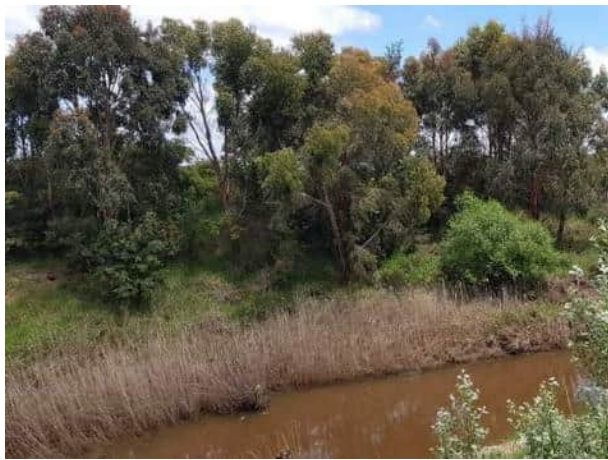
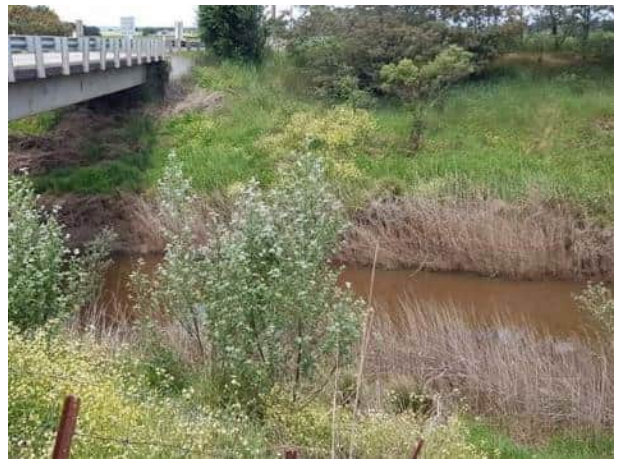
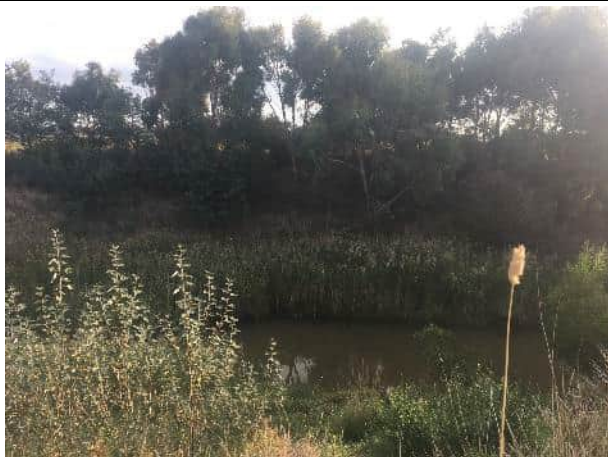
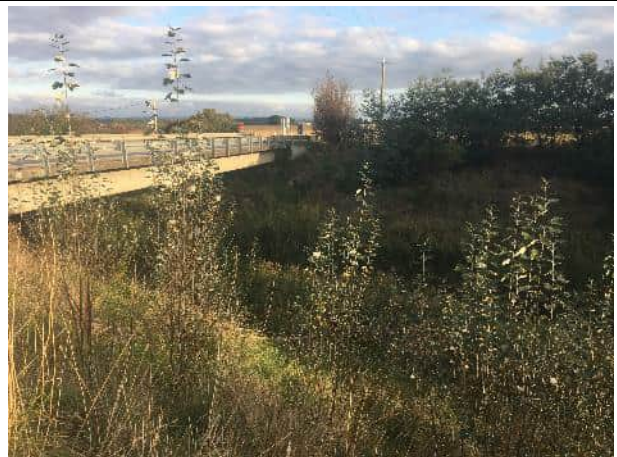
5.10. Site 10- Barwon River @ Conns Lane

The Barwon River at Conns Lane has large deep pools with some small deep backwaters and a narrow deep run at the top of the reach. The average stream width at this site is six meters. The substrate is clay and silt mixed with some sand and gravel. *Phragmites* beds line the channel and there are isolated patches of *Triglochin* in addition to *Polygonum* and trailing grasses along the waters edge. The trailing and shallow vegetation contained filamentous algae in Autumn 2021 and 2022. Larval fish and gambusia were collected in the macroinvertebrate net in Spring 2020 and gambusia were plentiful in Autumn 2021 though not in Spring 2021. The riparian zone consists of a native revegetation project that is more successful on the right side than the left. Exotic trees are re-establishing on the left side and pasture grass dominates. Overall analysis of the health of the waterway using EPA habitat parameters for Low Gradient Streams gave this site a score of 98 out of 140 in 2019 and a similar score of 101 in 2022.

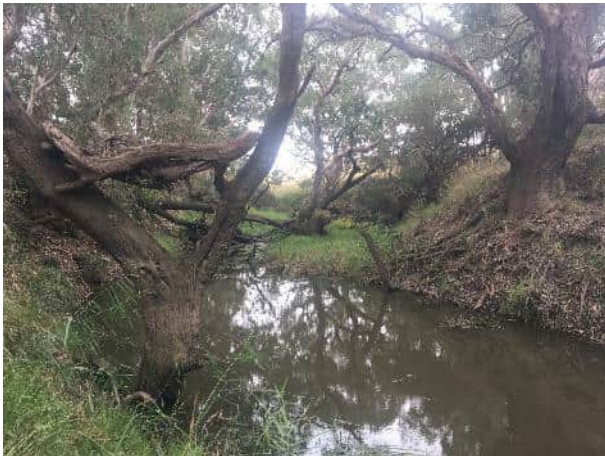
Site 11: upstream Autumn 2022

The Barwon River at Winchelsea- Deans Marsh Road has large deep pools with a shallow run at the top of the reach. The average stream width at this site is five meters and the substrate is clay and silt mixed with some sand and gravel. *Triglochin* is growing in the shallow areas of the channel and there are roots, large woody debris and trailing grasses. The riparian zone is predominately native trees and understory with a mix of grasses as groundcover. Rakali footprints were spotted at the waters edge in Spring 2019. The height and force of a flood between Autumn 2021 and Spring 2021 sampling can be seen in the upstream Spring 2021 photo of the log wedged in the forked tree in the left foreground. Overall analysis of the health of the waterway using EPA habitat parameters for Low Gradient Streams gave this site a score of 90 out of 140 in 2019 and the similar but slightly higher score of 98 in 2022 with the introduction of more woody debris into the channel following the 2021 floods and the continuing growth of riparian vegetation.

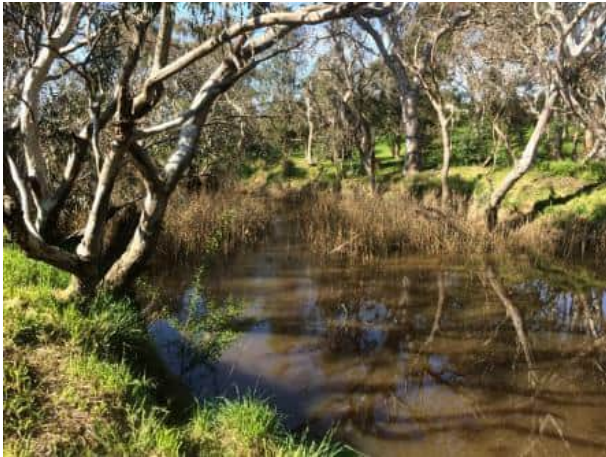
Site 12: upstream Spring 2019

The Barwon River at Winchelsea has large deep pools with a large shallow pool at the top of the reach. The average stream width at this site is twelve meters. The substrate is clay and silt mixed with sand and some gravel. In addition to the *Phragmites* beds at the top of the reach and along some edges there are also patches of *Triglochin*. Large woody debris, trailing grasses and emergent vegetation such as *Polygonum* are also present. Riparian vegetation is predominantly native with many established eucalypts and groundcover is pasture grass. A concurrent snapshot study by EnviroDNA (2019) in Spring found evidence of platypus at this site. Overall analysis of the health of the waterway using EPA habitat parameters for Low Gradient Streams gave this site a score of 88 out of 140 in 2019 and a similar score of 91 in 2022.

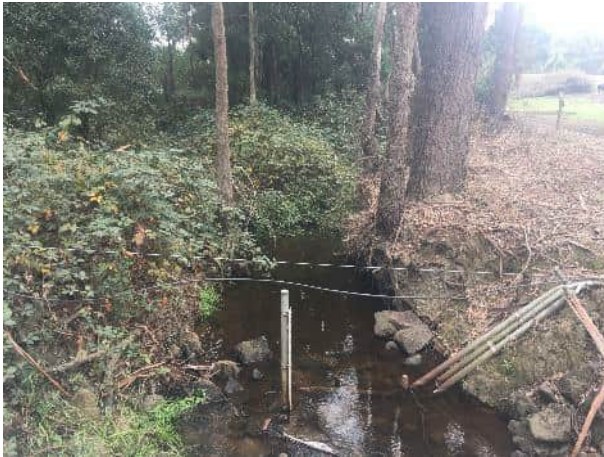
Site 5.1: upstream Autumn 2022

Site 5.1 on Boundary Creek was added to the current sampling regime to replicate the site sampled by Austral in 2014/2015 for Jacobs (2017) and give some context to the health of Boundary Creek upstream of Big Swamp. Boundary Creek below McDonalds Dam is between 3 and 4 meters wide with a mix of deep pools, shallower pools and artificial riffle areas from the culvert/ bridge. There were isolated patches of aquatic macrophytes in 2014 but none were present in 2022. Whilst large trees are a feature of the riparian zone, live blackberries and bare ground where they have been poisoned, dominate. Intensive agriculture exists outside of the riparian zone. Overall analysis of the health of the waterway using EPA habitat parameters for Low Gradient Streams gave this site a score of 87 out of 140 in 2014 and a similar score of 91 in 2022.

Site 5.1, downstream of McDonalds Dam was surveyed in Autumn 2015 as part of an assessment of the condition of Boundary Creek by Jacobs Australia and Austral Research and Consulting (2015). Just over half of the macroinvertebrate families were different between Autumn 2015 and Autumn 2022 but the majority of those different families were single individuals and whilst the number of families reduced from 21 in 2015 to 16 in 2022, the SIGNAL2 score went up from 3.65 in 2015 to 3.94 in 2022.

The addition of a site on Boundary Creek upstream of Big Swamp will give a measure of what could be expected downstream of the wetland should water quality conditions improve. Site 5.1 is most similar to Site 5 with regard to instream habitat and therefore would be a logical addition to the sampling regime. The number of sites sampled on the Barwon River could be reduced to Site 4 (above the confluence with Boundary Creek), and Sites 6, 7, 8 and 9 (Birregurra) as any impact on the Barwon River from Boundary Creek past this point has not been observed since monitoring commenced in 2019. Surveys conducted during wet periods such as during Spring 2021 showed the extent of connection between Boundary Creek and the Barwon River via overland flow and wetlands around Site 4. For this reason and safety issues associated with crossing Boundary Creek to access Site 4, consideration should be given to moving Site 4 further upstream just below the West Branch/ East Branch Barwon confluence. The site would need to be accessed from the east bank and would require the cooperation of adjacent landholders. An annual survey, perhaps during Spring to maximise wetted habitat could be conducted in Big Swamp but this is unlikely to assist in determining the effect of Boundary Creek/ Big Swamp on the upper Barwon River.

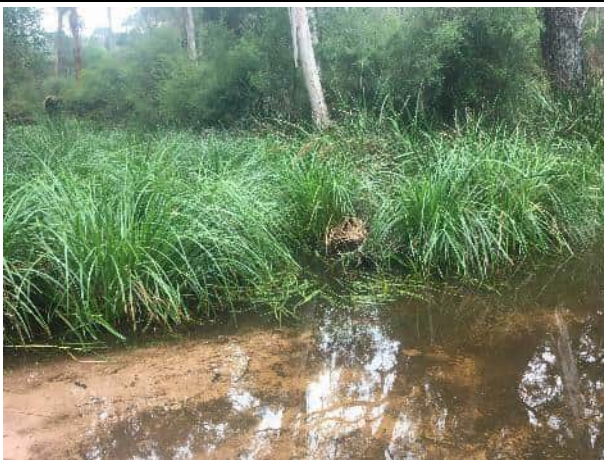
Site 5.2: upstream Autumn 2022

Site 5.2 on Boundary Creek was added to the current sampling regime to give additional information on the biological health of Boundary Creek upstream of Big Swamp. Boundary Creek is between 1 and 2 meters wide either side of the vehicle crossing and is very different to all other sites sampled with a mix of large and small, deep and shallow pools and runs. There are extensive areas of macrophytes including Triglochin, Ranunculus and Cyperus beds and isolated patches of Alisma and Juncus. The riparian zone is extensive consisting of predominantly, if not totally, native species. Overall analysis of the health of the waterway using EPA habitat parameters for Low Gradient Streams gave this site a score of 130 out of 140, the highest of any in this study.

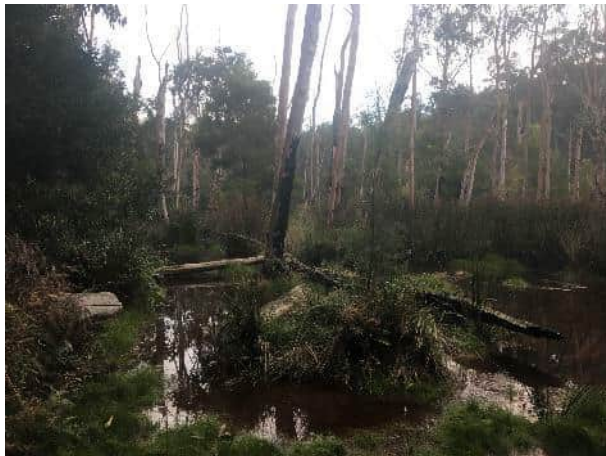
Site BS1: upstream Autumn 2022

Site BS1 in Big Swamp was added to the current sampling regime to give additional information on the condition of Big Swamp. The water level was shallow and was slowly flowing around the extensive amount of large woody debris and beds of Giant Rush and scattered sedges and rushes such as *Gahnia* and *Cyperus*. There was a high amount of iron floc present on the substrate.
