Investigation of Sediments and Macroinvertebrates in the Upper Barwon River

- Final Report
- December 2019

Austral Research and Consulting
ABN 73 007 840 779
15 Buntings Rd
Kirkstall Vic 3283 Australia
Web: www.austral.net.au

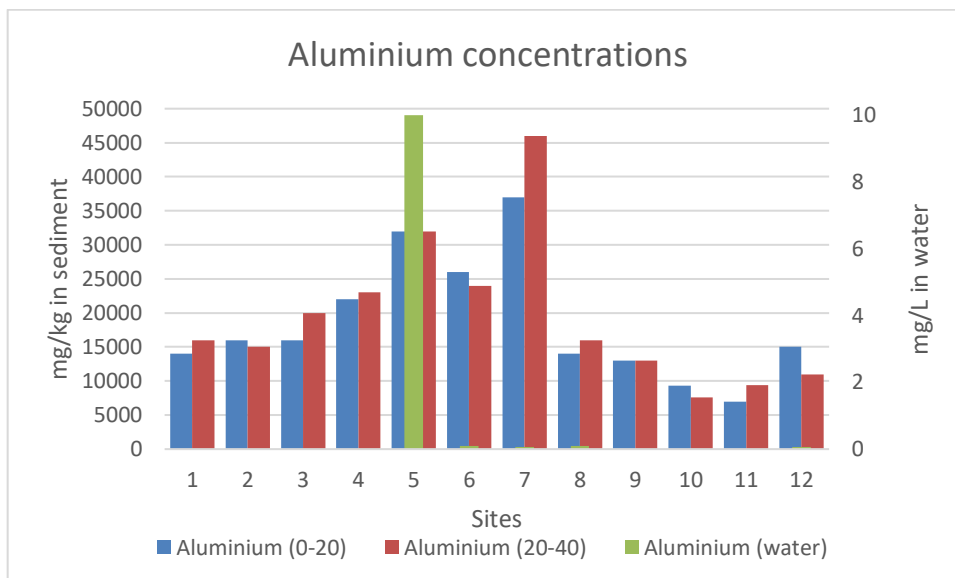
Aluminium was detected in water at sites 5, 6, 7, 8 and 12, exceeding the ANZECC trigger level (0.05mg/L). There was a spike in aluminium concentrations in sediments at sites 5 and 7 though levels are higher in the upper reaches above Boundary Creek than in the lower reaches around Birregurra and Winchelsea suggesting impacts other than from Boundary Creek. The deep and shallow sediments in Boundary Creek, site 5, have similar concentrations of aluminium.

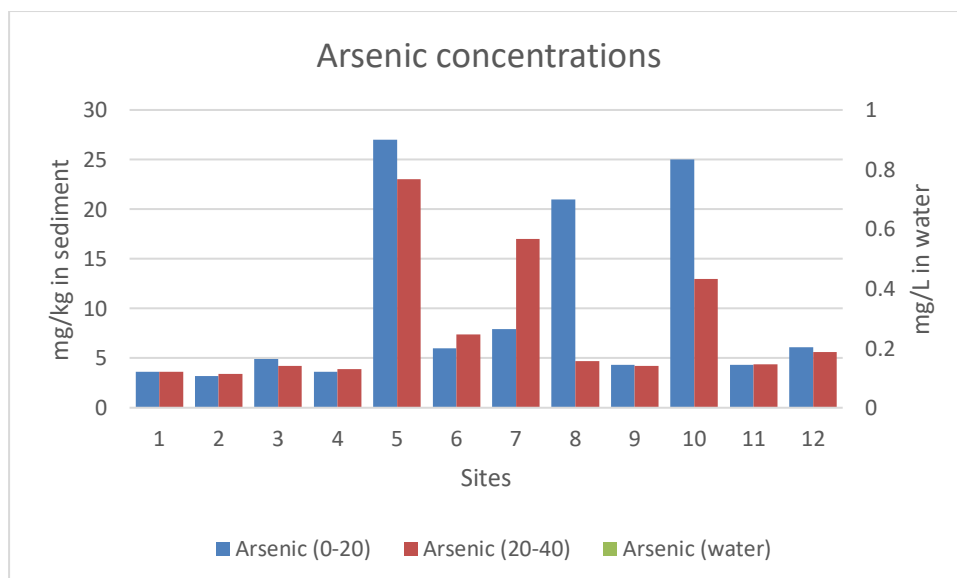
Arsenic was below detectable levels in the water and was over ANZECC guideline levels of 20 mg/kg in the shallow and deep sediments at site 5 and the shallow sediments at site 8 and 10.

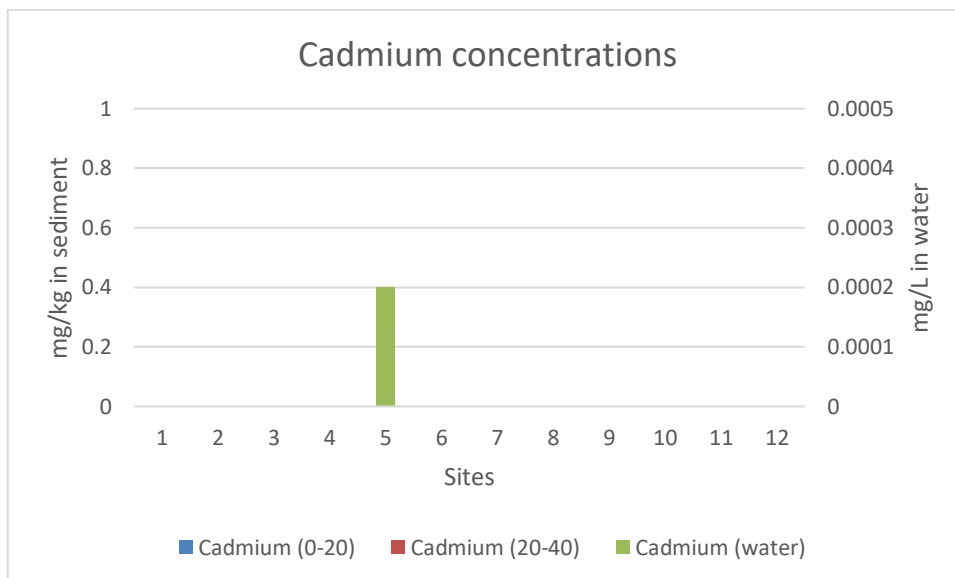
Cadmium was only detected in water at site 5 and was equal to the ANZECC guideline value (0.0002mg/L). Cadmium was not detected in sediments at any of the sites sampled.

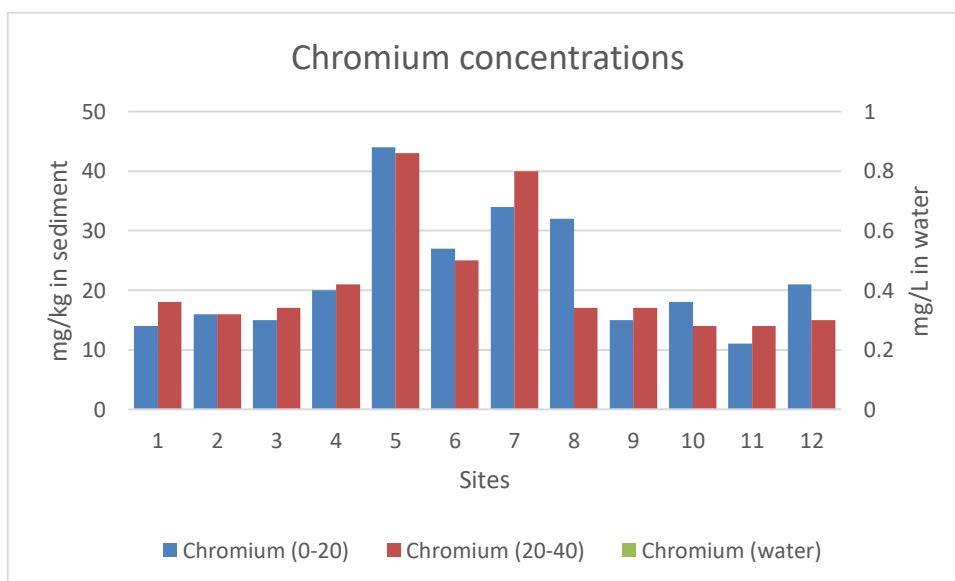
Chromium was not detected in water and despite levels in sediments peaking at sites 5 and 7 they were under ANZECC guideline levels (80mg/kg). Chromium was at similar levels in Boundary Creek (site 5) in the shallow and deeper samples.

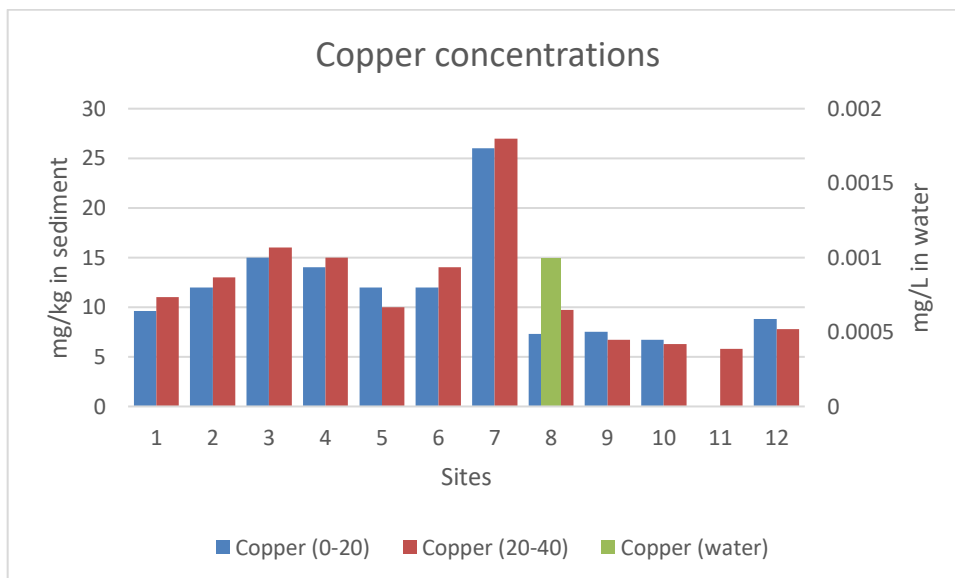
Copper was only detected in water at site 8 at the Colac-Lorne Road, below the ANZECC concentration of 0.0014mg/L. The highest concentrations of copper in sediment were recorded at site 7 and were similar in the shallow and deep samples but all results were well below ANZECC guideline levels (65mg/kg).

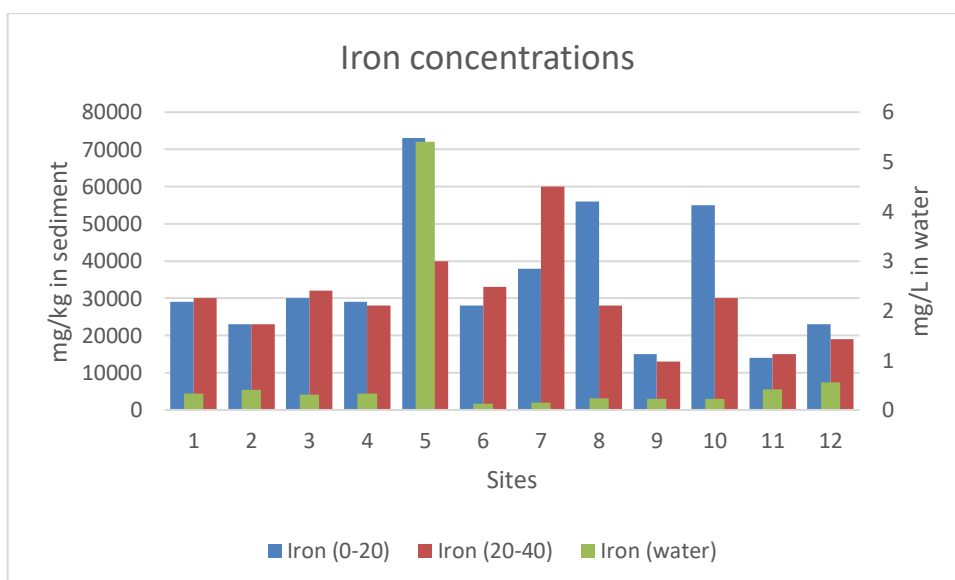
Iron was recorded in the water and sediments at all sites with highest levels in water and shallow sediments at site 5 (Boundary Creek). Iron was higher in the deeper sediments than in the shallow sediments at site 7 and higher in the shallow sediments compared to the deeper sediments at sites 5, 8 and 10.

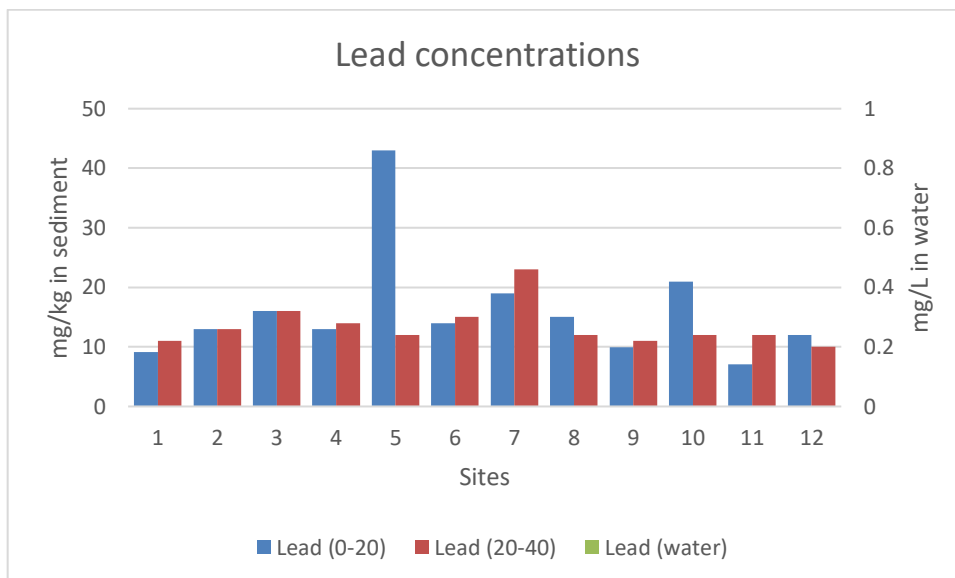
Lead was undetectable in water and was highest in shallow sediments (triple the concentration in the deeper sediments) at site 5 though below ANZECC guideline levels (50mg/kg).

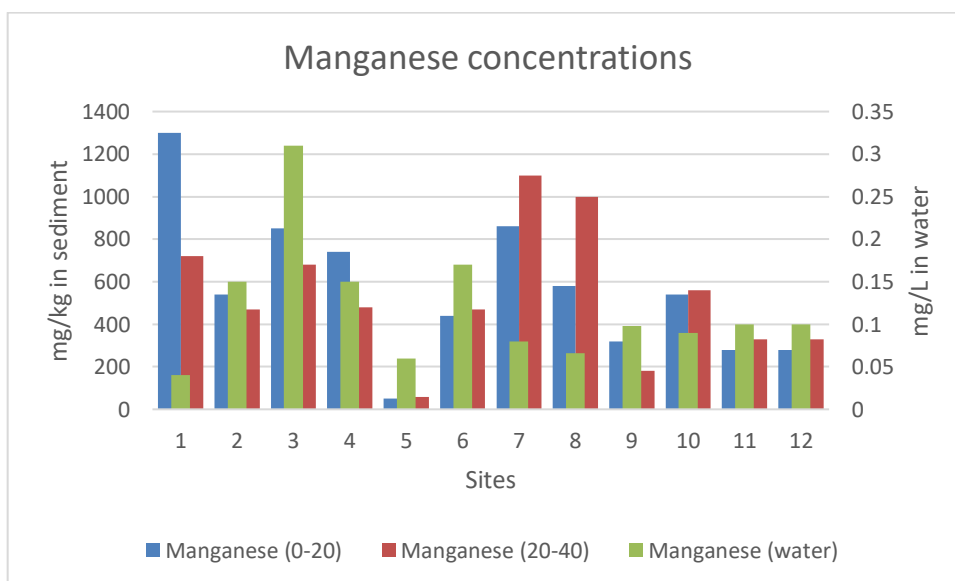
Manganese is a naturally occurring trace element and concentrations in the water are well below the ANZECC guidelines for water (1.2mg/L). There are no ANZECC guidelines for sediments.

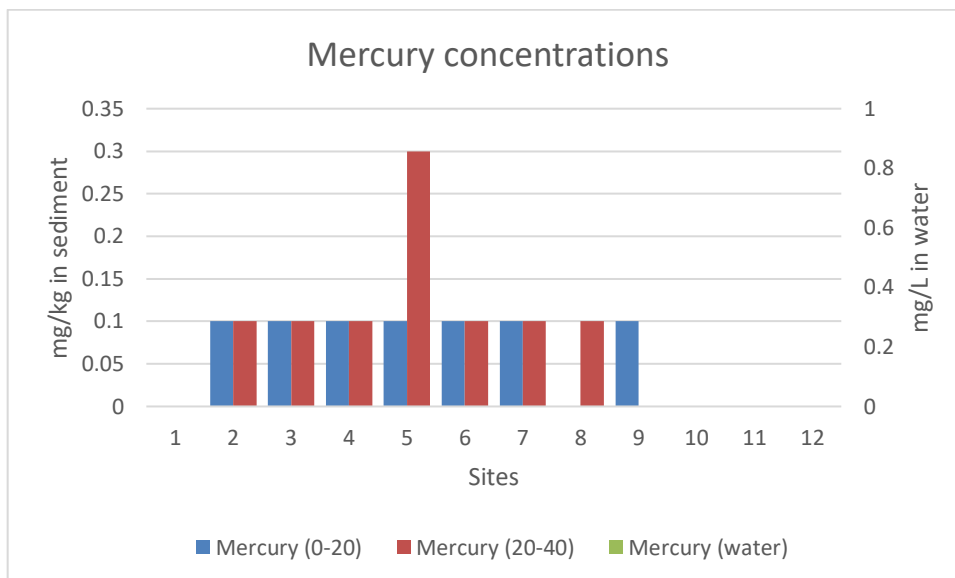
Mercury was undetectable in water and in sediment downstream of Birregurra (site 9). It is at detectable limits in sediment (0.1 mg/kg) at site 2-9 but below ANZECC guideline levels of 0.15mg/kg except in the deep sediments at site 5 where it exceeds ANZECC levels.

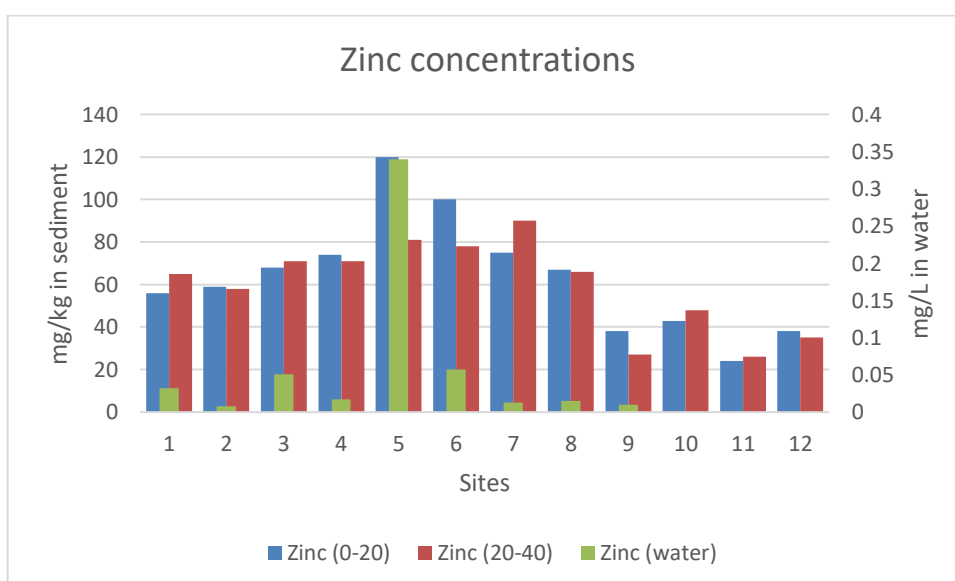
Zinc concentrations in sediments were below ANZECC level of 200mg/kg at all sites. Levels in water reduce along East Barwon and Barwon until site 6, after Boundary Creek and are undetectable by Conns Lane Birregurra (site 10). Concentrations are higher in shallow sediments at sites 5 and 6 and in deeper sediments at site 7.

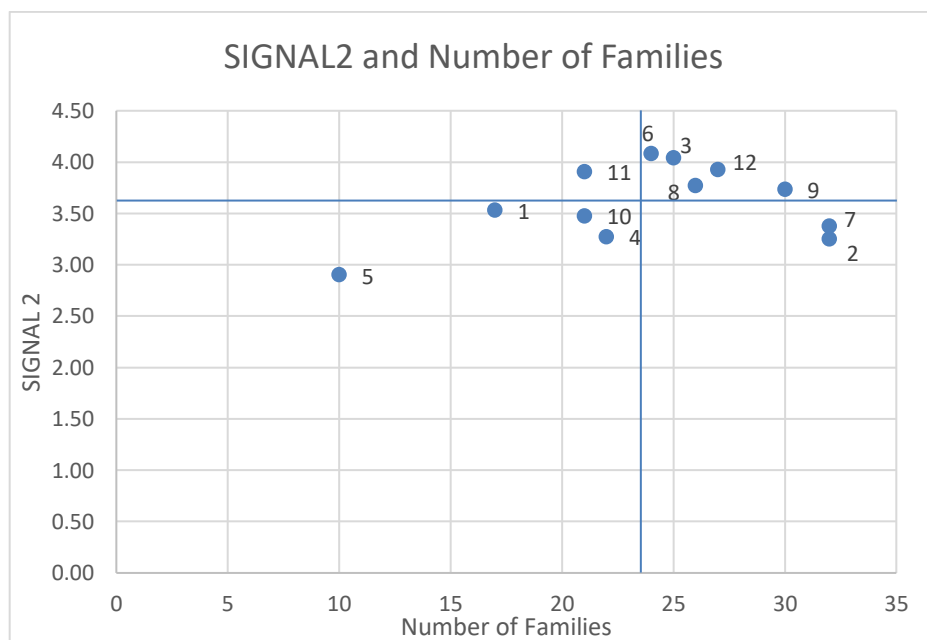
The plot is split into quadrants, the borders chosen to include the healthiest sites in the top right (Quadrant 1) and the quadrants are defined by those boundaries as detailed in Chessman (2003). As there were not any sites without human disturbance, those sites that met or were close to meeting EPA biological objectives for number of families and SIGNAL scores were included in Quadrant 1 and a cross check of which sites had the most EPT families (Table 5) confirmed the quadrant borders.

■ **Figure 2 SIGNAL2 index plotted against number of families recorded for each site.**

Sites 3, 6, 8, 9 and 12 have high SIGNAL2 and number of macroinvertebrate families suggesting the habitat and water quality are favorable and stress factors are low. Sites 2 and 7 in the bottom right quadrant have lower SIGNAL2 scores, possibly due to water quality influences but the high number of families present suggest that any toxicants are not present in large amounts. Site 11 in the top left quadrant has high SIGNAL2 scores but fewer number of families. This site is possibly affected by pollution other than what SIGNAL scores are based on (organic, nutrient enrichment or salinity). Sites 1, 4, 5, and 10 have lower SIGNAL2 scores and low numbers of families suggesting that they are subject to a number of impacts.

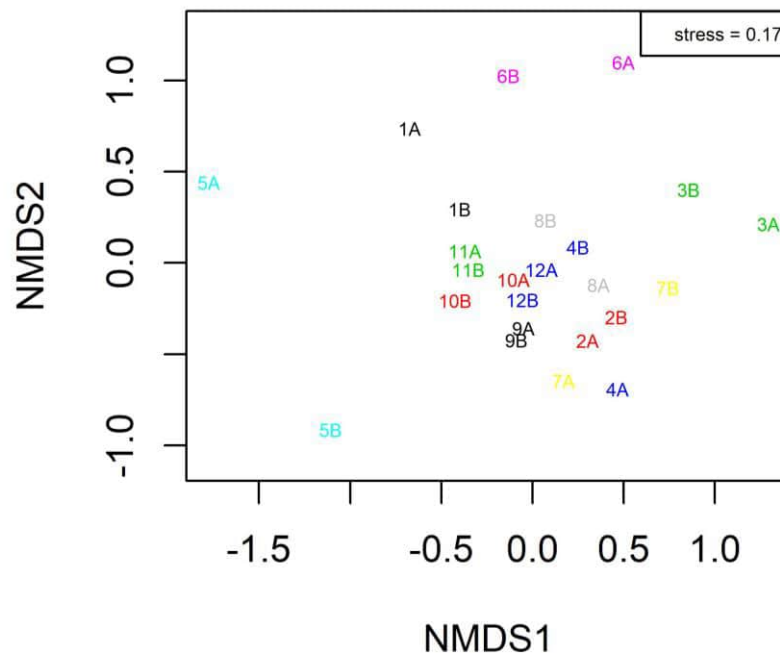
The MDS (Multidimensional Scaling) plot (Figure 3) shows how similar, or dissimilar, the macroinvertebrate community compositions at each site are to one another based on presence absence data.

■ **Figure 3: MDS plot of families from two edge habitats (A and B) at twelve sites.**

The above MDS plot (Figure 3) shows that sites above and below the Boundary Creek confluence have similar macroinvertebrate families present, with site 3 (East Barwon), site 5 (Boundary Creek), and site 6 (Barwon River immediately downstream of Boundary Creek) having different macroinvertebrate community compositions present.

Within the Barwon River, macroinvertebrate community composition is impacted by Boundary Creek immediately downstream of the confluence (shown by the MDS plot) but the overall health at this site (using the biotic indices) and continuing downstream are not adversely impacted. The absence of snails at Site 6 directly downstream is one of the contributors to the difference in macroinvertebrate community composition. Their absence is possibly due to the low pH affecting shell development but has not impacted on other species such as yabbies which were only found at this site and other grazing animals such as amphipods, mayflies and caddisflies are all present.

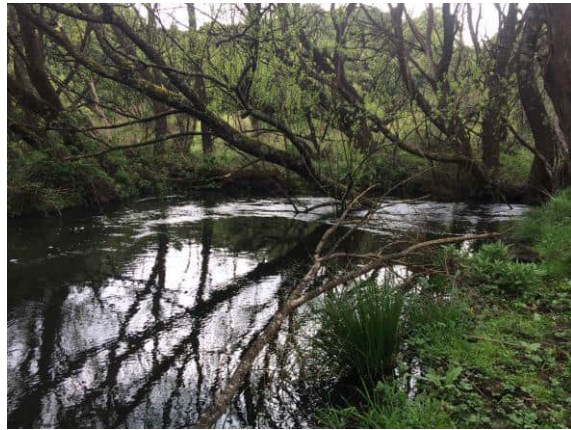
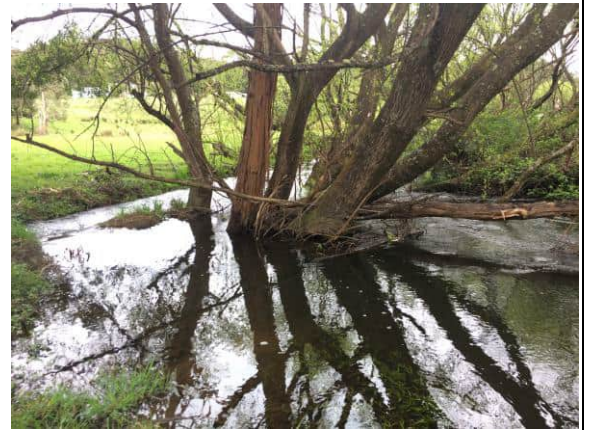
Site 1: upstream

Site 1: downstream

The East Barwon at Kents Road has diverse habitat with large deep pools and some riffle/run areas. Willows dominate the riparian zone and are growing within the stream channel. The substrate is a mix of clay and silt with a number of aquatic macrophytes growing in the margins and shallow pool areas. The average stream width at this site was eight meters and was bank full at the time of sampling. The majority of the riparian zone is exotic vegetation, dominated by blackberries, willows and pasture grass. One larval fish was collected as bycatch during macroinvertebrate sampling. A concurrent snapshot study by EnviroDNA (2019) found evidence of platypus at this site. Overall analysis of the health of the waterway using EPA habitat parameters for Low Gradient Streams gives this site a score of 74 out of 140.

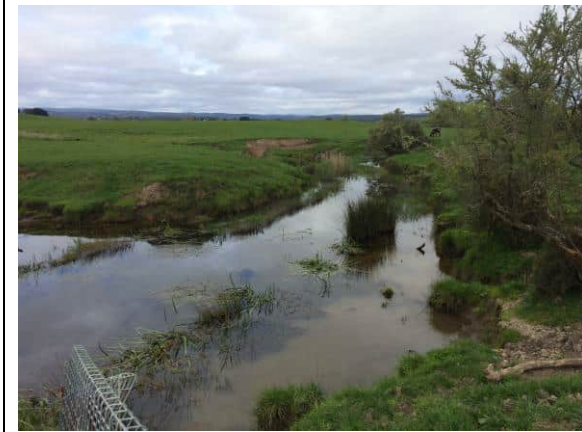
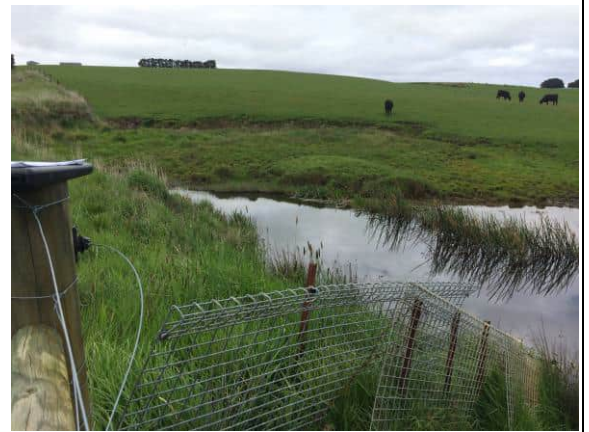
Site 2: upstream

Site 2: downstream

The East Barwon at Dewings Bridge Road consists of a slow flowing channel with extensive backwaters. There is very little riparian zone present but a number of submerged and emergent macrophytes provide good habitat. The substrate is a mix of clay and silt with some sand. The average stream width at this site was seven meters and was bank full at the time of sampling. The majority of the riparian zone is pasture grass with stock access on both sides. Overall analysis of the health of the waterway using EPA habitat parameters for Low Gradient Streams gives this site a score of 59 out of 140.

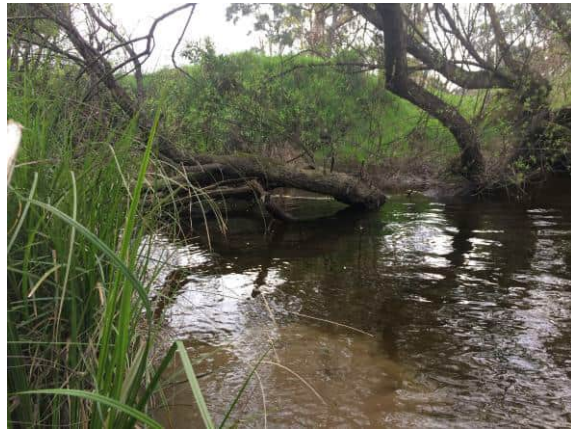
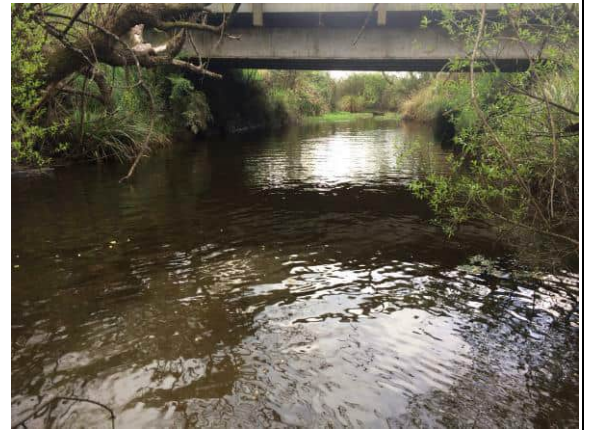
Site 3: upstream

Site 3: downstream

The West Barwon River at Seven Bridges Road has large deep pools with a number of large deep backwaters. The average stream width at this site is seven meters, narrow at the top of the surveyed reach and widening into a large pool near the bridge. The substrate is clay and silt mixed with 20% sand. There are some macrophytes present along with trailing bank vegetation, roots and instream large woody debris (primarily willow branches). Willows dominate the riparian zone a mix of shrubs and native and pasture grasses in the understory. Four larval fish were collected as bycatch during macroinvertebrate sampling. A concurrent snapshot study by EnviroDNA (2019) found evidence of platypus at this site. Overall analysis of the health of the waterway using EPA habitat parameters for Low Gradient Streams gives this site a score of 85 out of 140.

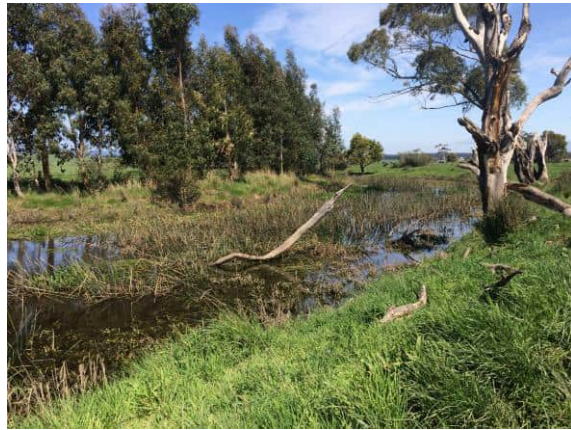
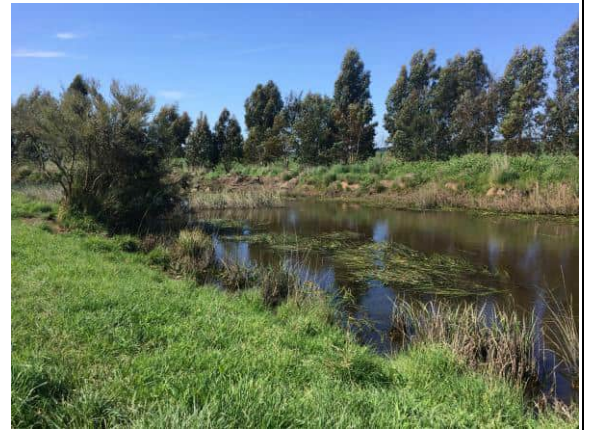
Site 4: upstream

Site 4: downstream

The Barwon River immediately upstream of the Boundary Creek confluence is a large slow flowing channel with shallow side sections that support a number of macrophyte beds. The average stream width at this site is nine meters. The substrate is clay and black silt with some large woody debris and filamentous algae present in addition to the macrophytes. *Juncus*, *Typha*, *Triglochin* and *Polygonum* are all present instream though riparian vegetation is limited to some isolated trees, a narrow native plantation and pasture grass with stock access. The introduced *Gambusia* (mosquito fish) were collected as bycatch during macroinvertebrate sampling. Overall analysis of the health of the waterway using EPA habitat parameters for Low Gradient Streams gives this site a score of 79 out of 140.

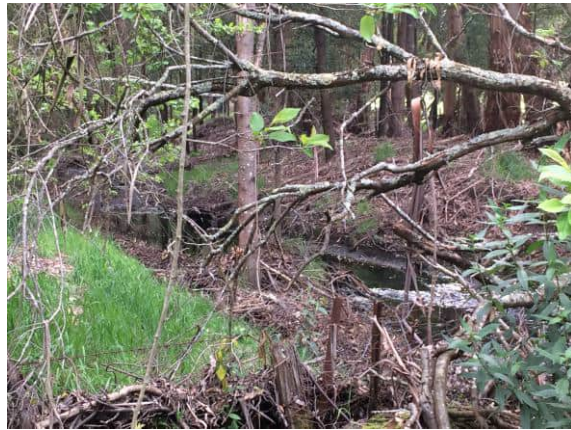
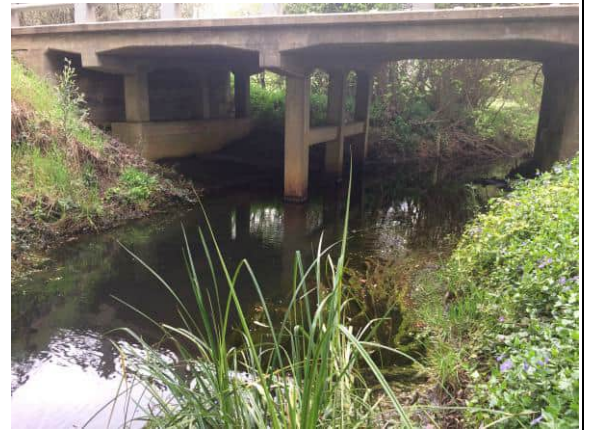
Site 5: upstream

Site 5: downstream

Boundary Creek at Colac- Forrest Road has a mix of large deep pools, a large shallow pool at the bridge and shallow runs. It was bankfull at the time of sampling with an average stream width of four meters, narrow at the top of the surveyed reach and widening into a large pool upstream of the bridge. The substrate is a mix of cobble, pebble, gravel, sand, clay and silt. There are no macrophytes but there is some filamentous algae and trailing bank vegetation present. The riparian zone is wide and a mix of native and exotic vegetation except the ground cover which is dominated by *Convolvulus* sp. and pasture grasses. Overall analysis of the health of the waterway using EPA habitat parameters for Low Gradient Streams gives this site a score of 81 out of 140.

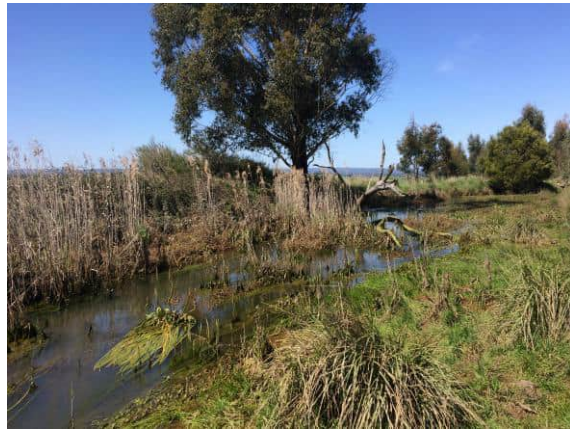
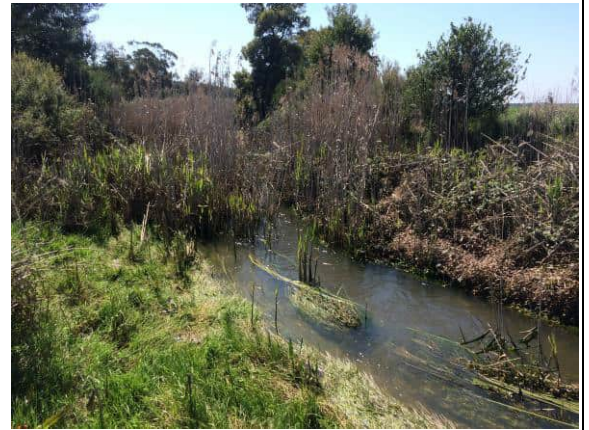
Site 6: upstream

Site : downstream

The Barwon River immediately downstream of the Boundary Creek confluence is a narrow deep channel with wide shallow edges dominated by grasses and aquatic macrophytes. The average stream width at this site is five meters and is bank full. It is wide but still with a narrow channel at the top of the surveyed reach and narrowing to a confined channel downstream. The substrate consists of clay and silt with filamentous algae tangled through the macrophyte beds. Macrophyte species are varied with Triglochin, Polygonum, Phragmites, and Juncus all present in addition to trailing grasses. The riparian zone is limited to grasses and scattered native trees and shrubs with stock access to the site. Overall analysis of the health of the waterway using EPA habitat parameters for Low Gradient Streams gives this site a score of 70 out of 140.

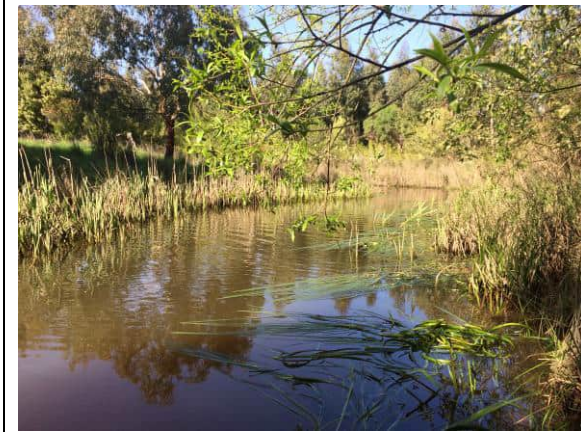
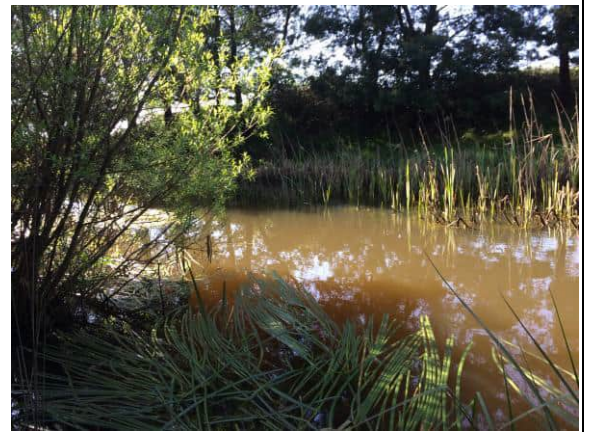
Site 7: upstream

Site 7: downstream

The Barwon River upstream of CO_BAR16 adjacent to the northern boundary of the pine plantation has a large deep channel with any shallow areas dominated by beds of *Phragmites*. The average stream width at this site is seven meters. The substrate is clay and silt. In addition to the *Phragmites* beds there are beds of *Triglochin*, and scattered *Polygonum*, *Juncus* and other grasses. The riparian zone has a good mix of trees, shrubs and understory with a majority of native trees and shrubs. Overall analysis of the health of the waterway using EPA habitat parameters for Low Gradient Streams gives this site a score of 90 out of 140.

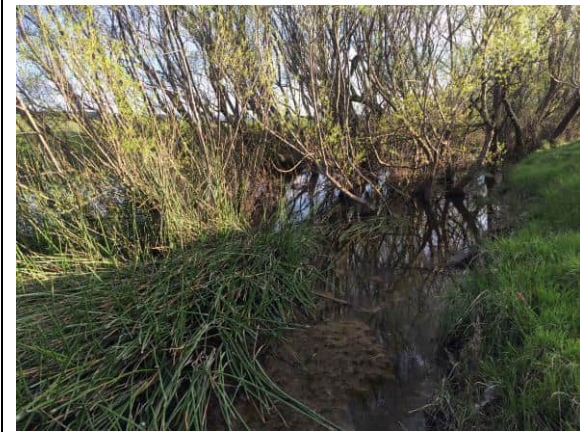
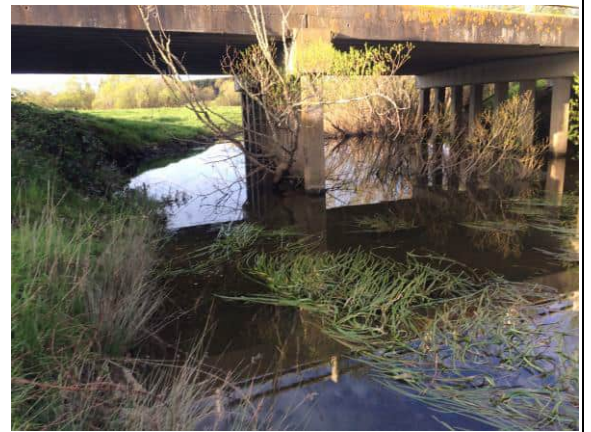
Site 8: upstream

Site 8: downstream

The Barwon River at Colac- Lorne Road has large deep pools with a shallow areas at the sides and willow trees growing in the channel and some substrate exposed. The average stream width at this site is eight meters with a predominantly clay and silt substrate mixed with some sand. There are beds of Triglochin and Phragmites in addition to trailing grasses and large willows. The riparian zone consists of willow trees, pasture grasses and blackberries and allows stock access. Overall analysis of the health of the waterway using EPA habitat parameters for Low Gradient Streams gives this site a score of 69 out of 140.

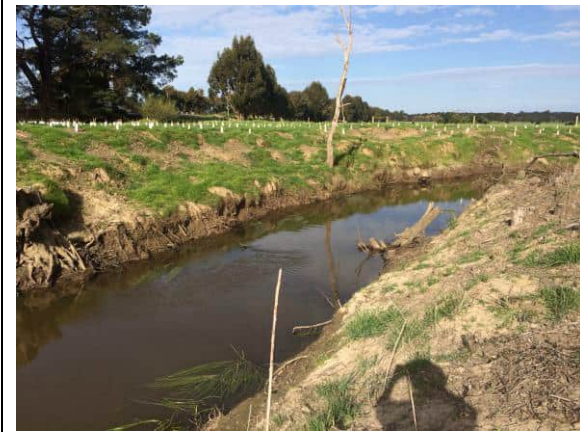
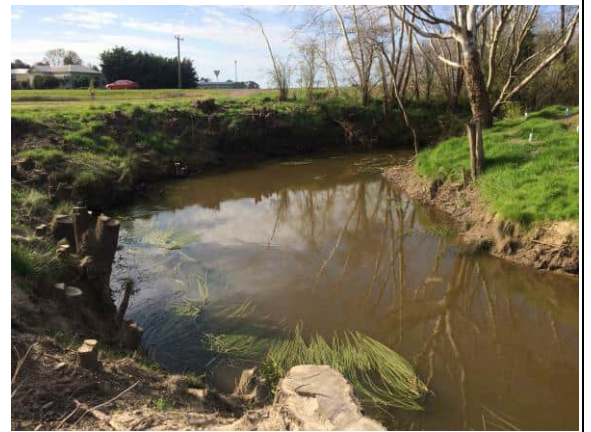
Site 9: upstream

Site 9: downstream

The Barwon River at Birregurra consists of a large deep slow flowing pool. The average stream width at this site is five meters with steep clay banks. The substrate is clay and silt with willow roots, some snags and Triglochin beds scattered along the edges of the channel. There have been recent willow removal works and replanting of the riparian zone in amongst the pasture grass and blackberry groundcover. Rakali footprints were evident in the soft sediment edge. Overall analysis of the health of the waterway using EPA habitat parameters for Low Gradient Streams gives this site a score of 67 out of 140.

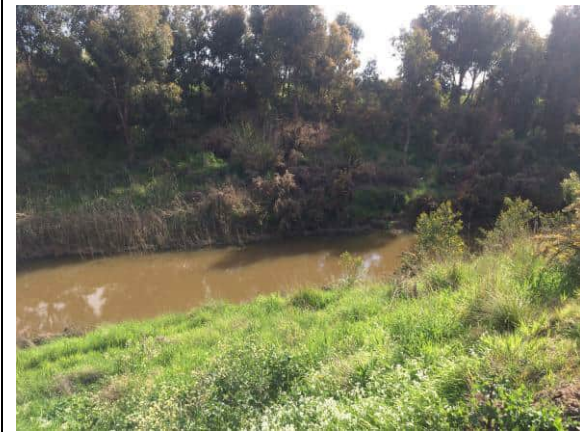
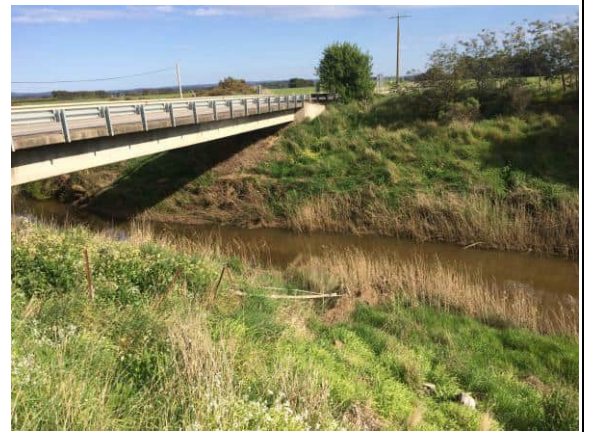
Site 10: upstream

Site 10: downstream

The Barwon River at Conns Lane has large deep pools with some small deep backwaters and a narrow deep run at the top of the reach. The average stream width at this site is six meters. The substrate is clay and silt mixed with some sand and gravel. Phragmites beds line the channel and there are isolated patches of Triglochin in addition to Polygonum and trailing grasses along the waters edge. The riparian zone consists of relatively new and older native revegetation with pasture grass understory. Overall analysis of the health of the waterway using EPA habitat parameters for Low Gradient Streams gives this site a score of 98 out of 140.

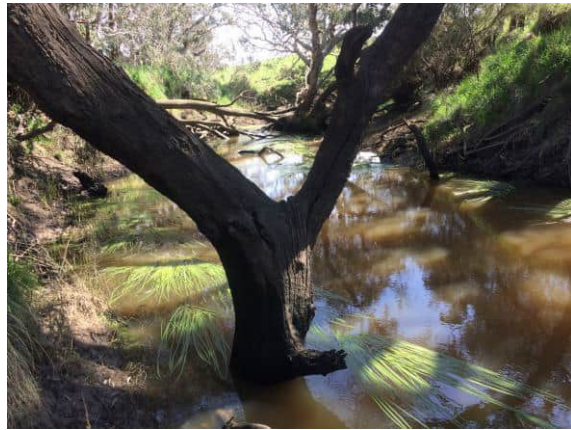
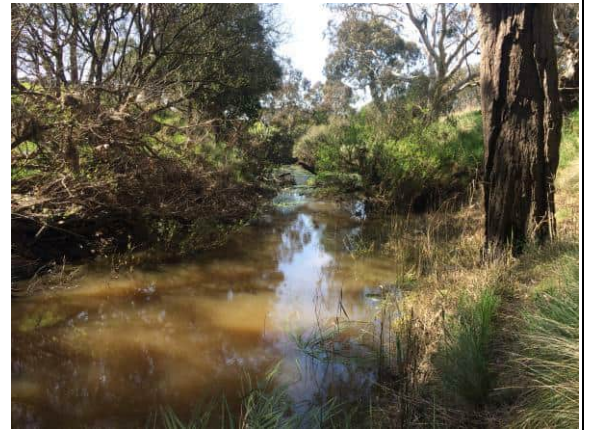
Site 11: upstream

Site 11: downstream

The Barwon River at Winchelsea- Deans Marsh Road has large deep pools with a shallow run at the top of the reach. The average stream width at this site is five meters and the substrate is clay and silt mixed with some sand and gravel. Triglochin is growing in the shallow areas of the channel and there are roots, large woody debris and trailing grasses. The riparian zone is predominately native trees and understory with a mix of grasses as groundcover. Rakali footprints were spotted at the waters edge. Overall analysis of the health of the waterway using EPA habitat parameters for Low Gradient Streams gives this site a score of 90 out of 140.

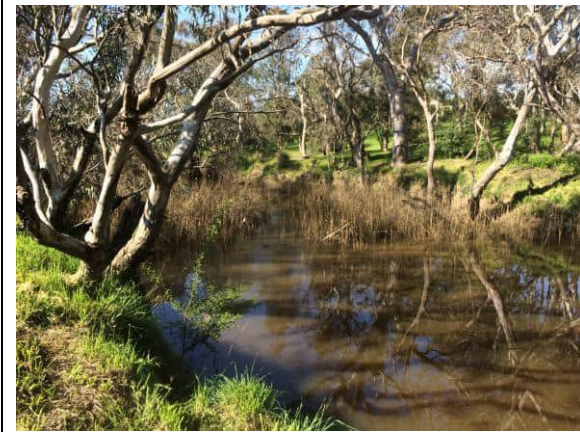
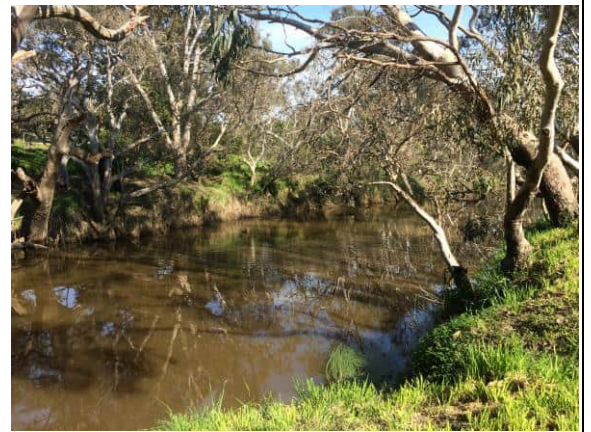
Site 12: upstream

Site 12: downstream

The Barwon River at Winchelsea has large deep pools with a large shallow pool at the top of the reach. The average stream width at this site is twelve meters. The substrate is clay and silt mixed with sand and some gravel. In addition to the *Phragmites* beds at the top of the reach and along some edges there are also patches of *Triglochin*. Large woody debris, trailing grasses and emergent vegetation such as *Polygonum* are also present. Riparian vegetation is predominantly native with many established eucalypts and groundcover is pasture grass. A concurrent snapshot study by EnviroDNA (2019) found evidence of platypus at this site. Overall analysis of the health of the waterway using EPA habitat parameters for Low Gradient Streams gives this site a score of 88 out of 140.
