Upper Barwon River Macroinvertebrate Sampling Report Spring 2022

- Final
- January 2022

Printed:	7 February 2023
Last saved:	7 February 2023 12:06 PM
File name:	
Author:	Kylie Iervasi
Project manager:	Kylie Iervasi
Name of organisation:	Barwon Water
Name of project:	Barwon River/ Boundary Creek Survey
Name of document:	Upper Barwon River Macroinvertebrate Sampling Report 2019-2022
Document version:	Final
Project number:

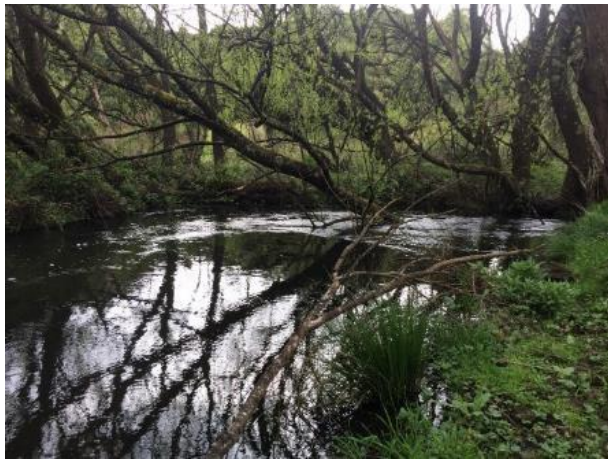
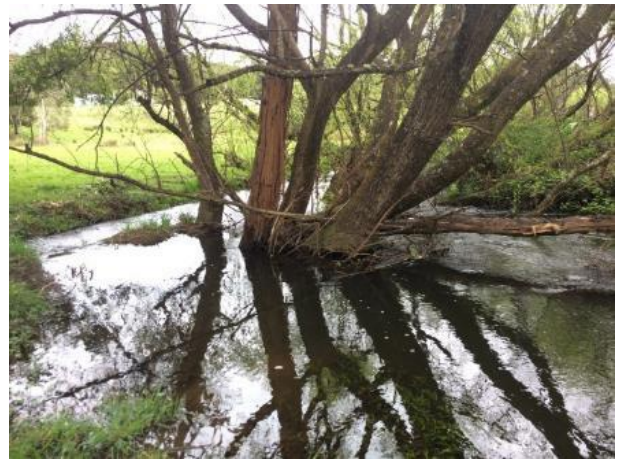
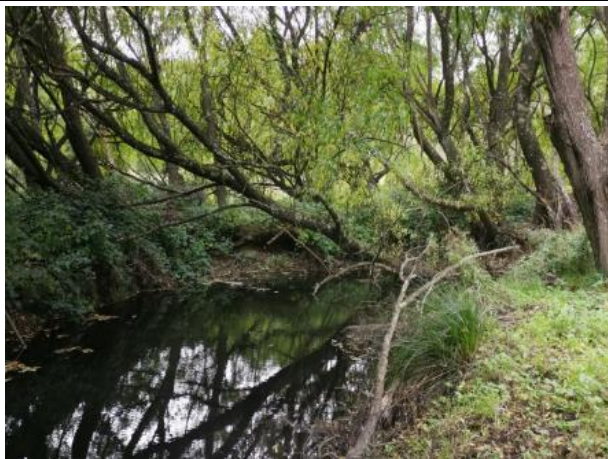
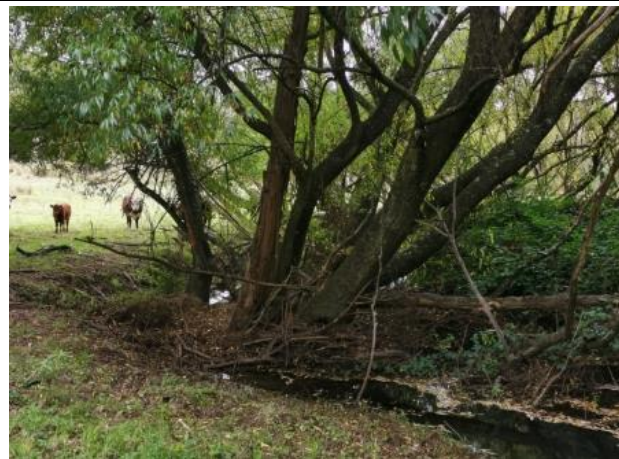
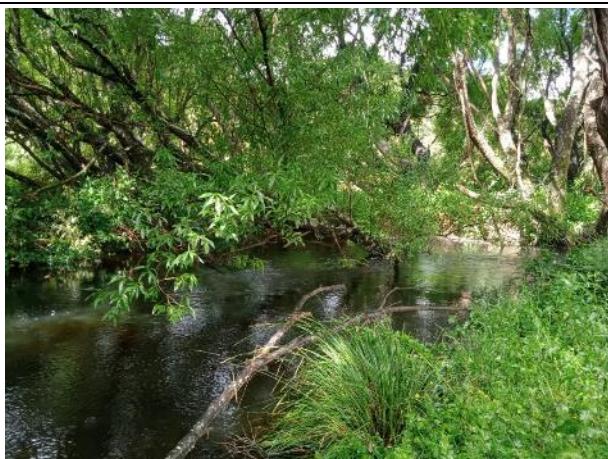
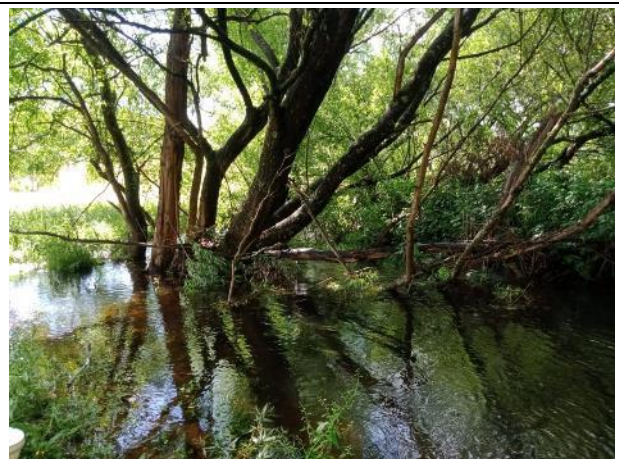
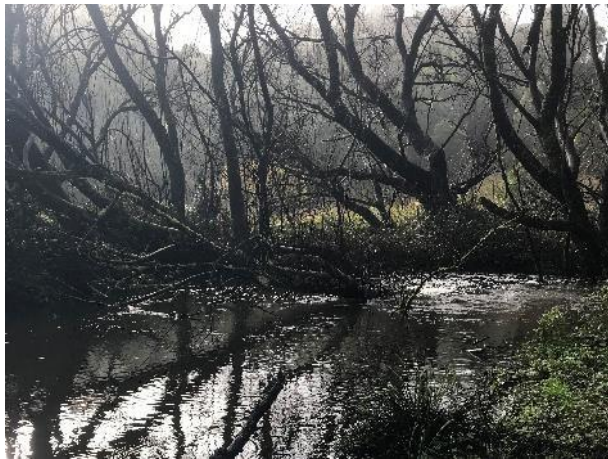
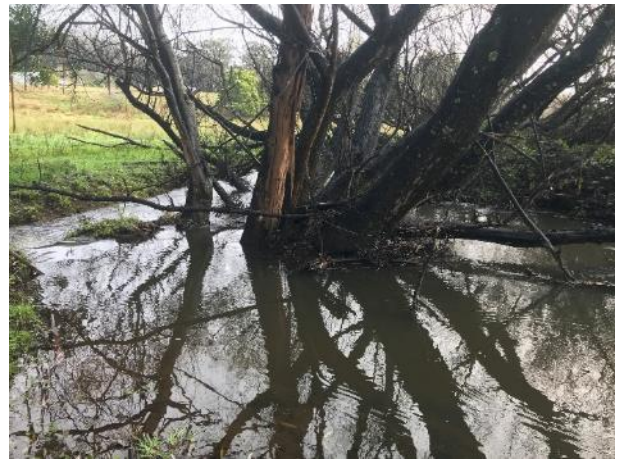
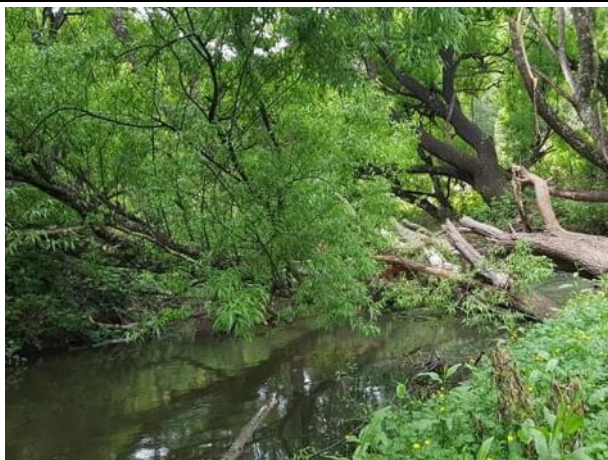
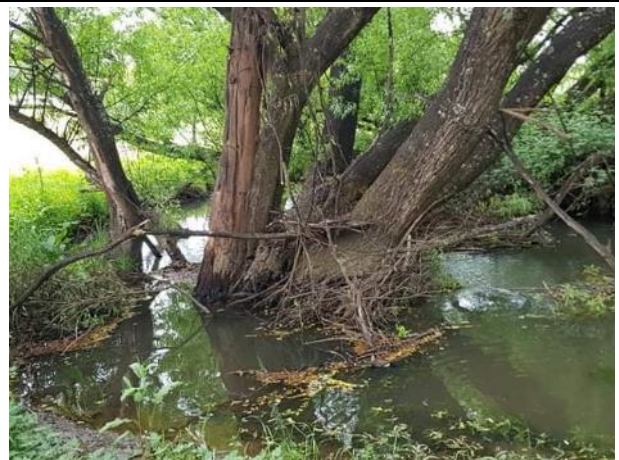
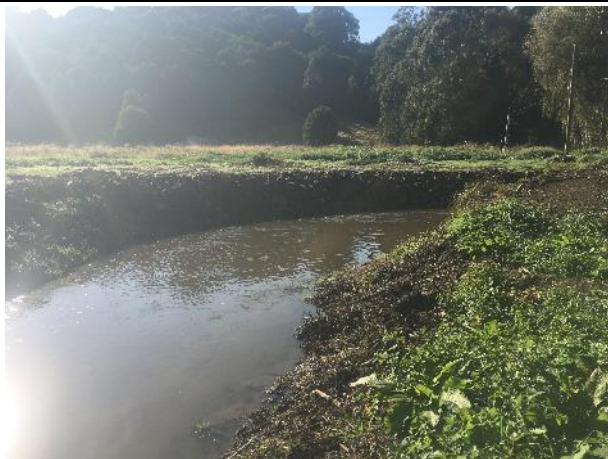
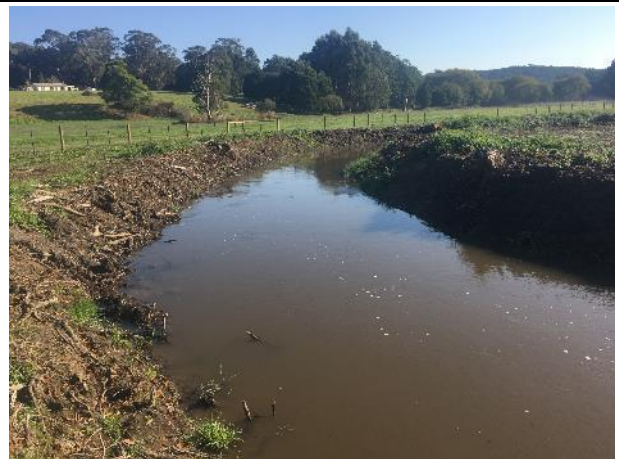
5.1. Site 1- East Barwon River@ Kents Road

Prior to the willow removal and river realignment in early 2022, the East Barwon River at Kents Road had diverse habitat with large deep pools and some riffle/ run areas. These runs had dried to trickles in Autumn 2020 but were flowing well in Spring and Autumn 2021. The average stream width was eight meters and bank full but had contracted to five meters in Autumn 2020. Willows dominate the riparian zone and are growing within the stream channel. The substrate was a mix of clay and silt with a number of aquatic macrophytes growing in the margins and shallow pool areas. The majority of the riparian zone was exotic vegetation, dominated by blackberries (possibly poisoned in Summer 20/21), willows and pasture grass. One larval fish has been collected as bycatch during macroinvertebrate sampling. A concurrent snapshot study by EnviroDNA (2019) found evidence of platypus at this site.

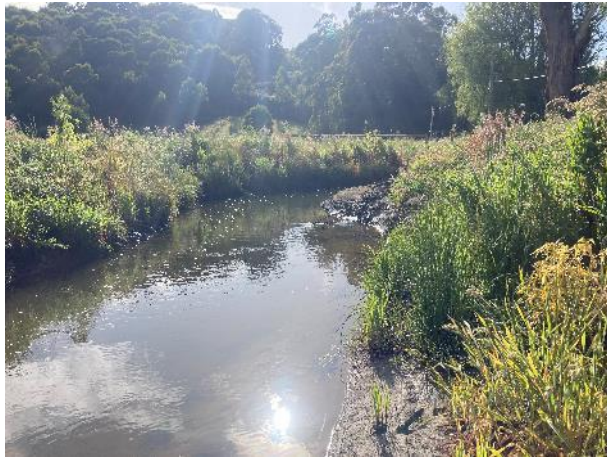
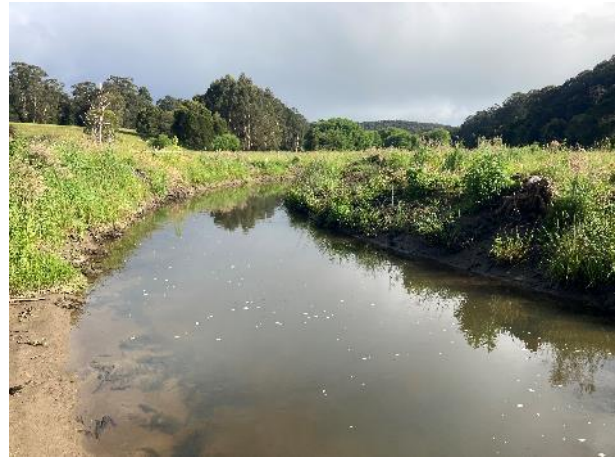
Following the works in January to April 2022 (Barwon Water, 2022), the East Barwon River at Kents Road is a homogenous channel with very little riparian zone and submerged macrophytes. The banks had healed in areas in Spring 2022 from the disturbed bare earth or rip rap in Autumn 2022. Stock now appear excluded from the waterway and all woody weeds have been removed within the vicinity of the site.

Overall analysis of the health of the waterway using EPA habitat parameters for Low Gradient Streams gives this site a score of 74 out of 140 in 2019 and a downgraded score of 57 out of 140 in 2022 due to the recent works. It is expected that this score will improve following the planned revegetation works and ongoing stock exclusion.

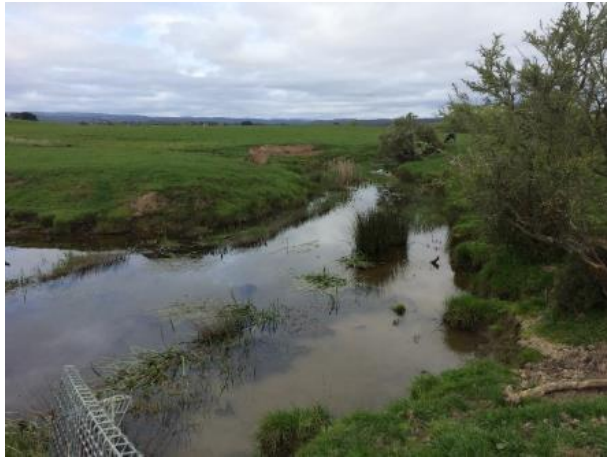
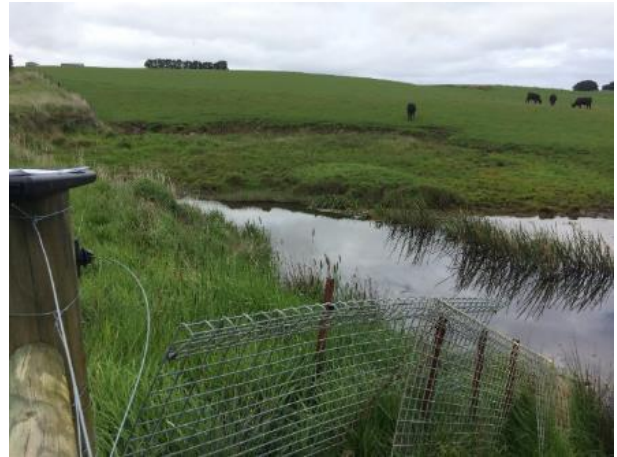
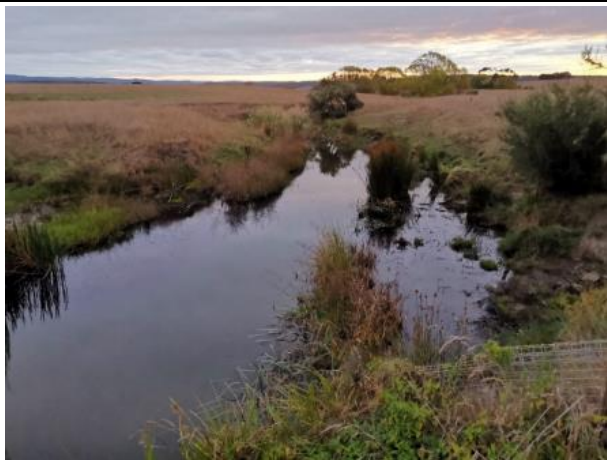
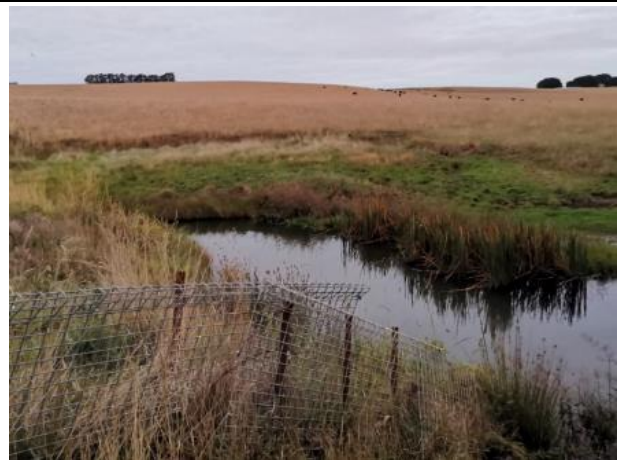
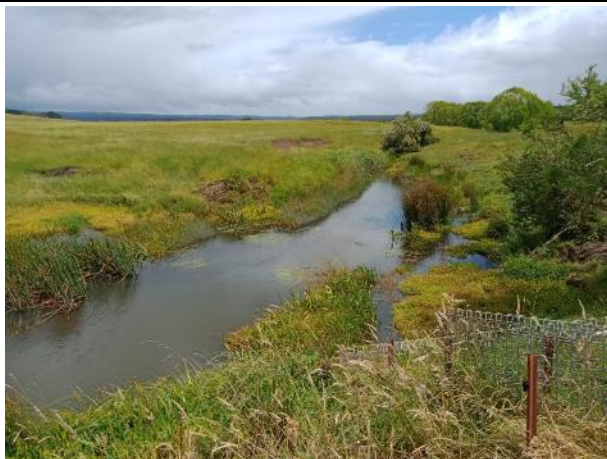
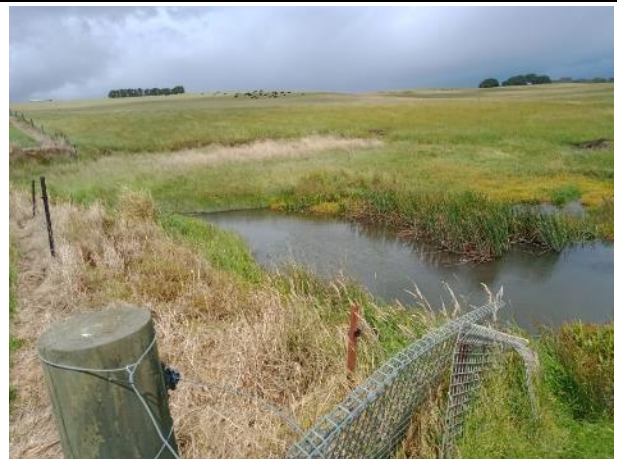
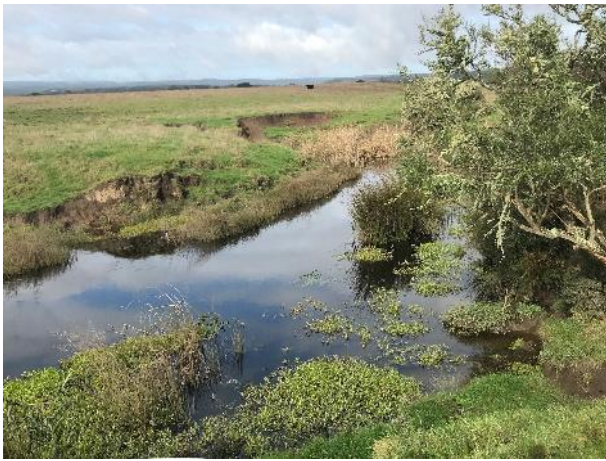
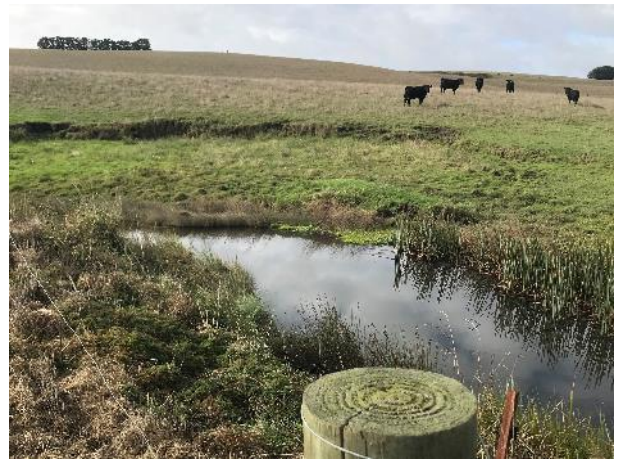
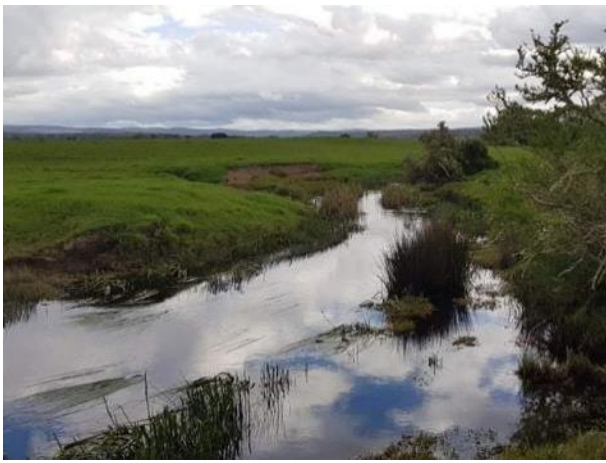
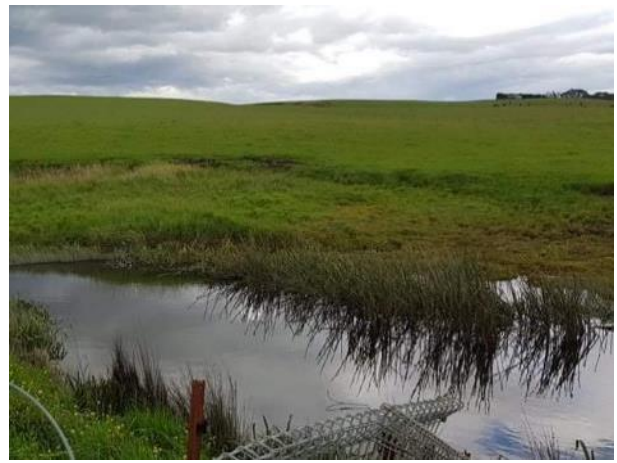
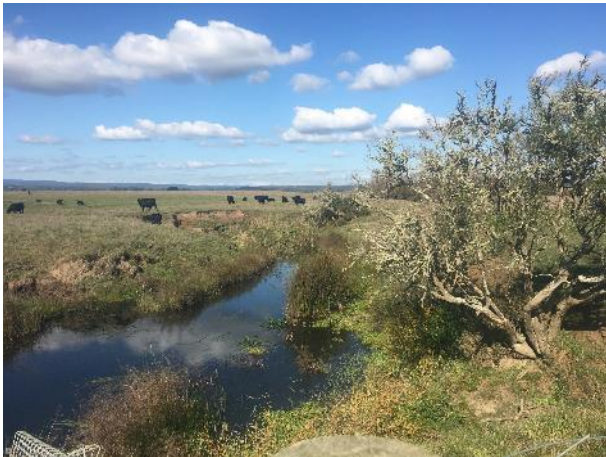
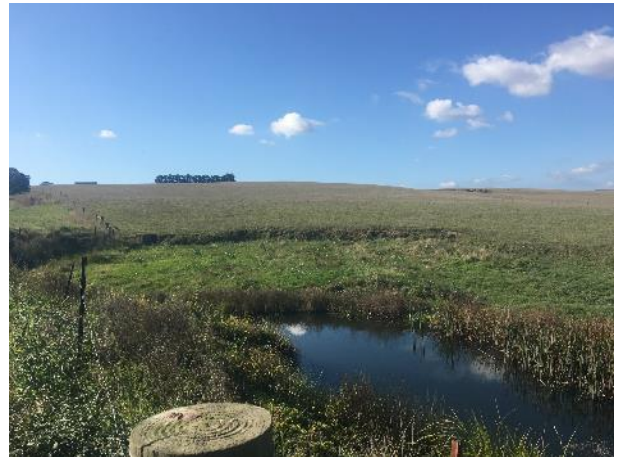
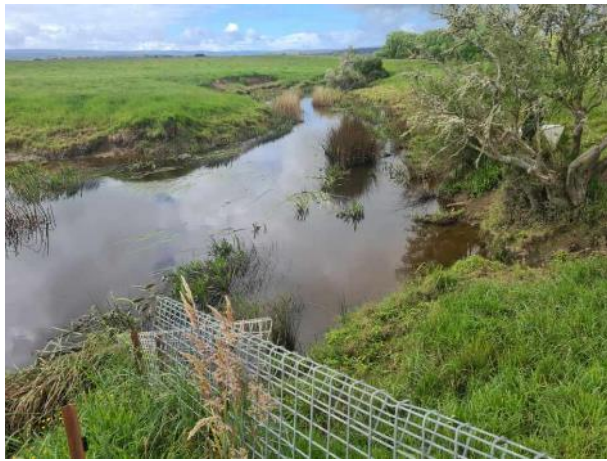
5.2. Site 2- East Barwon River@ Dewings Bridge Road

The East Barwon at Dewings Bridge Road consists of a slow flowing channel with extensive backwaters. There is very little riparian zone present but a number of submerged and emergent macrophytes provide good habitat for macroinvertebrates and fish. One larval fish was found in the sample net in Autumn 2020, three pygmy perch in Spring 2020 and a pygmy perch in Spring 2021. The substrate is a mix of clay and silt with some sand. The average stream width at this site was seven meters and was bank full during both Spring and Autumn sampling. The majority of the riparian zone is pasture grass with stock access on both sides. Overall analysis of the health of the waterway using EPA habitat parameters for Low Gradient Streams gave this site a score of 59 out of 140 and increased to 70 out of 140, primarily due to the gradual reduction in erosional scars and the increase in submerged and emergent macrophyte beds, despite the constant stock access. Removing stock access and establishing riparian vegetation will improve the health of this site significantly.

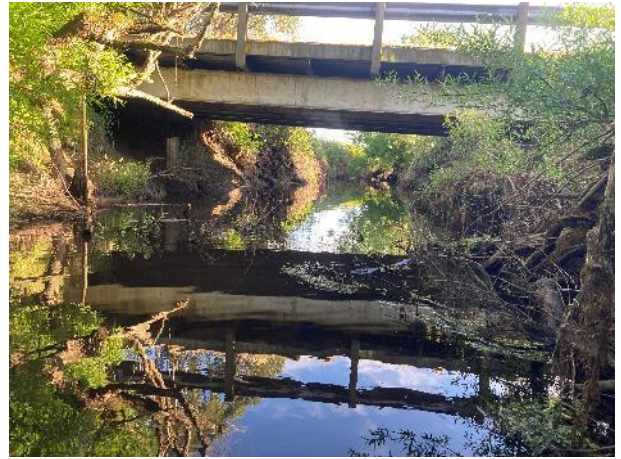
Spring 2022

The West Barwon River at Seven Bridges Road has large deep pools with a number of backwaters. The average stream width at this site is seven meters, narrow at the top of the surveyed reach and widening into a large pool near the bridge. The substrate is clay and silt mixed with 20% sand. There are some macrophytes present along with trailing bank vegetation, roots and instream large woody debris (primarily willow branches). Willows dominate the riparian zone a mix of shrubs and native and pasture grasses in the understory. Four larval fish were collected as bycatch during macroinvertebrate sampling in Spring 2019. One mountain galaxias, one common galaxias, one pygmy perch and a laval galaxias were collected in Spring 2020 and another galaxias in Spring 2021. A number of pygmy perch were collected in Autumn 2022. A concurrent snapshot study by EnviroDNA (2019) found evidence of platypus at this site in Spring 2019. Overall analysis of the health of the waterway using EPA habitat parameters for Low Gradient Streams gave this site a score of 85 out of 140 in 2019 and this has remained steady over the three years of the study.

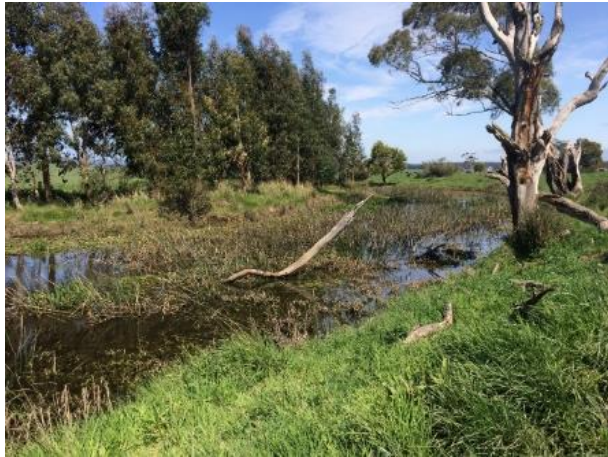
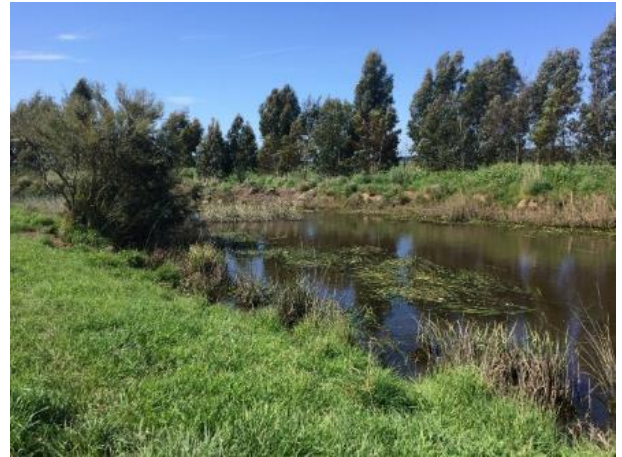
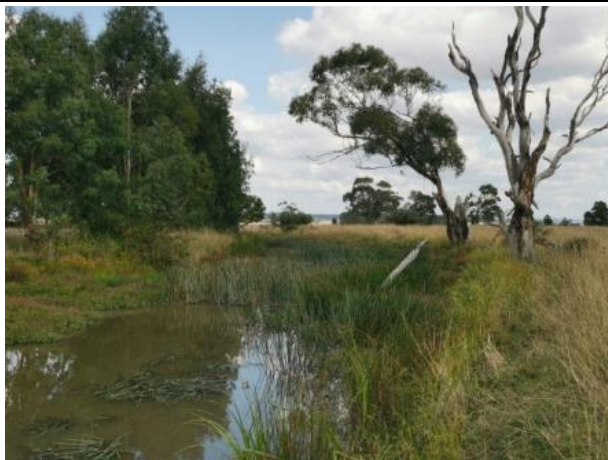
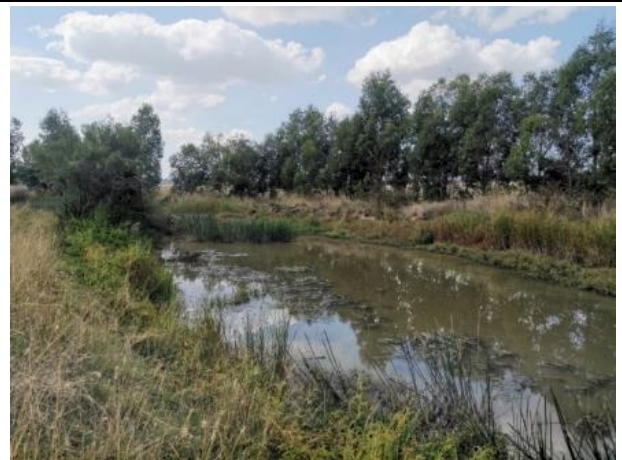
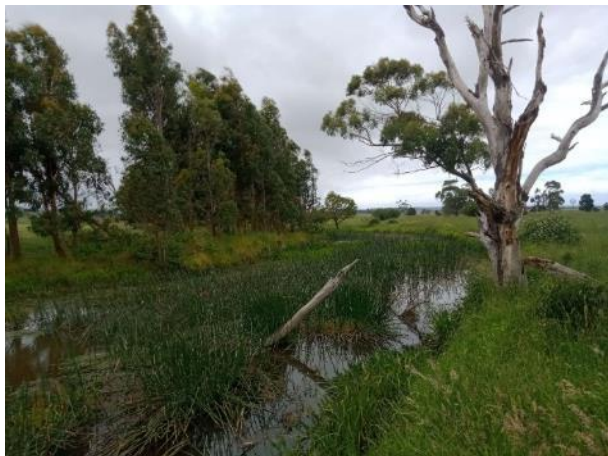
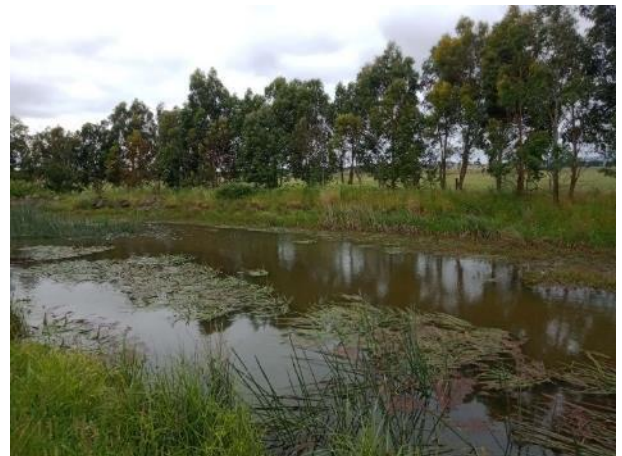
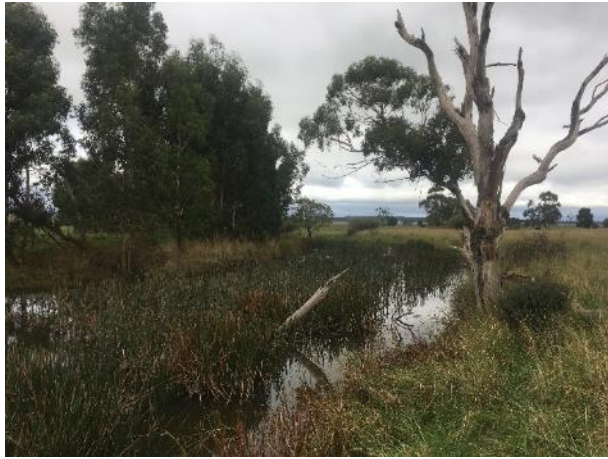
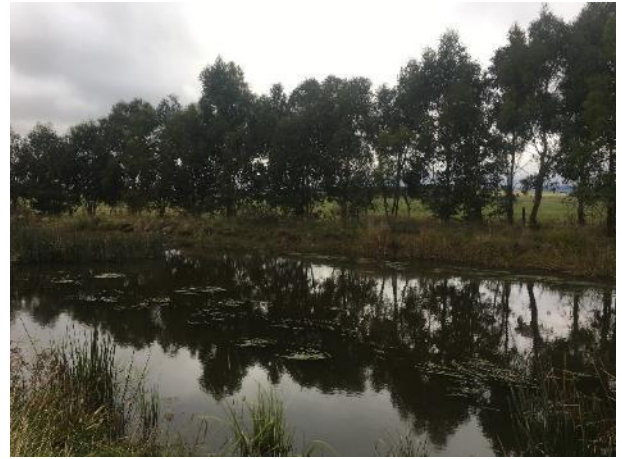
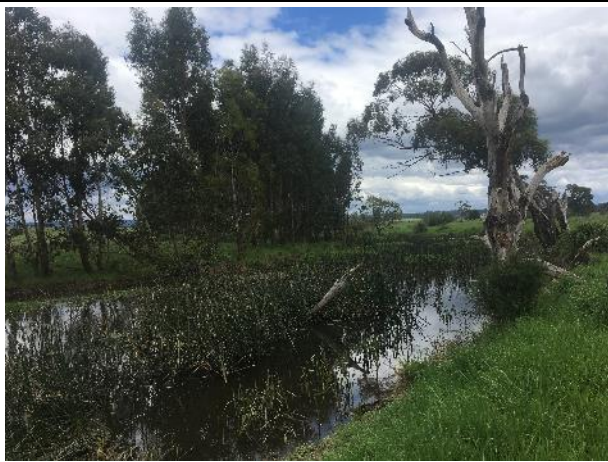
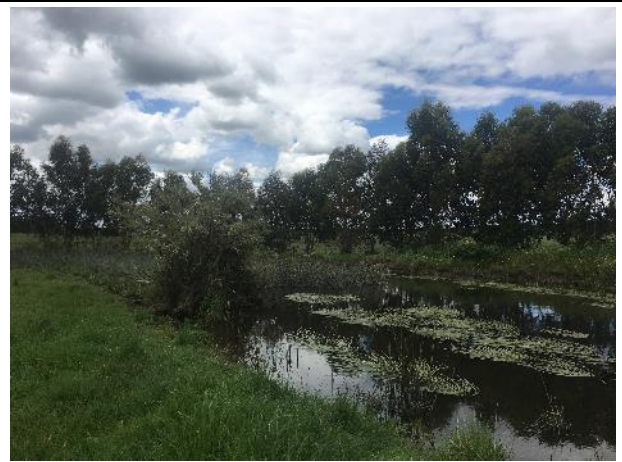
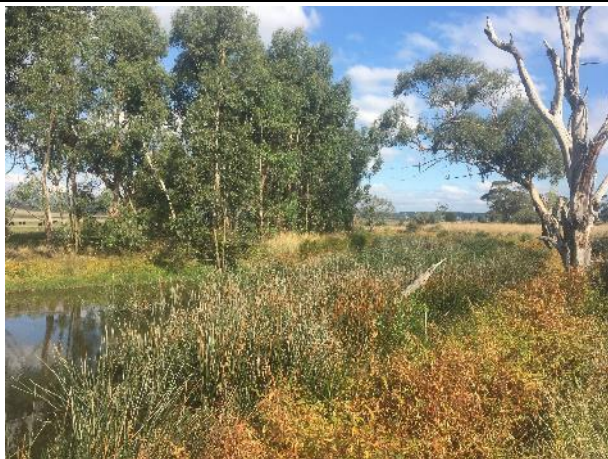
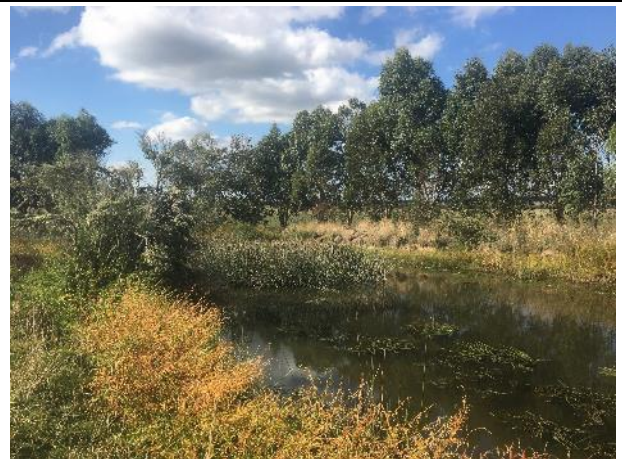
5.4. Site 4- Barwon River 100m upstream of Boundary Creek confluence

The Barwon River 100 meters upstream of the Boundary Creek confluence is a large slow flowing channel with shallow side sections that support a number of macrophyte beds. The average stream width at this site is nine meters. The substrate is clay and black silt with some large woody debris and filamentous algae present in addition to the macrophytes. *Juncus*, *Typha*, *Triglochin* and *Polygonum* species are all present instream though riparian vegetation is limited to some isolated trees, a narrow native plantation and pasture grass with stock access. The introduced *Gambusia* (mosquito fish) were collected as bycatch during macroinvertebrate sampling in Spring 2019, Autumn 2021 and Autumn 2022 and a pygmy perch sampled in Spring 2021. Overall analysis of the health of the waterway using EPA habitat parameters for Low Gradient Streams gave this site a score of 79 out of 140 in 2019 and an increased score of 99 due to the establishment of more aquatic macrophytes and healed erosion. Fencing and revegetation of the left side of the river to a similar standard as the right side would see further improvements to the health of the river.

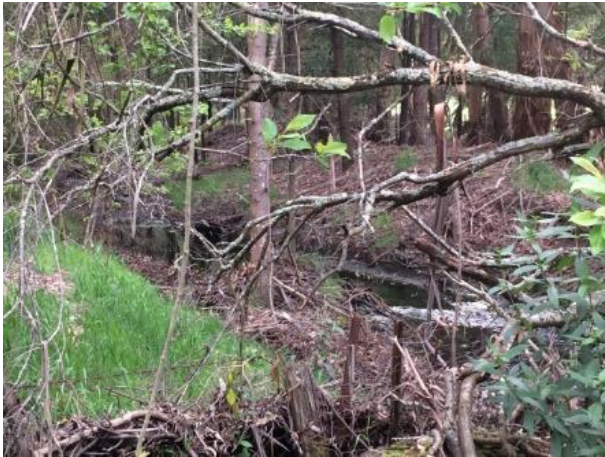
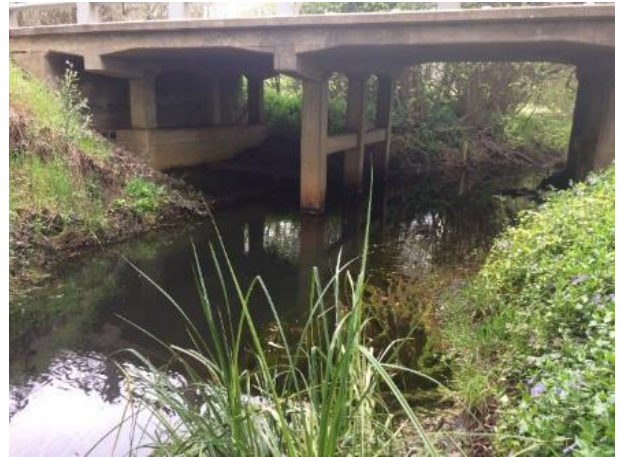
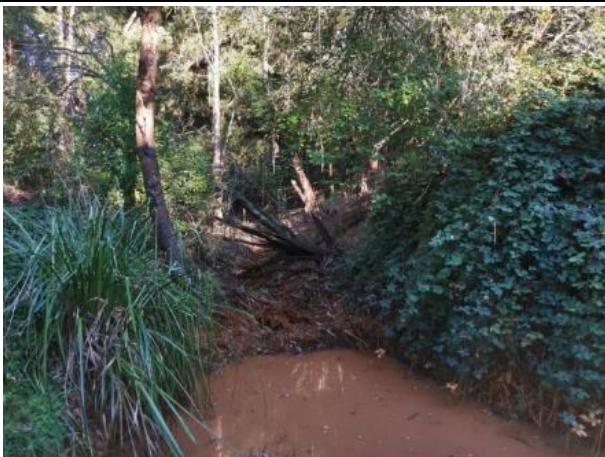
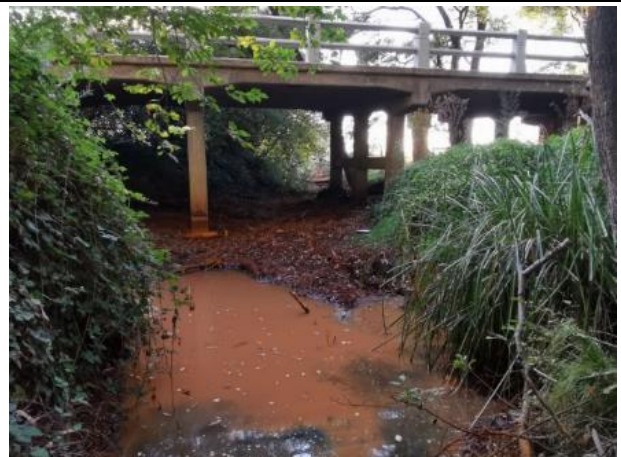
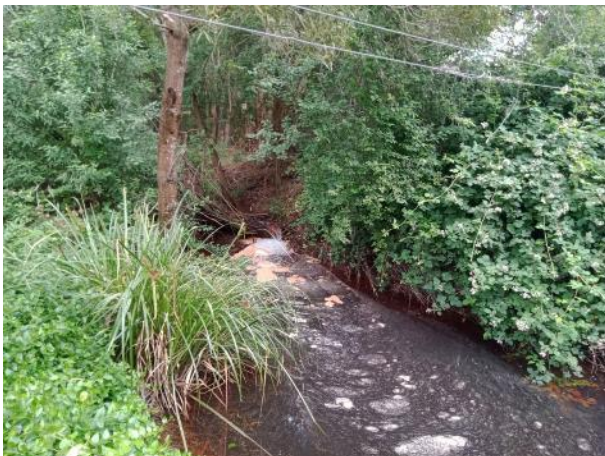
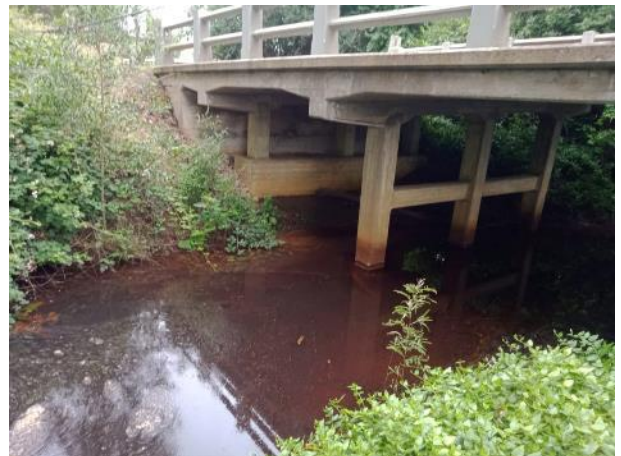
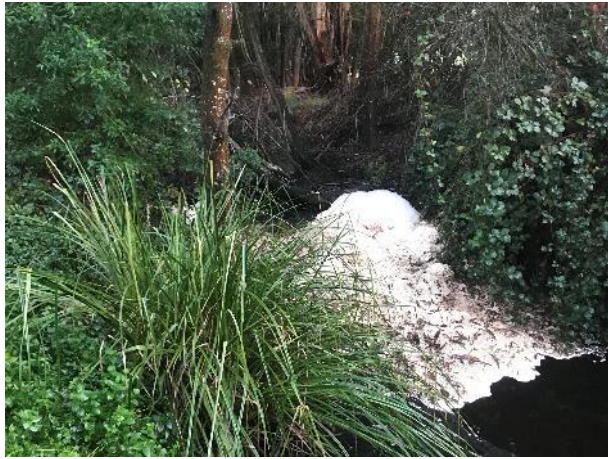
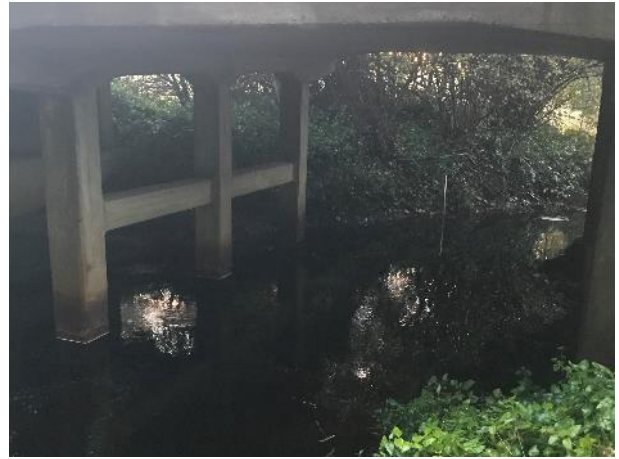
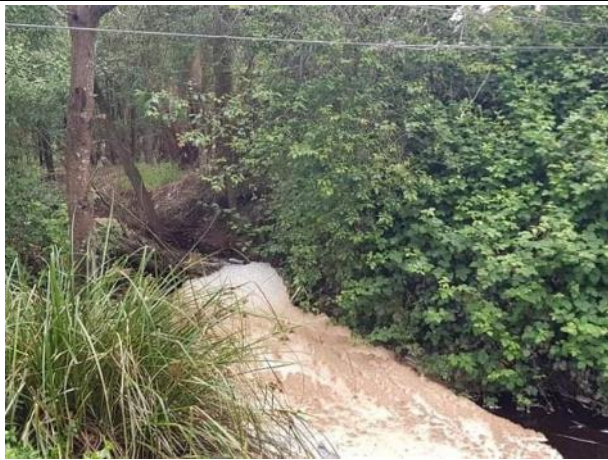
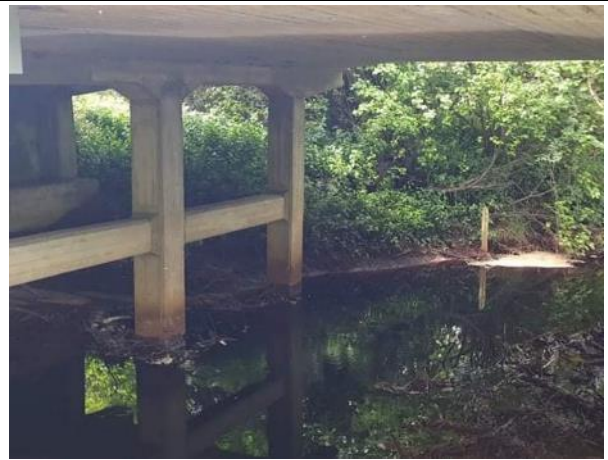
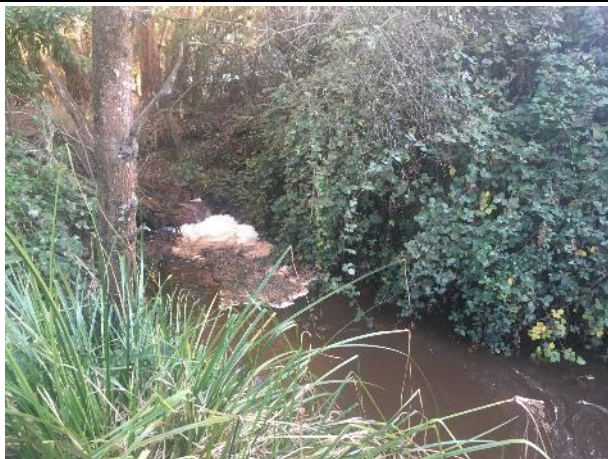
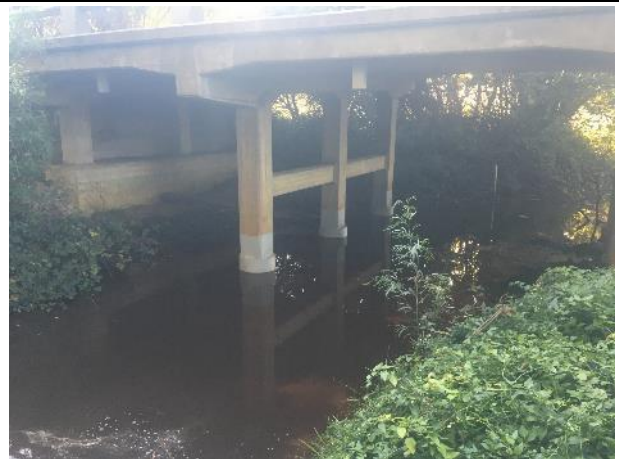
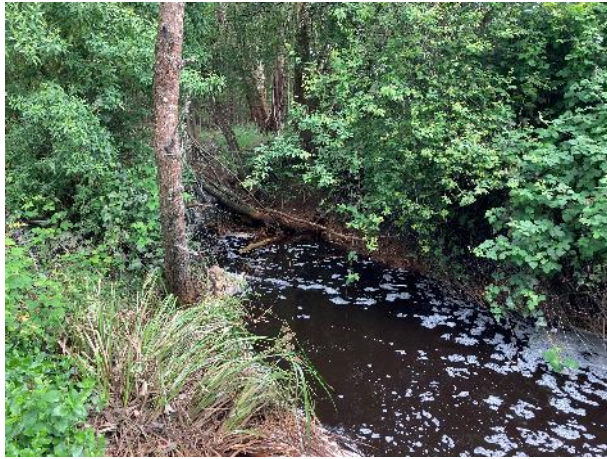
5.5. Site 5- Boundary Creek @ Colac- Forrest Road

Boundary Creek at Colac- Forrest Road has a mix of large deep pools, a large shallow pool at the bridge and shallow runs. It has been bank full with an average stream width of four meters, narrow at the top of the surveyed reach and widening into a large pool upstream of the bridge during each sampling event excepting during Autumn 2020 sampling when the creek had contracted to a pool approximately 4 meters long by 2.5 meters wide. During this time the pooled water was stagnant, with low oxygen concentrations and very high turbidity. The substrate is a mix of cobble, pebble, gravel, sand, clay and silt. There are no macrophytes but there was some filamentous algae in Spring 2019, (absent since) and trailing bank vegetation present. Foam was present at the top of the reach in Spring 2020, Autumn 2021, Spring 2021 and Autumn 2022. The riparian zone is wide and a mix of native and exotic vegetation except the ground cover which is dominated by *Convolvulus* sp. and pasture grasses. Overall analysis of the health of the waterway using EPA habitat parameters for Low Gradient Streams has remained steady at 81 out of 140 between 2019 and 2022 and is likely to remain so until conditions allow aquatic vegetation to establish and the riparian vegetation is improved.

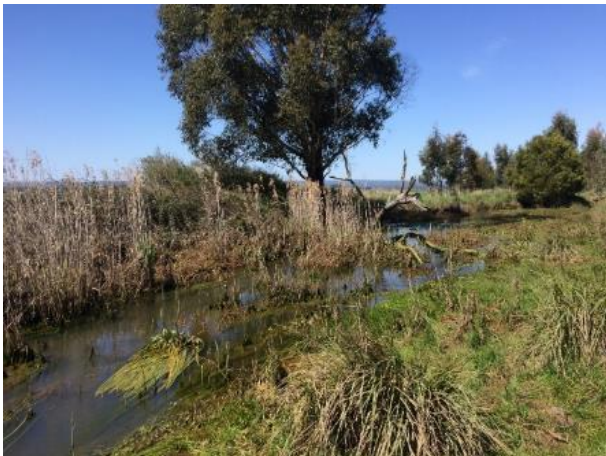
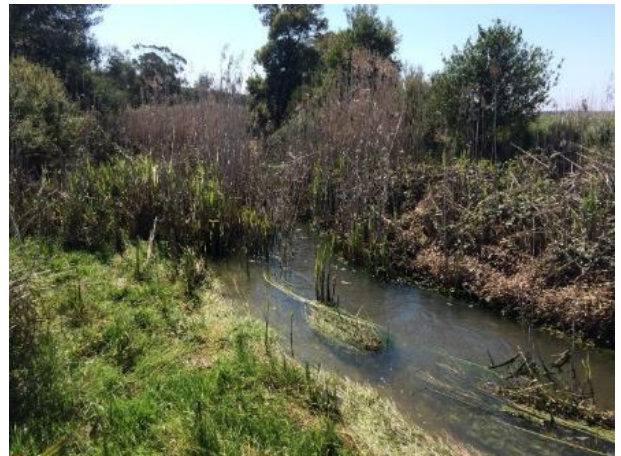
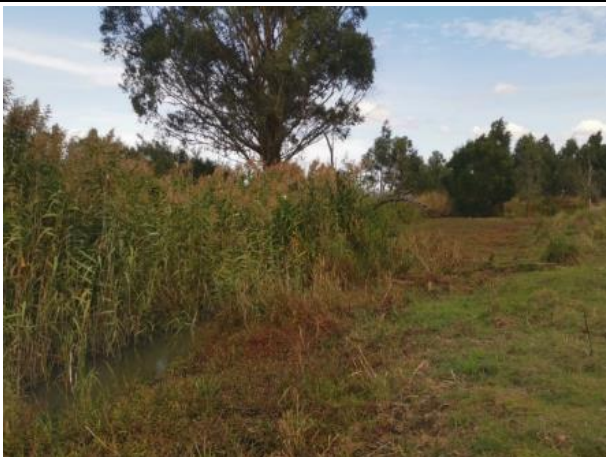
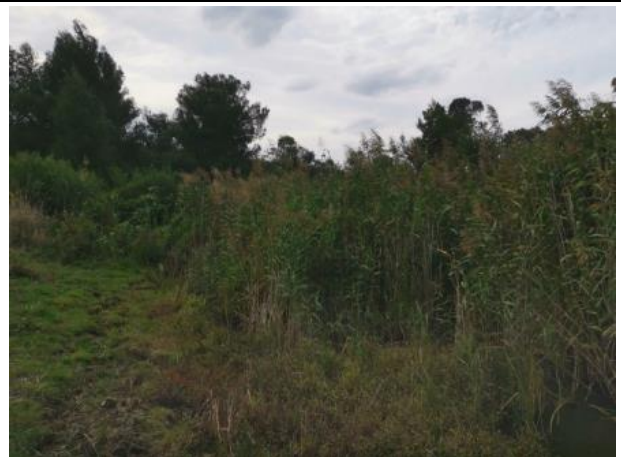
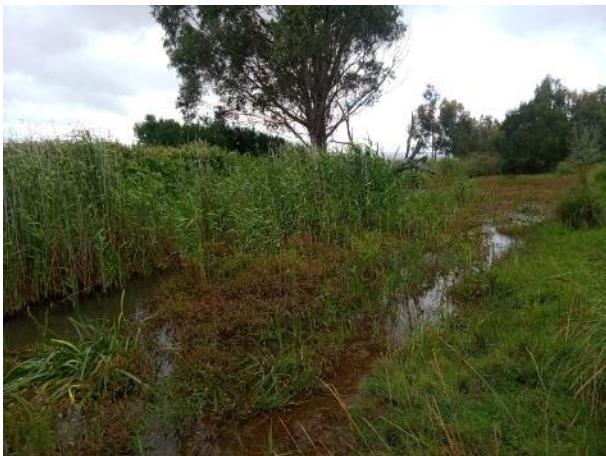
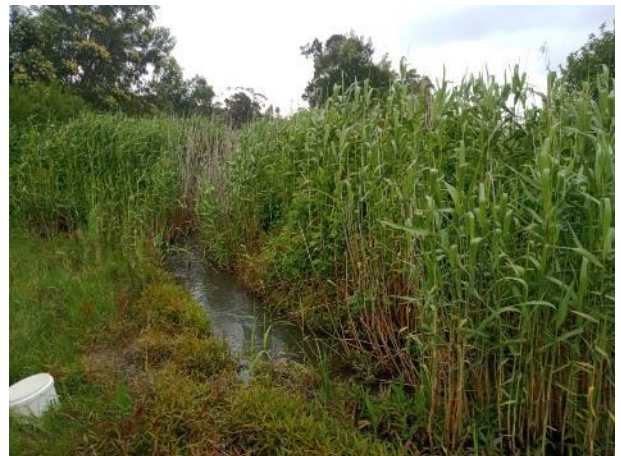
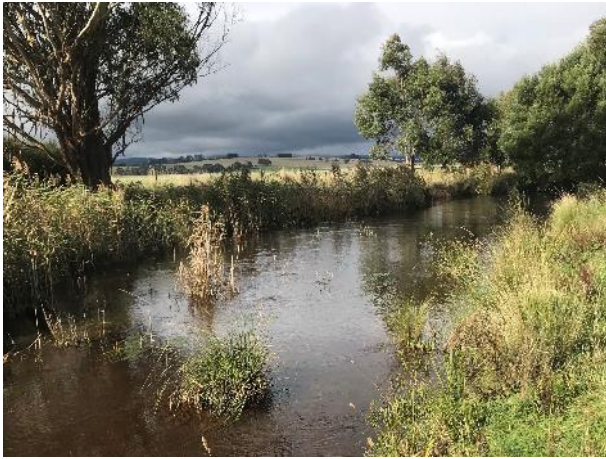
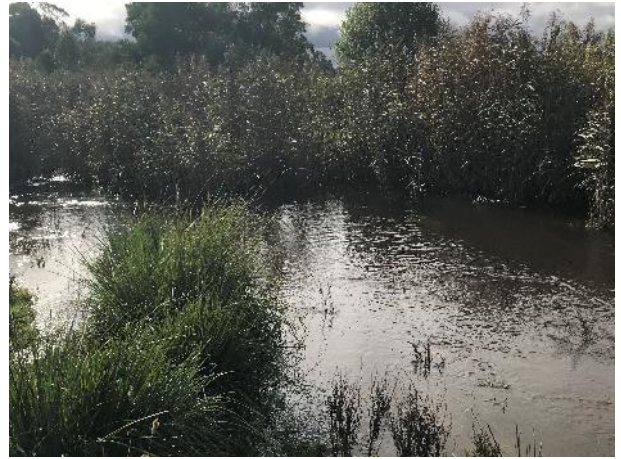
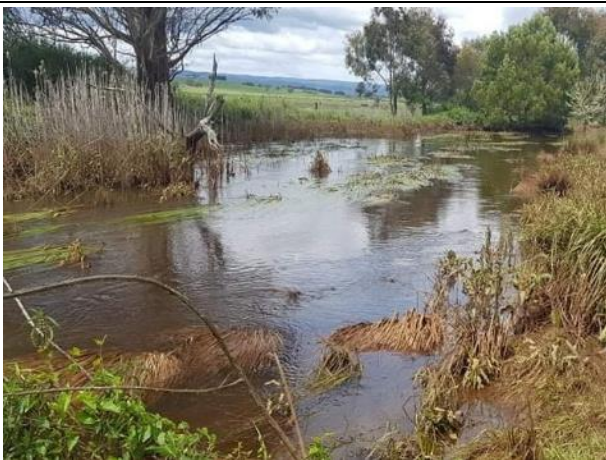
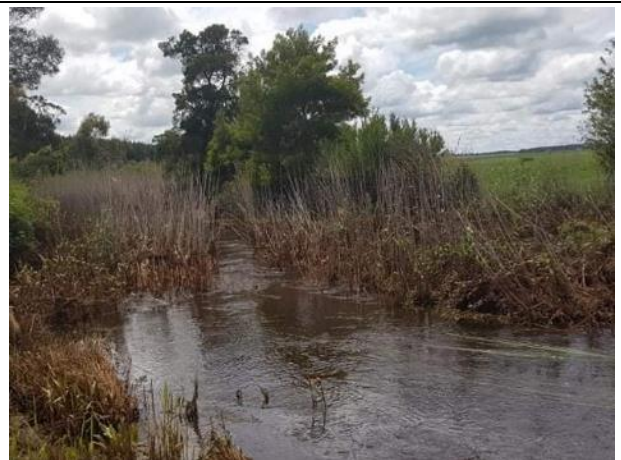
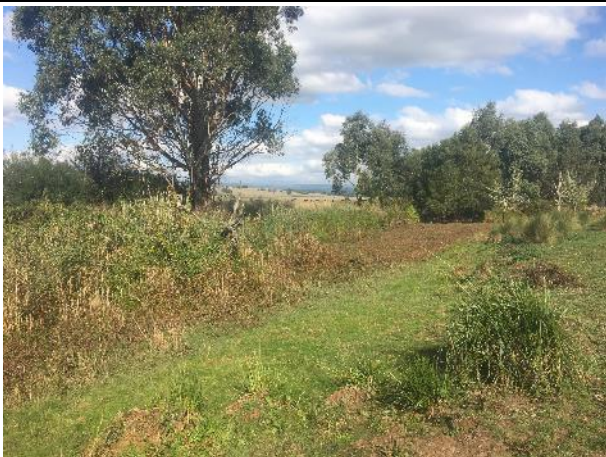
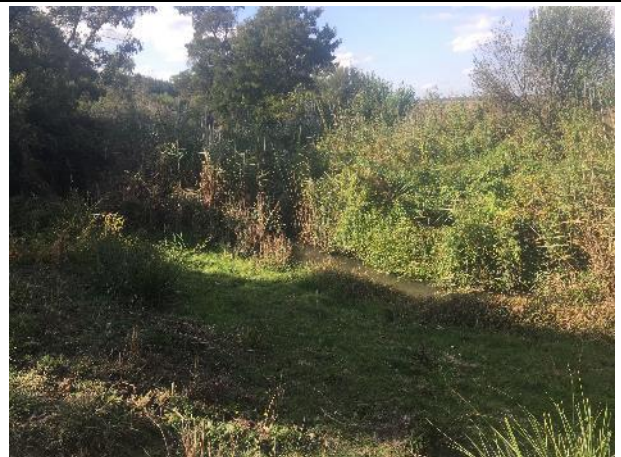
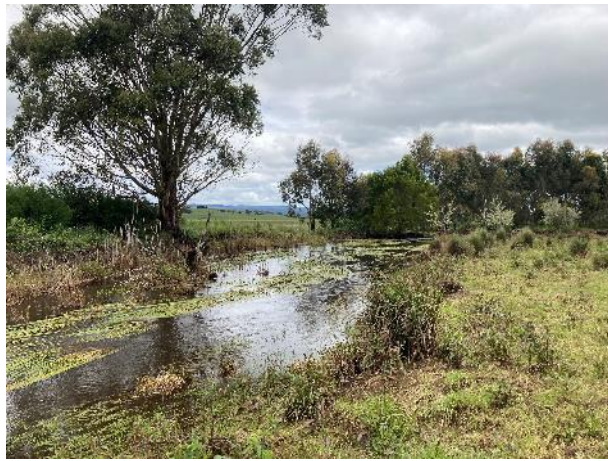
5.6. Site 6- Barwon River 100m downstream of Boundary Creek confluence

The Barwon River 100 meters downstream of the Boundary Creek confluence is a narrow deep channel with wide shallow edges dominated by grasses and aquatic macrophytes. The average stream width at this site is five meters and was bank full in Spring 2019, Spring 2020, Autumn 2021 and Spring 2021 and had contracted to a narrow (1-2 meter) channel in Autumn 2020 and Autumn 2022. There is a narrow channel at the top of the surveyed reach, narrowing to a confined channel downstream. The river had contracted to the main channel but remained flowing, leaving the fringes to dry out in Autumn 2020 and Autumn 2022. The substrate consists of clay and silt usually with filamentous algae tangled through the macrophyte beds but in Autumn 2021 and Spring 2021 the macrophyte beds were covered in a smothering floc that was easily disturbed, forming a thick plume. This plume appeared to be absent in Autumn 2022 but this could have been due to the absence of slow flowing areas where floc would be able to settle. Macrophyte species are varied with *Triglochin*, *Polygonum*, *Phragmites*, and *Juncus* species all present in addition to trailing grasses. Four different fish species have been collected at this site as bycatch; southern pygmy perch, smelt and a galaxid in Autumn 2020, gambusia and southern pygmy perch in Spring 2020. The riparian zone is limited to grasses and scattered native trees and shrubs with stock access to the site. Overall analysis of the health of the waterway using EPA habitat parameters for Low Gradient Streams gave this site a score of 70 out of 140 in 2019 and a very similar score of 71 in 2022. As with all sites that have unrestricted stock access, the health of this site would be improved by fencing and revegetating the river on both sides.

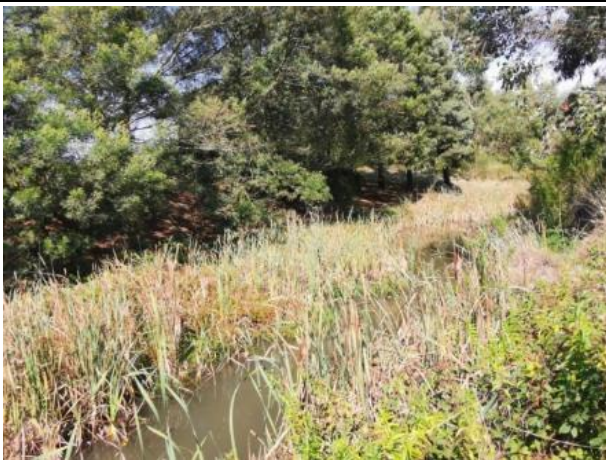
Site 7: downstream Spring 2019

The Barwon River adjacent to the northern boundary of the pine plantation has a large deep channel with any shallow areas dominated by beds of *Phragmites*. The average stream width at this site is seven meters. The substrate is clay and silt. In addition to the *Phragmites* beds there are beds of *Triglochin*, and scattered *Polygonum*, *Juncus* and other grasses. The riparian zone has a good mix of trees, shrubs and understory with a majority of native trees and shrubs. Overall analysis of the health of the waterway using EPA habitat parameters for Low Gradient Streams gave this site a score of 90 out of 140 in 2019 and increased to 104 in 2022 primarily due to continued improvements in riparian and instream macrophyte condition.

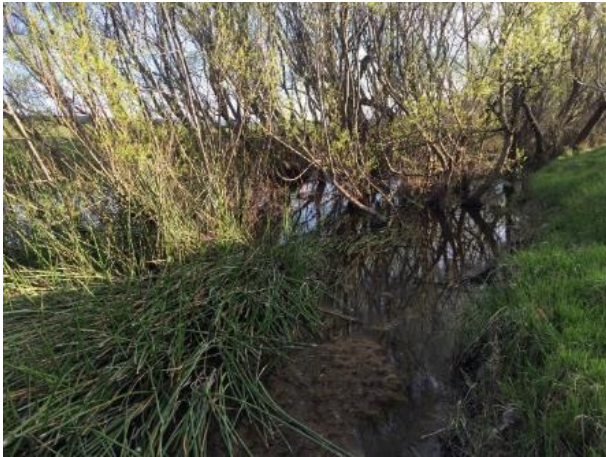
Site 8: upstream Spring 2019

The Barwon River at Colac- Lorne Road has large deep pools with a shallow areas at the sides and willow trees growing in the channel with some substrate exposed when the river level is low. The average stream width at this site is eight meters with a predominantly clay and silt substrate mixed with some sand. There are beds of *Triglochin* and *Phragmites* in addition to trailing grasses and large willows. The riparian zone consists of willow trees, pasture grasses and blackberries and allows stock access. Overall analysis of the health of the waterway using EPA habitat parameters for Low Gradient Streams gives this site a score of 69 out of 140 in 2019 and a similar score of 73 in 2022.

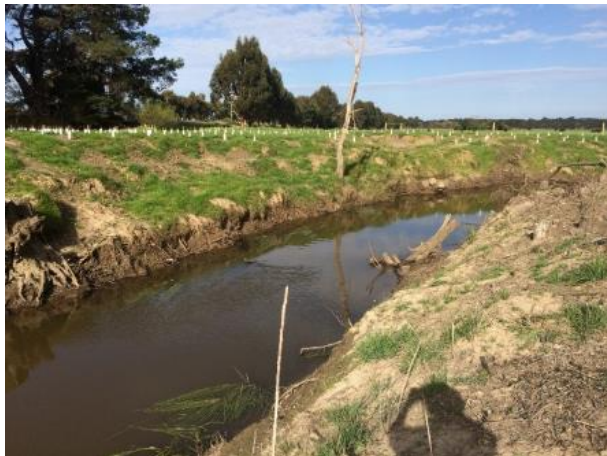
Site 9: upstream Spring 2019

The Barwon River at Birregurra consists of a large deep slow flowing pool. The average stream width at this site is five meters with steep clay banks. The substrate is clay and silt with willow roots, some snags and *Triglochin* beds scattered along the edges of the channel and establishing well over time. There were willow removal works and replanting of the riparian zone in Spring 2019 in amongst the pasture grass and blackberry groundcover. The riparian zone is established and growing well although follow up ground cover weed management may be required. Rakali footprints are evident in the soft sediment edge during many of the sampling events. Introduced mosquitofish (*Gambusia sp.*) were bycatch in Autumn 2022. Overall analysis of the health of the waterway using EPA habitat parameters for Low Gradient Streams gave this site a score of 67 out of 140 in 2019 but has increased to 98 in 2022, primarily due to the successful reintroduction of the riparian zone following large scale willow removal.
