Upper Barwon River Macroinvertebrate Sampling Report Spring 2022

- Final
- January 2022

Printed:	7 February 2023
Last saved:	7 February 2023 12:06 PM
File name:	
Author:	Kylie Iervasi
Project manager:	Kylie Iervasi
Name of organisation:	Barwon Water
Name of project:	Barwon River/ Boundary Creek Survey
Name of document:	Upper Barwon River Macroinvertebrate Sampling Report 2019-2022
Document version:	Final
Project number:

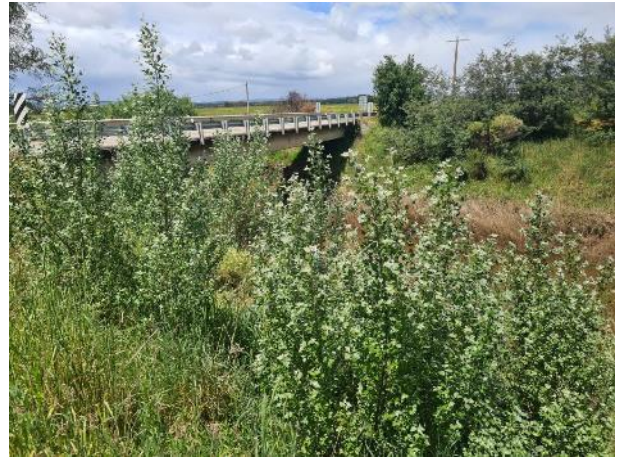
Spring 2022

The Barwon River at Conns Lane has large deep pools with some small deep backwaters and a narrow deep run at the top of the reach. The average stream width at this site is six meters. The substrate is clay and silt mixed with some sand and gravel. *Phragmites* beds line the channel and there are isolated patches of *Triglochin* in addition to *Polygonum* and trailing grasses along the waters edge. The trailing and shallow vegetation contained filamentous algae in Autumn 2021 and 2022. Larval fish and gambusia were collected in the macroinvertebrate net in Spring 2020 and gambusia were plentiful in Autumn 2021 though not in Spring 2021. The riparian zone consists of a native revegetation project that is more successful on the right side than the left. Exotic trees are re-establishing on the left side and pasture grass dominates. Overall analysis of the health of the waterway using EPA habitat parameters for Low Gradient Streams gave this site a score of 98 out of 140 in 2019 and a similar score of 101 in 2022.

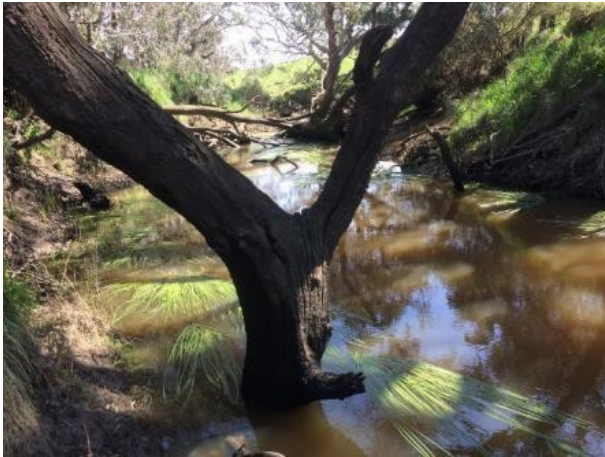
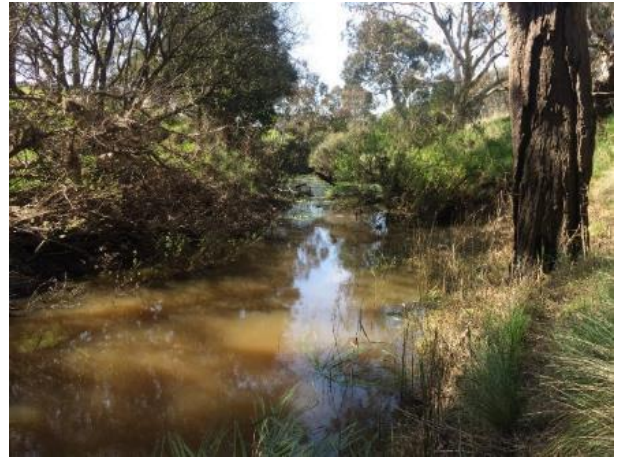
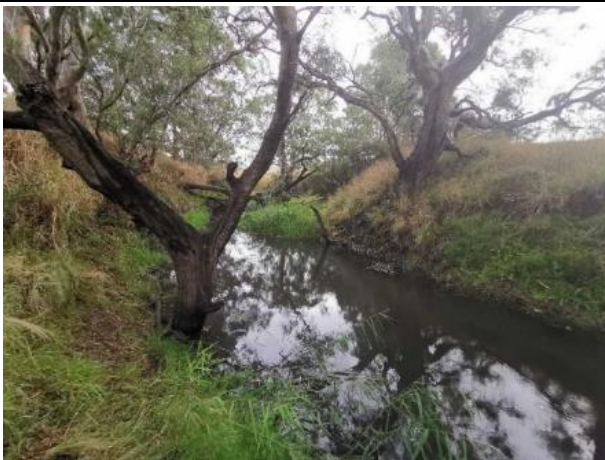
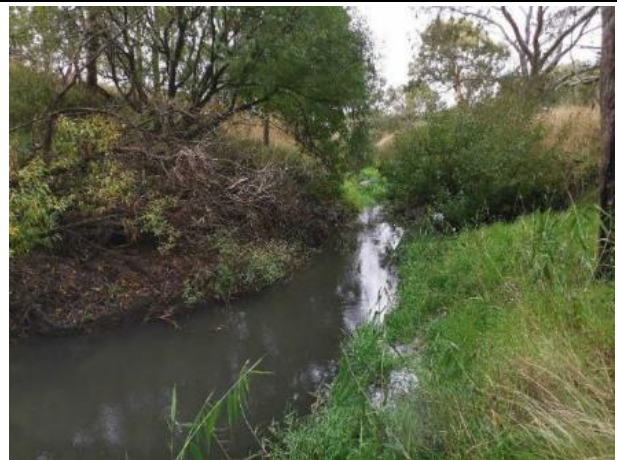
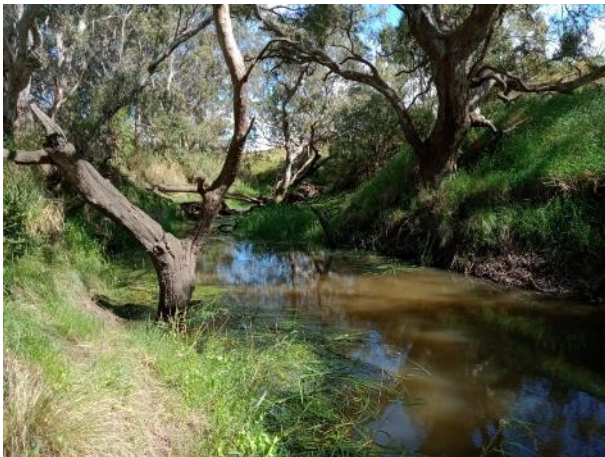
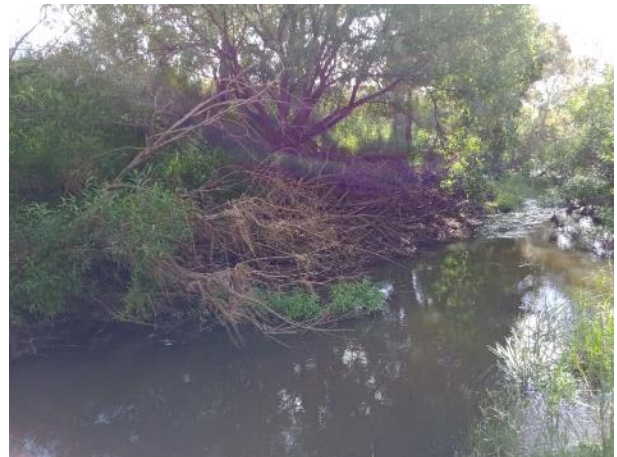
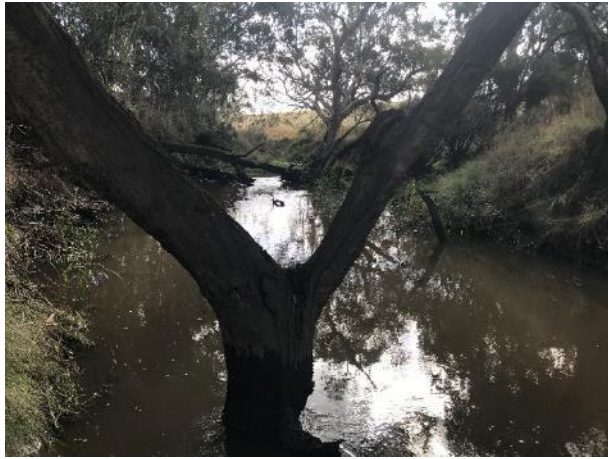
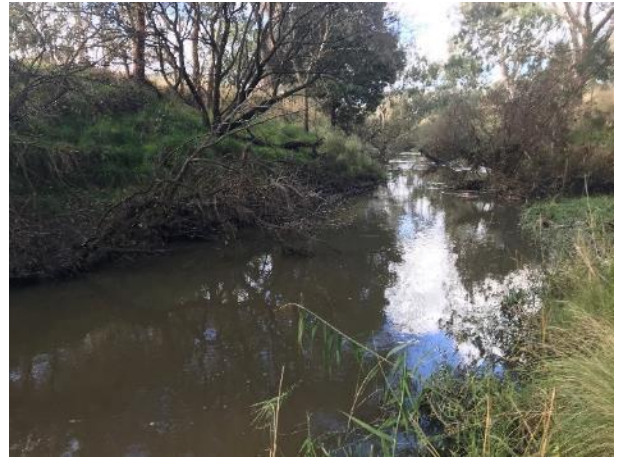
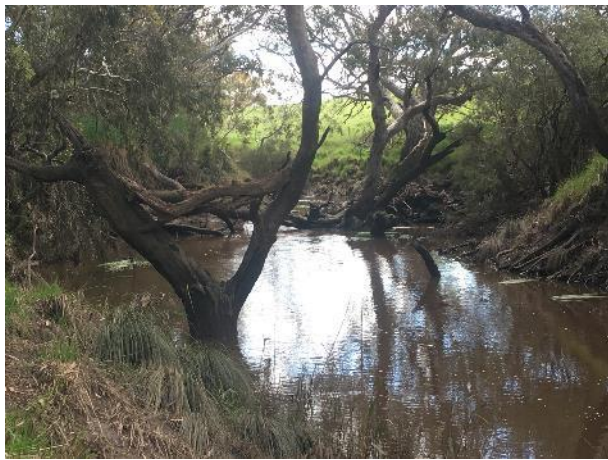
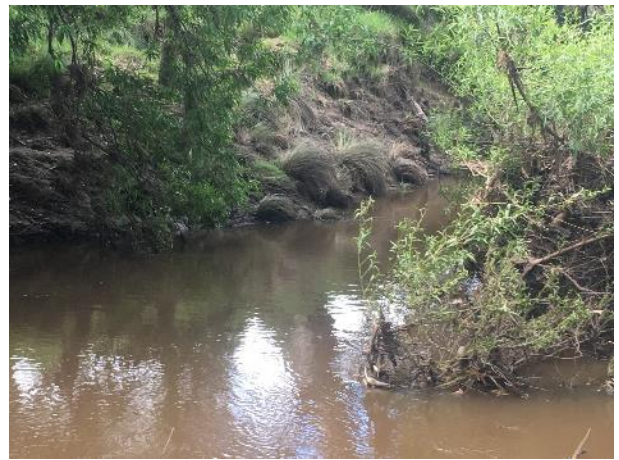
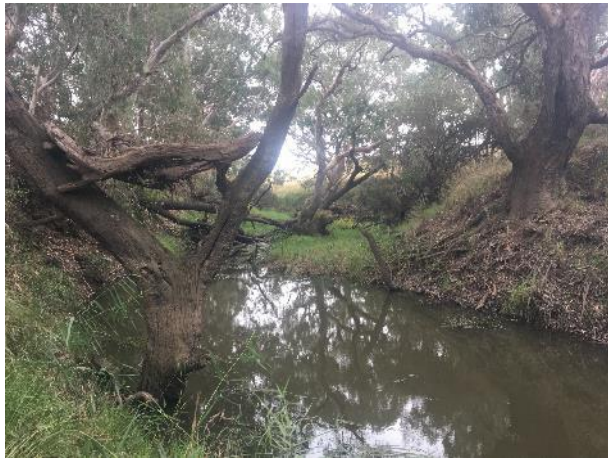
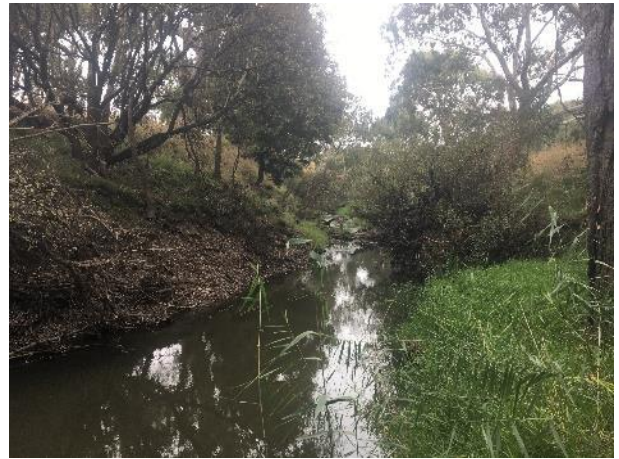
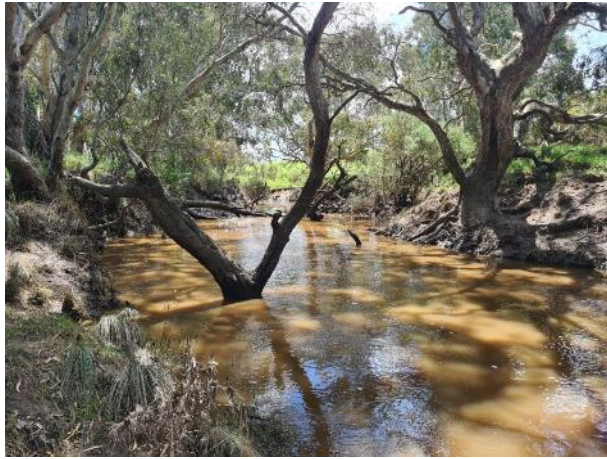
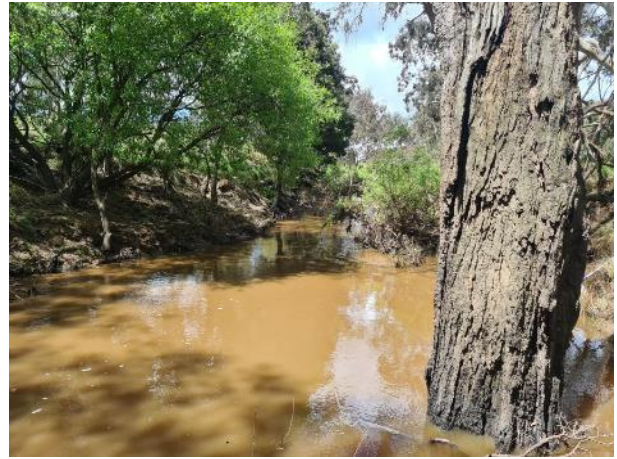
5.11. Site 11- Barwon River@ Winchelsea- Deans Marsh Road

The Barwon River at Winchelsea- Deans Marsh Road has large deep pools with a shallow run at the top of the reach. The average stream width at this site is five meters and the substrate is clay and silt mixed with some sand and gravel. *Triglochin* is growing in the shallow areas of the channel and there are roots, large woody debris and trailing grasses. The riparian zone is predominately native trees and understory with a mix of grasses as groundcover. Rakali footprints were spotted at the waters edge in Spring 2019. The height and force of a flood between Autumn 2021 and Spring 2021 sampling can be seen in the upstream Spring 2021 photo of the log wedged in the forked tree in the left foreground. Overall analysis of the health of the waterway using EPA habitat parameters for Low Gradient Streams gave this site a score of 90 out of 140 in 2019 and the similar but slightly higher score of 98 in 2022 with the introduction of more woody debris into the channel following the 2021 floods and the continuing growth of riparian vegetation.

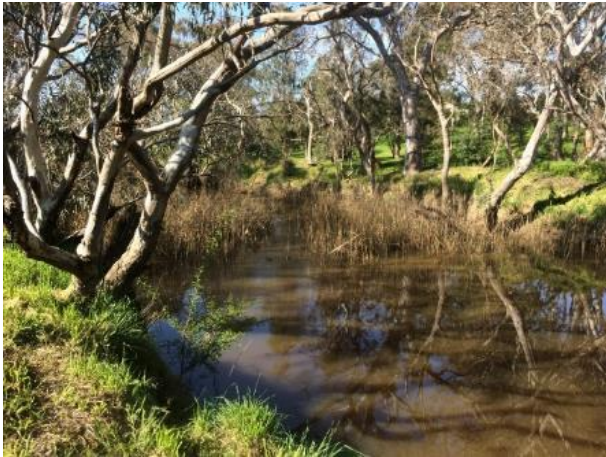
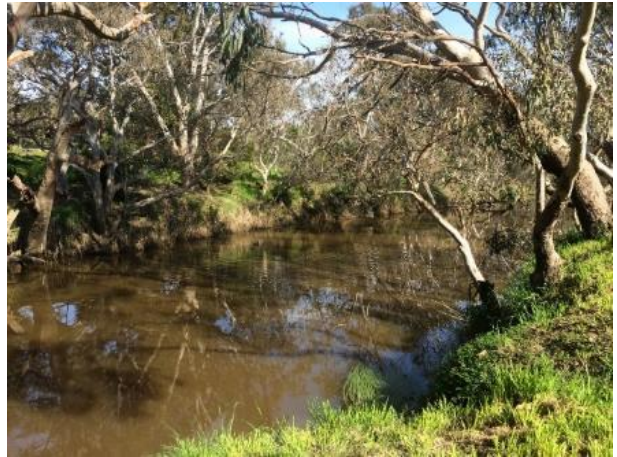
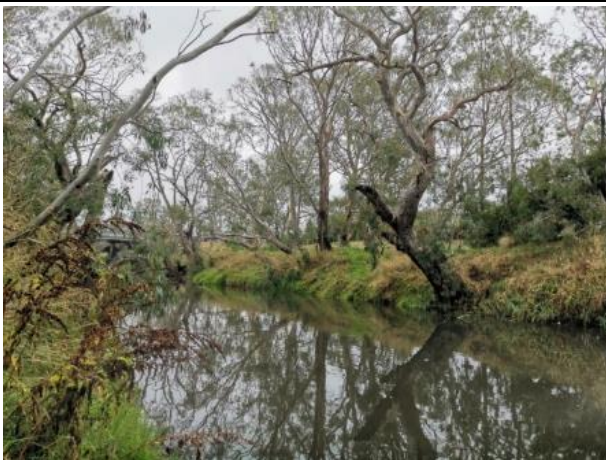
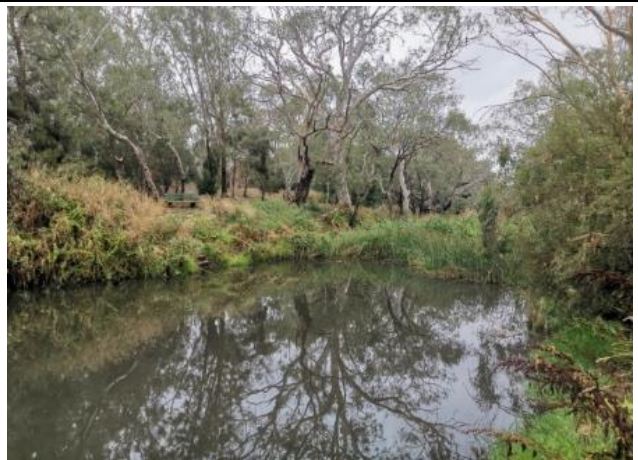
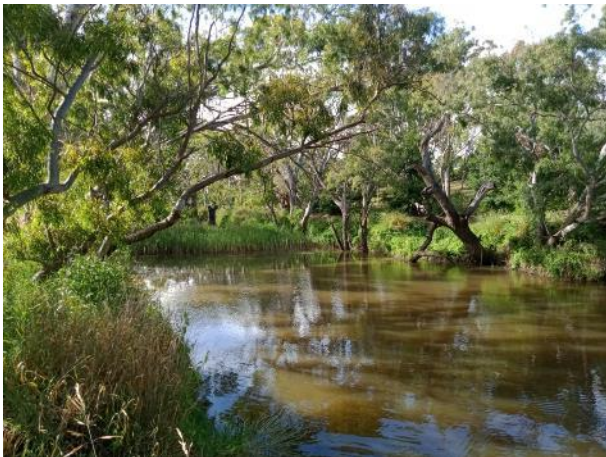
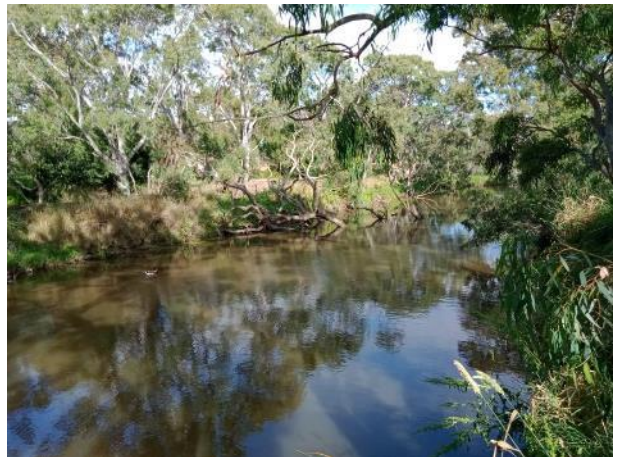
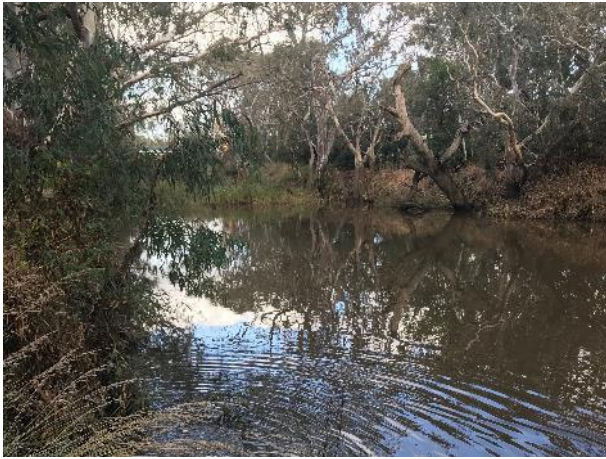
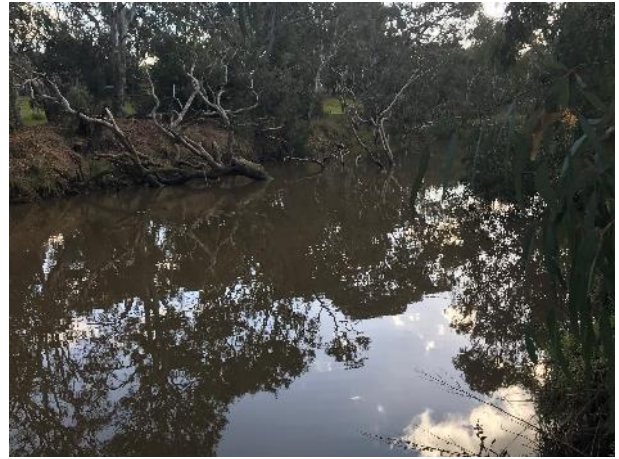
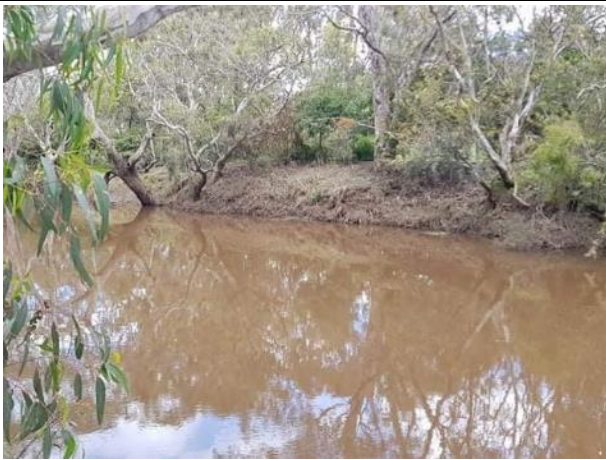
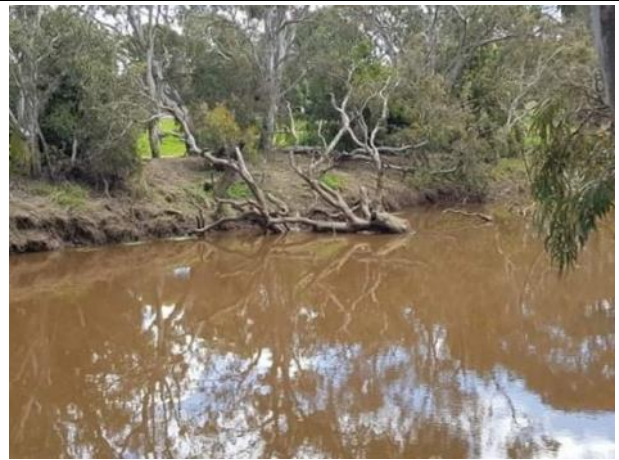
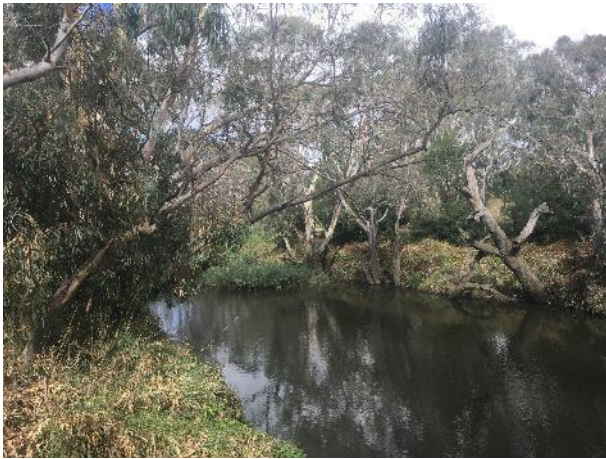
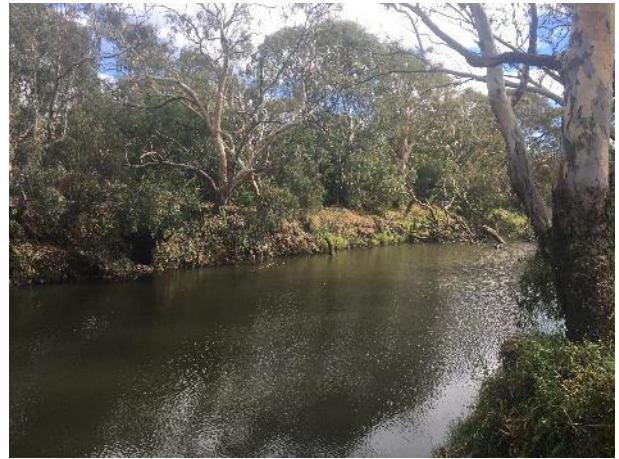
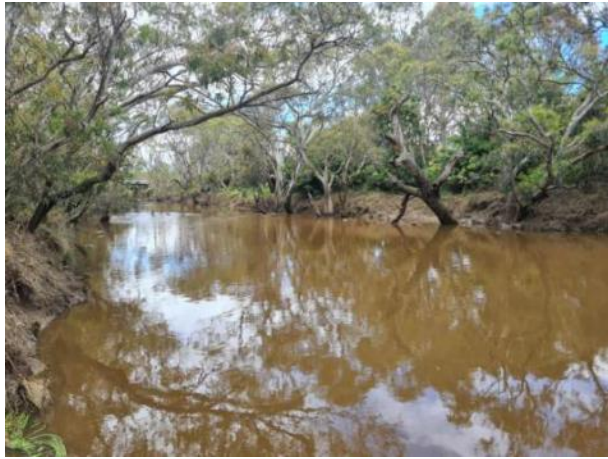
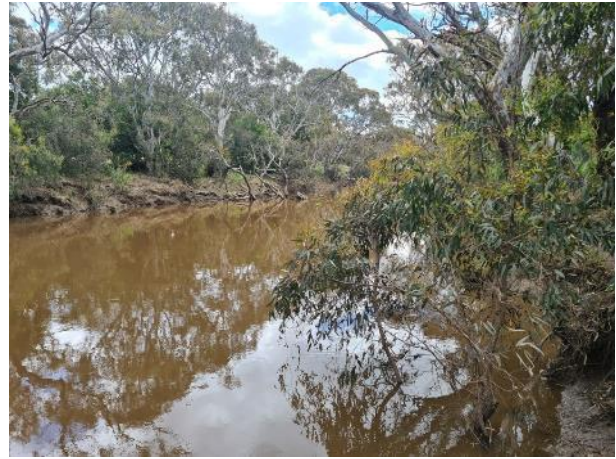
5.12. Site 12- Barwon River @ Princes Hwy bridge, Winchelsea

The Barwon River at Winchelsea has large deep pools with a large shallow pool at the top of the reach. The average stream width at this site is twelve meters. The substrate is clay and silt mixed with sand and some gravel. In addition to the *Phragmites* beds at the top of the reach and along some edges there are also patches of *Triglochin*. Large woody debris, trailing grasses and emergent vegetation such as *Polygonum* are also present. Riparian vegetation is predominantly native with many established eucalypts and groundcover is pasture grass. A concurrent snapshot study by EnviroDNA (2019) in Spring found evidence of platypus at this site. Overall analysis of the health of the waterway using EPA habitat parameters for Low Gradient Streams gave this site a score of 88 out of 140 in 2019 and a similar score of 91 in 2022.

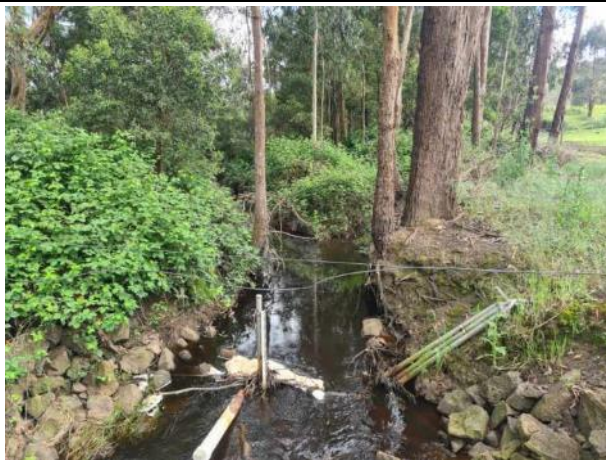
Spring 2022

Site 5.1 on Boundary Creek was added to the current sampling regime to replicate the site sampled by Austral in 2014/2015 for Jacobs (2017) and give some context to the health of Boundary Creek upstream of Big Swamp. Boundary Creek below McDonalds Dam is between 3 and 4 meters wide with a mix of deep pools, shallower pools and artificial riffle areas from the culvert/ bridge. There were isolated patches of aquatic macrophytes in 2014 but none were present in 2022. Whilst large trees are a feature of the riparian zone, live blackberries and bare ground where they have been poisoned, dominate. Intensive agriculture exists outside of the riparian zone. Overall analysis of the health of the waterway using EPA habitat parameters for Low Gradient Streams gave this site a score of 87 out of 140 in 2014 and a similar score of 91 in 2022.

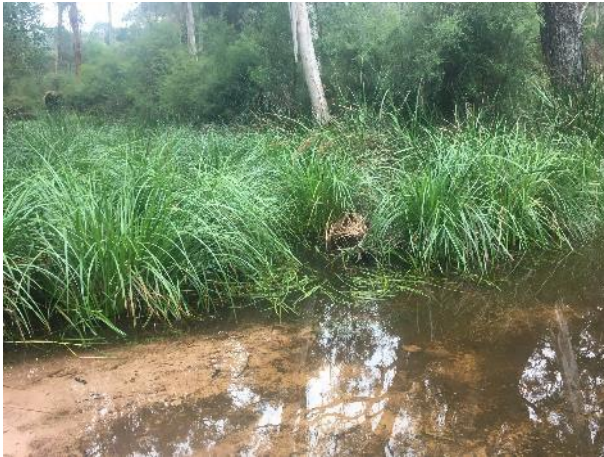
Site 5.2: upstream Autumn 2022

Site 5.2 on Boundary Creek was added to the current sampling regime to give additional information on the biological health of Boundary Creek upstream of Big Swamp. Boundary Creek is between 1 and 2 meters wide either side of the vehicle crossing and is very different to all other sites sampled with a mix of large and small, deep and shallow pools and runs. There are extensive areas of macrophytes including *Triglochin*, *Ranunculus* and *Cyperus* beds and isolated patches of *Alisma* and *Juncus*. The riparian zone is extensive consisting of predominantly, if not totally, native species. Overall analysis of the health of the waterway using EPA habitat parameters for Low Gradient Streams gave this site a score of 130 out of 140, the highest of any in this study.

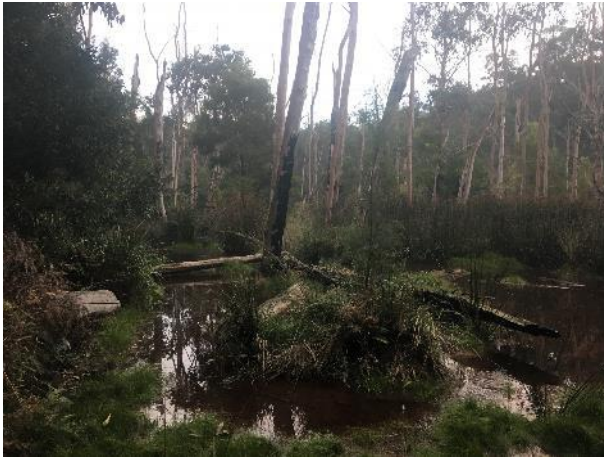
Site BS1: upstream Autumn 2022

Site BS1 in Big Swamp was added to the current sampling regime to give additional information on the condition of Big Swamp. The water level was shallow and was slowly flowing around the extensive amount of large woody debris and beds of Giant Rush and scattered sedges and rushes such as *Gahnia* and *Cyperus*. There was a high amount of iron floc present on the substrate.

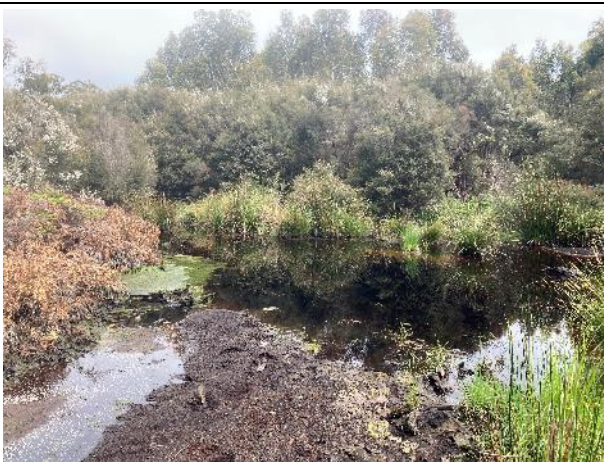
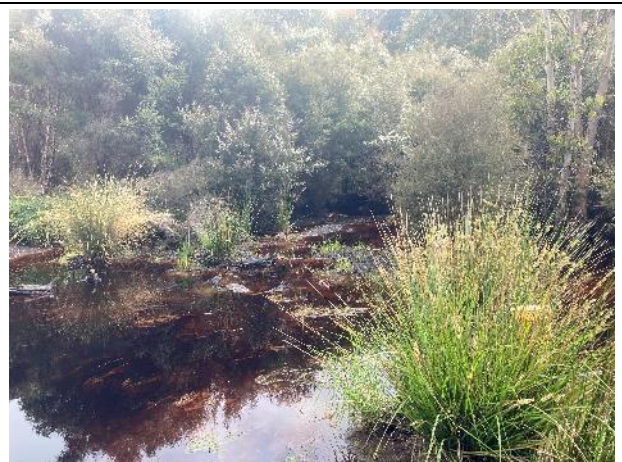
5.16. Site BS2- Big Swamp western end

Site BS2 in Big Swamp was dry in Autumn 2022 and whilst was holding water in Spring 2022, this was not flowing as it is at Site BS1. The vegetation and water quality were similar in the two Big Swamp sites.
