Boundary Creek aquatic ecology investigation

Barwon Water

17 March 2017

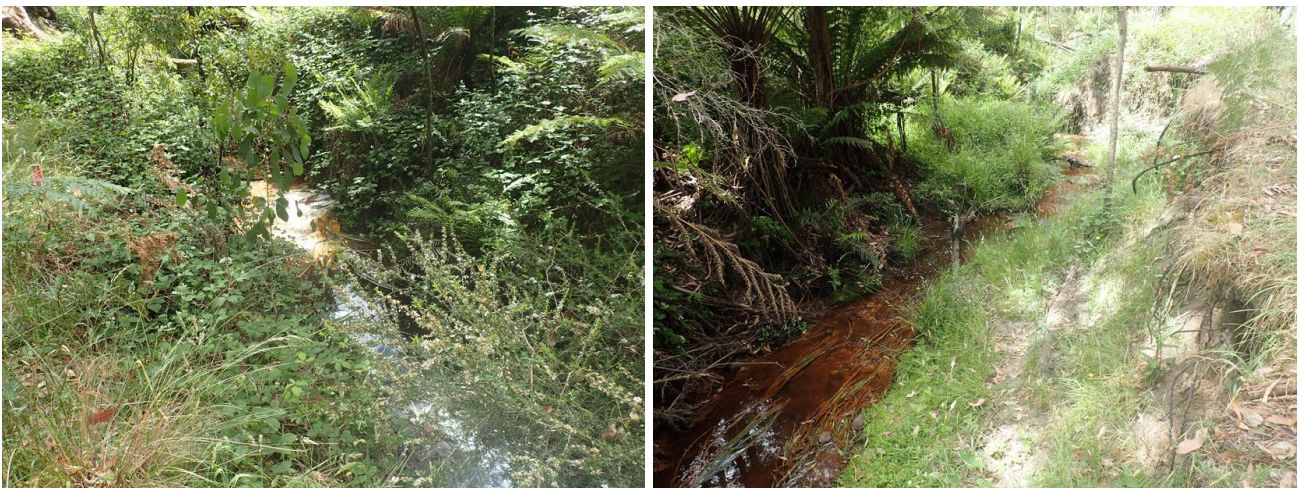
Figure 2-2 Boundary Creek upstream of McDonalds Dam, the habitat assessment site in Reach 1.

For Reach 1, the habitat assessment site is downstream of Langdons Road, just upstream of McDonalds Dam. The channel in this area is deeply incised in parts and the wetted width was about 1 m at the time of the assessment in December 2014 (Figure 2-2). The creek in this section flows over a number of shallow rocky riffles, approximately 10 cm deep. Some pool/run sections in this area were up to about 50 cm deep during the assessment and there was some overhanging vegetation and undercut banks. A conceptual model of Boundary Creek at the habitat assessment site in Reach 1 is provided in Figure 2-3.

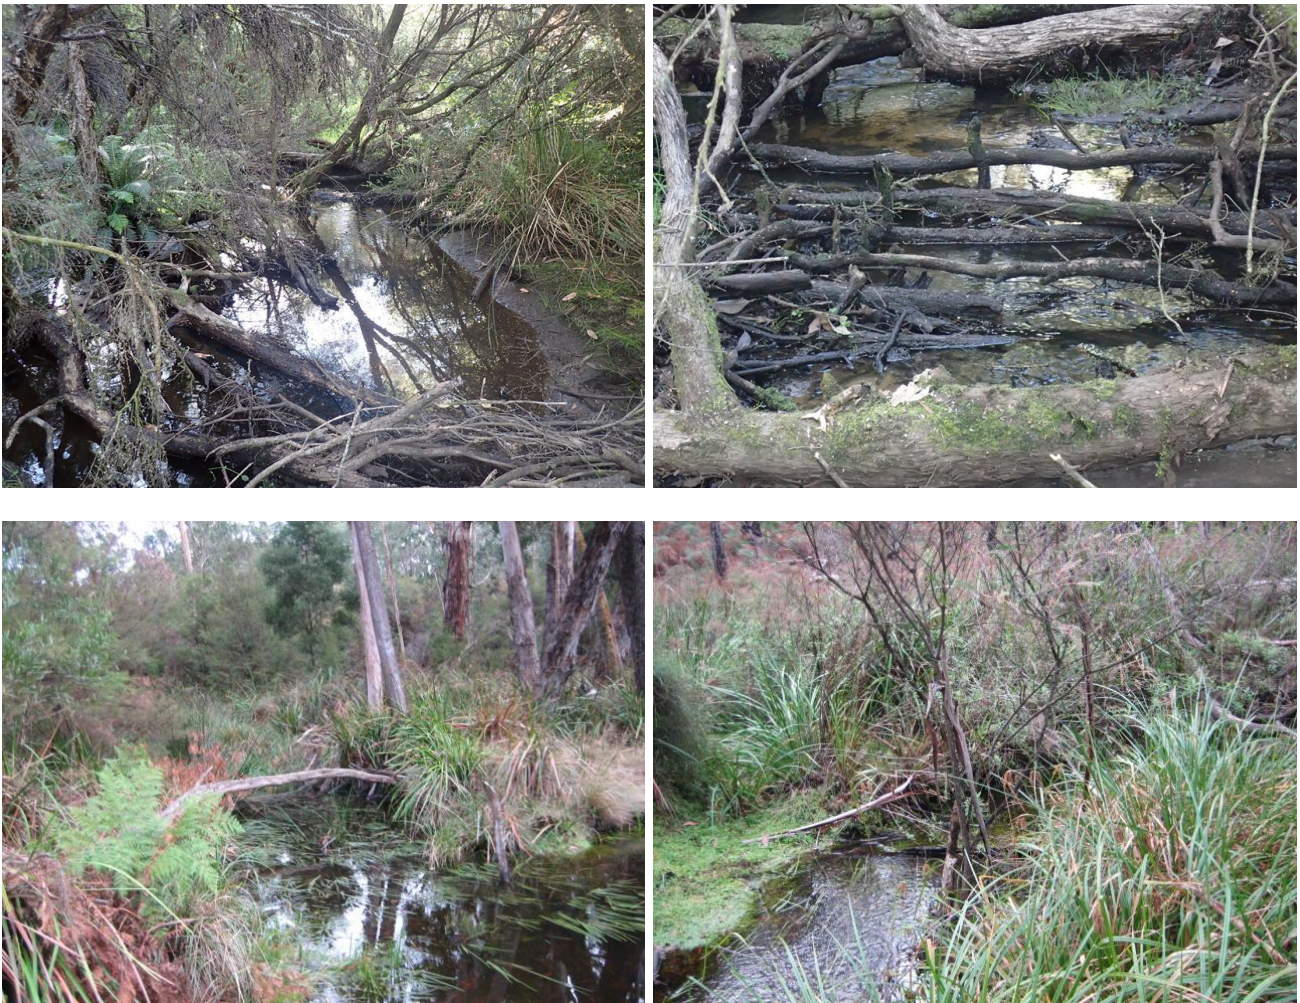
Figure 2-4 Boundary Creek, just upstream of Big Swamp at the location of the habitat assessment site in Reach 2.

Photos of the habitat assessment site in Reach 2 are shown in Figure 2-4. A conceptual model illustrating the aquatic habitats at this site is presented in Figure 2-5.

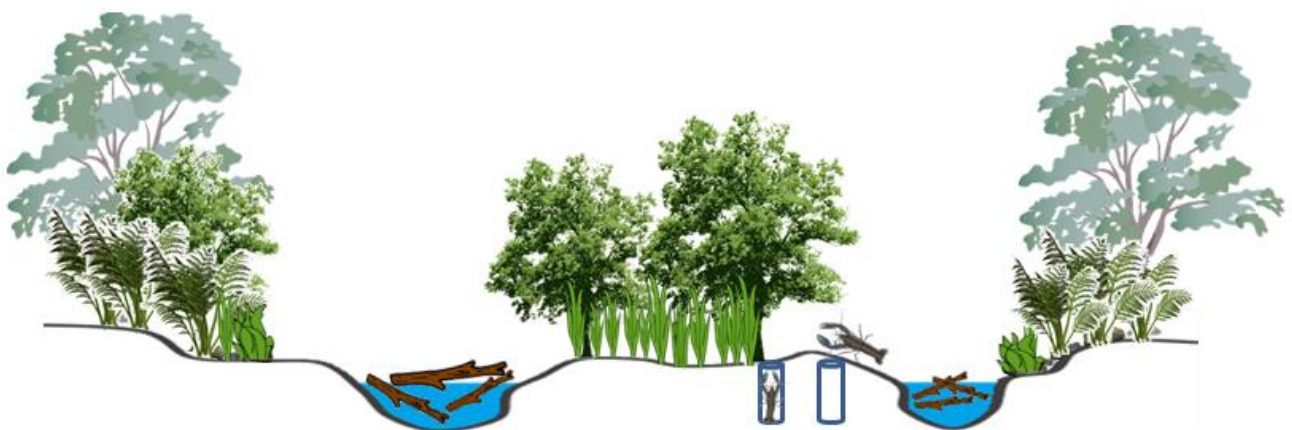
Figure 2-5 Conceptual model of Boundary Creek at the habitat assessment site in Reach 2. Note that the communities and species depicted are for illustrative purposes and are not intended to represent the actual species present at Boundary Creek.

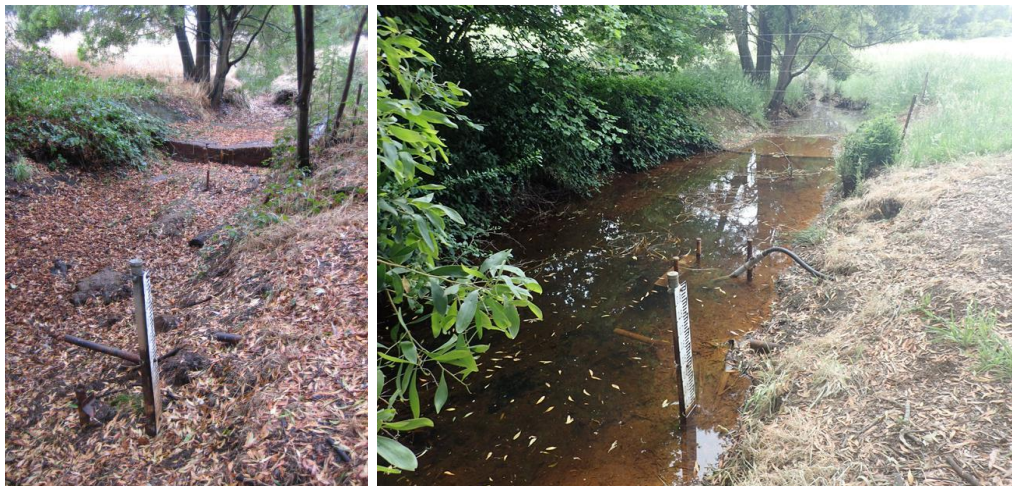
Figure 2-6 Boundary Creek at the Yeodene flow gauge near the Colac-Forrest Road. Left: Photo taken in April 2013 when the channel was dry. Right: Photo taken in December 2014, no flow was apparent at the time of the assessment.

The channel in this section was dry during the April 2013 site inspection and there was no obvious flow on the day of the habitat assessment in December 2014 (Figure 2-6). This was despite the supplementary flow being provided to the creek and there being obvious flow upstream of Big Swamp.

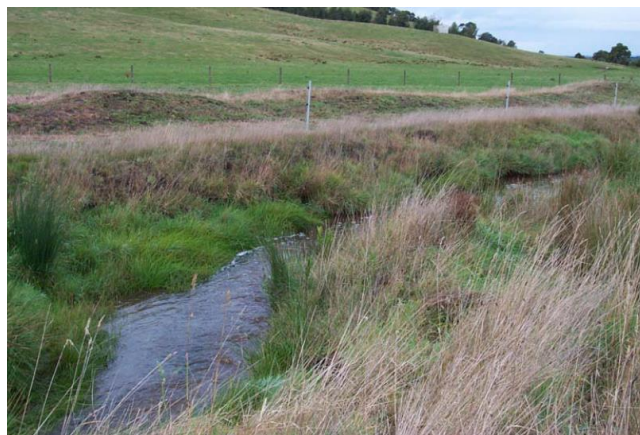
Figure 2-7 Boundary Creek at the location of the previous assessment, about halfway between the Yeodene gauge and the upper Barwon River (photo taken from Lloyd *et al*. 2005).

An additional site, about halfway between the gauge and the upper Barwon River was assessed as part of a previous study completed on the broader Barwon River catchment by Lloyd *et al* (2005). This part of the channel was also characterised by a largely cleared riparian zone with much of the aquatic habitat provided by fringing and submerged vegetation (Figure 2-7).

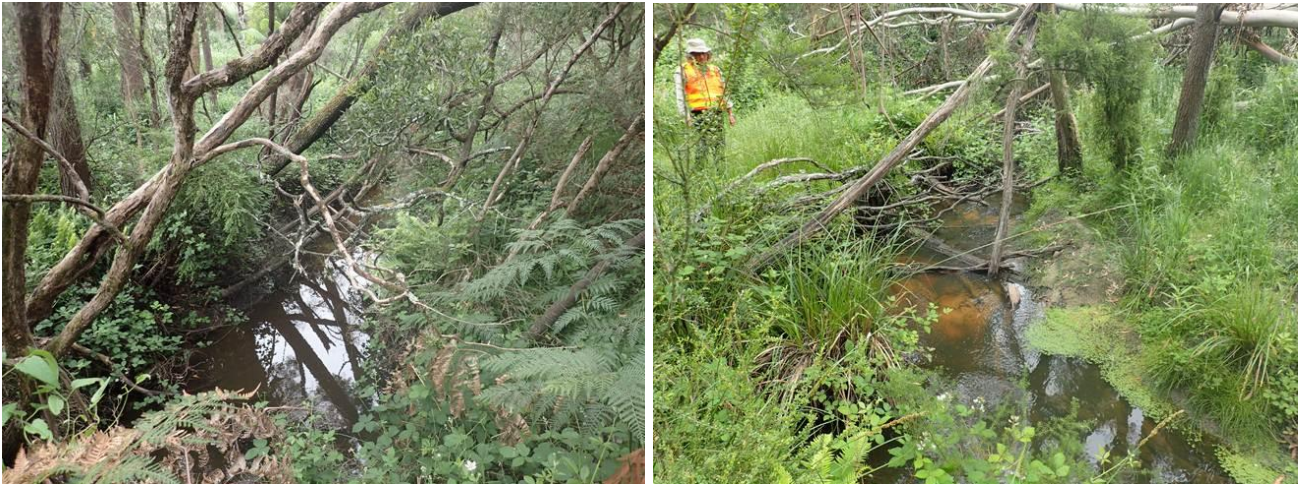
Figure 2-9 Boundary Creek at Langdons Road, site of the macroinvertebrate sampling.

At the time of the habitat assessment in December 2014, water depth through much of the channel at this site was between 10 and 30 cm, with some pool/run sections up to 50 cm deep. This site is located downstream of the inflow of the supplementary flow release at Bushby Road.

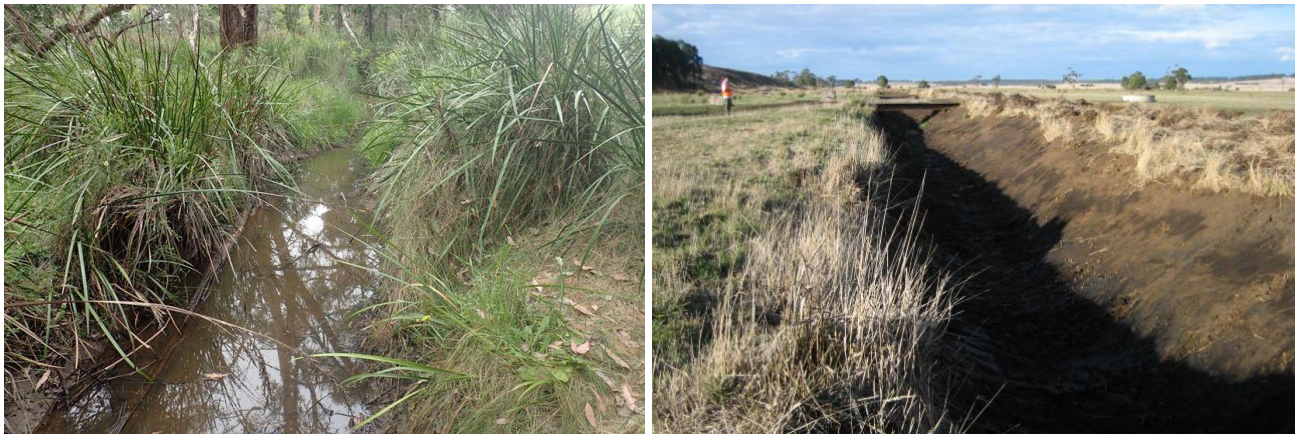
Figure 2-10 Left: Boundary Creek in the upper reaches, at Barongarook. Right: Boundary Creek immediately upstream of the confluence with the Barwon River (photo April 2013).

The upper part of the catchment retains extensive areas of remnant native vegetation and a largely unmodified channel structure (Figure 2-10). However, the lower part of the catchment, near the confluence with the upper Barwon River, has been cleared of native vegetation and the creek has been channelised (Figure 2-10). Pre-European settlement, it is likely that the lower part of the creek would have been a broad, undefined marsh, with the channel dug in the early years of settlement to improve drainage to the Barwon River and to open up the area for agricultural development. Channelisation changed the hydrology of the lower part of Boundary Creek by conveying flows efficiently to the Barwon River and drying the marshland which is likely to have been present.

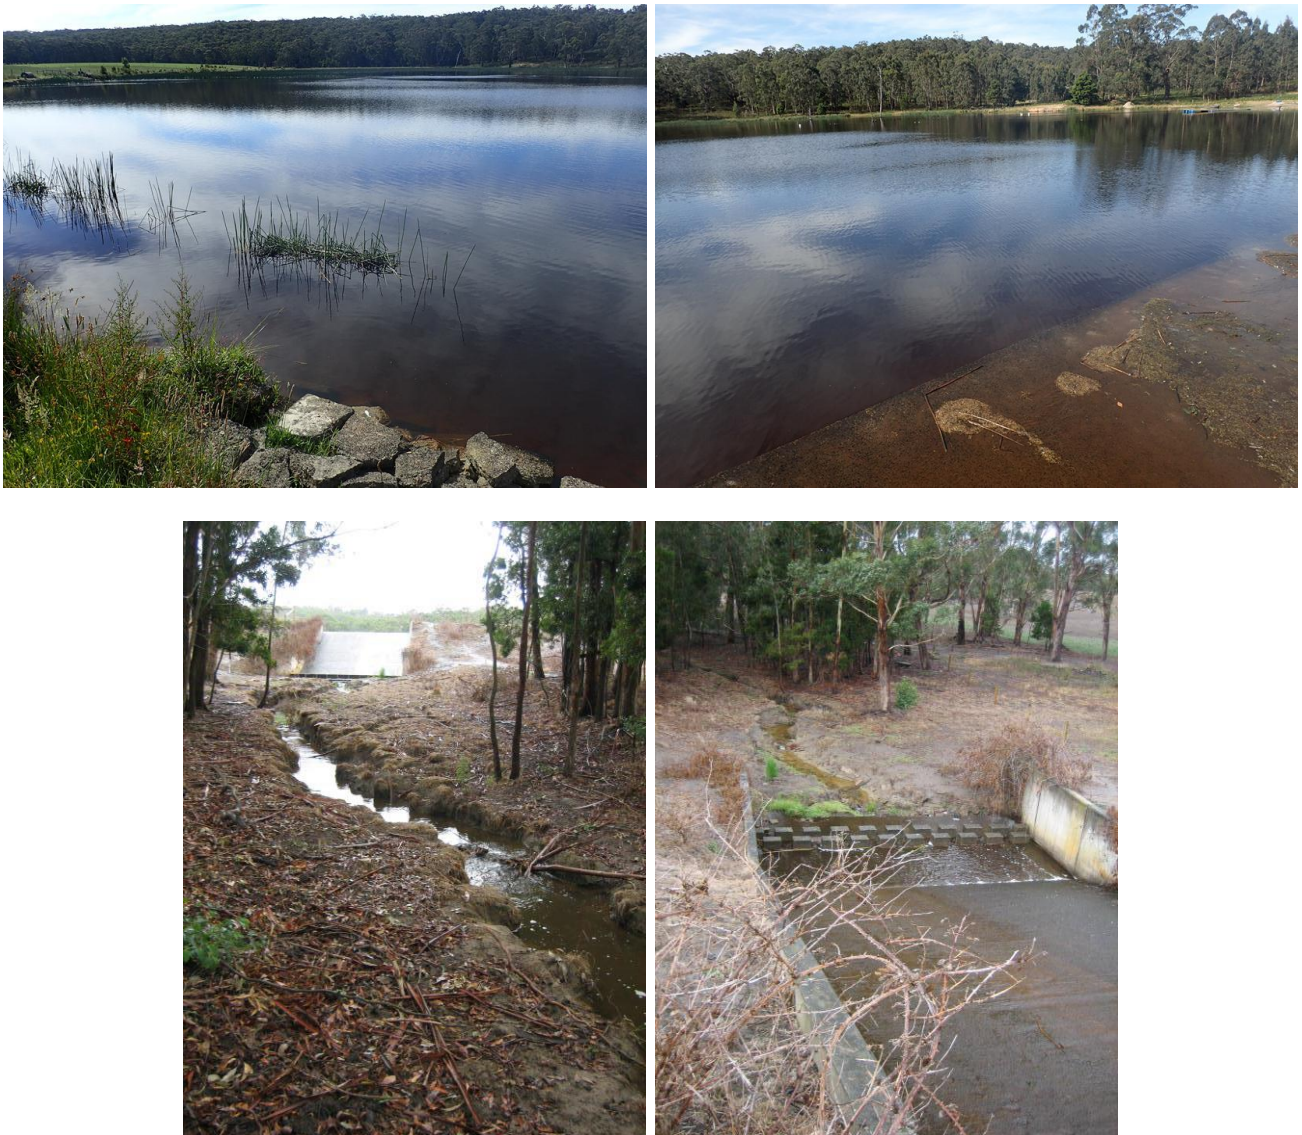
Figure 2-11 McDonalds Dam and Boundary Creek immediately downstream.

McDonalds Dam is an on-stream water storage located in the middle of the catchment and was constructed in approximately 1979 (Figure 2-11). All the flow in the creek is captured by this dam and when it is not full and overtopping, downstream flow in the creek requires the active passing of flow. The dam may provide refuge habitat for a range of aquatic species in dry conditions, however the dam wall is likely to be a movement barrier for most fish species.

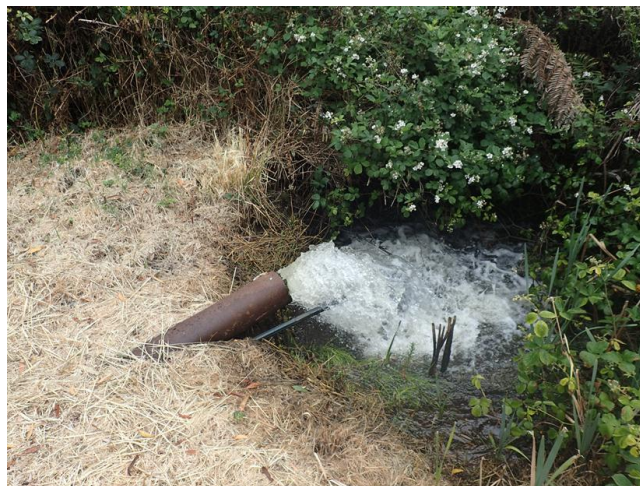
Figure 2-12 Tributary of Boundary Creek at Bushby Road, showing the 2 ML/day release.

Barwon Water releases a supplementary flow of 2 ML/day into Boundary Creek to compensate stock and domestic users who may have been impacted by groundwater extraction from the Barwon Downs bore field. This flow was not intended to support the ecological values of Boundary Creek. The supplementary flow is released except when the groundwater level in bore Yeo 40 recovers above a level of 158.5 m AHD following the cessation of pumping or at any time between 1 June and 30 November that the natural flow at Yeodene exceeds 1 ML/day (Southern Rural Water 2006). The supplementary flow has been provided since at least 2003 (Barwon Water 2004) and is delivered to a tributary of Boundary Creek near Bushby Road (Figure 2-12). The tributary joins Boundary Creek approximately 1 km downstream of Barongarook Road.

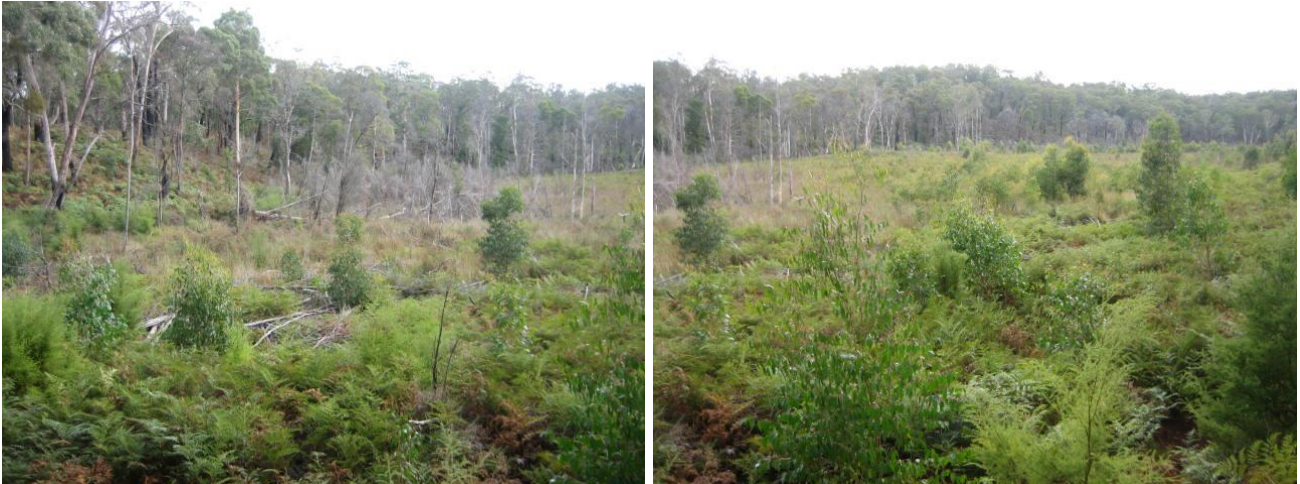
Figure 2-13 Big Swamp.

Big Swamp is a peat swamp located near the middle of the catchment downstream of McDonalds Dam (Figure 2-13). A fire was reported in the swamp on October 10 1997 (Colac Otway Fire Management Plan 2015), which suggests that it dried at some stage prior to this time. Subsequent fires presented at the surface at various times between 1997 and 2010, with the peat swamp burning underground throughout that period (Colac Otway Fire Management Plan 2015). Trenches up to 3 m deep were dug by the Country Fire Authority (CFA) at the margins of the swamp in an attempt to control the spread of the fire (Himmelreich 2010). The drying, fire and trenching have had considerable impacts on both the quantity and quality of water flowing out of the swamp.

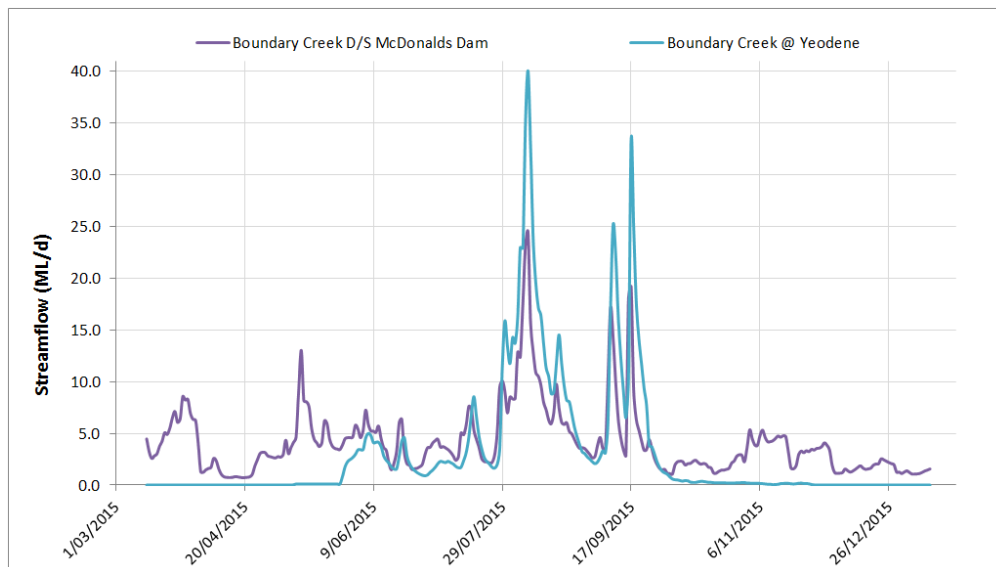
Figure 3-3 Stream flow record from gauges upstream and downstream of McDonalds Dam.

Boundary Creek stream flow is gauged upstream and downstream of Big Swamp at the gauge downstream of McDonalds Dam and at Yeodene. The flow record indicates that in the summer months Boundary Creek is flowing upstream of Big Swamp but not downstream (Figure 3-3). Flow magnitude is reduced downstream of the swamp in winter but to a minor extent. This is only a very short period of record, however, it shows that the supplementary flow is making it downstream of McDonalds Dam, but rarely downstream of Big Swamp in the summer months.

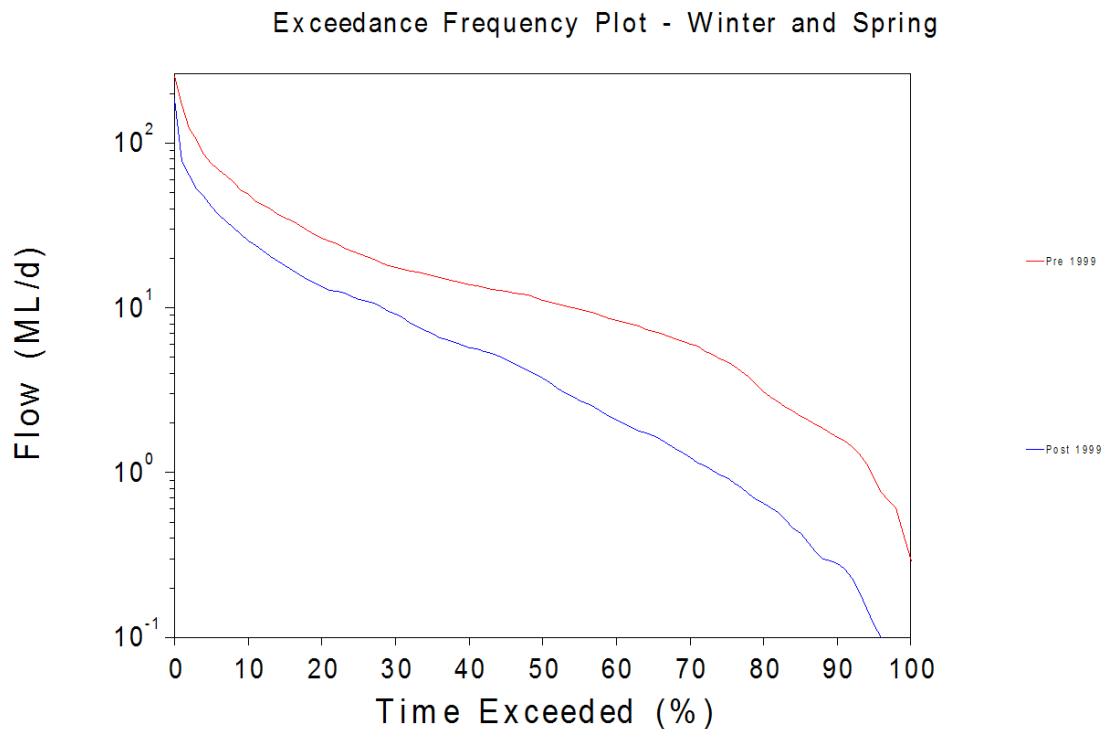
Figure 3-7 Flow duration curve for winter and spring months at Yeodene gauge (233288) pre (red) and post (blue) 1999.

There is an obvious difference between the frequency of cease-to-flow events pre and post 1999, as demonstrated in the flow duration curve of summer and autumn months (Figure 3-6). Between 1986 and 1998 flow at the Yeodene gauge stopped approximately 2% of the time during summer and autumn months. After 1999 Boundary Creek at Yeodene stopped flowing approximately 58 % of the time during summer months. Occasional cease-to-flow events have been recorded at Yeodene in winter and spring since 1999 (Figure 3-7). The cause of this is not currently well understood.

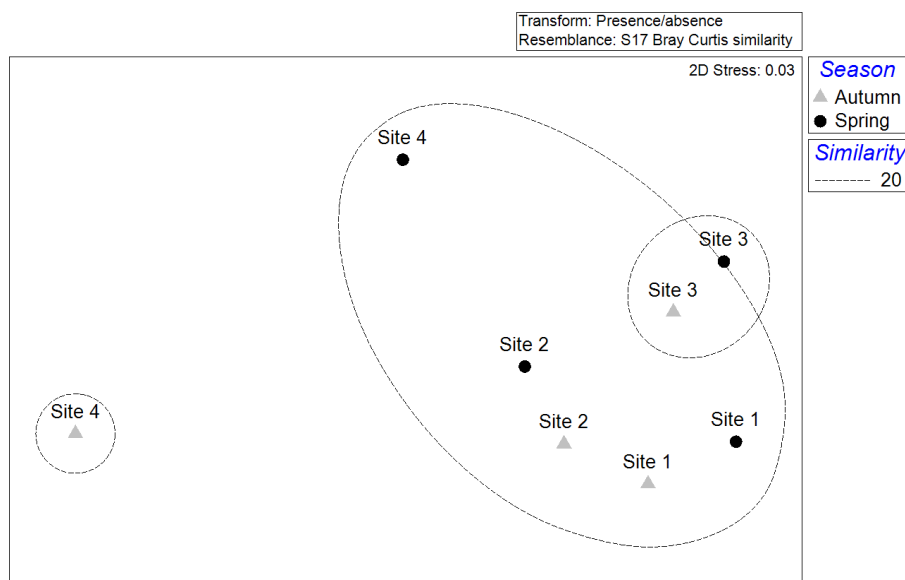
Figure A-2 MDS plot of families from edge habitat of each site.

The MDS (Multidimensional Scaling) plot (Figure A-2) shows how similar, or dissimilar, the macroinvertebrate families at each site are to one another. Those that have 20% of the macroinvertebrate families in common are indicated by a dotted line. Only edge habitats are plotted as a riffle habitat wasn't present at every site.

Macroinvertebrate families at Site 4 in autumn are very different to all other sites, almost certainly due to the very low water levels at this site. Site 4 in spring is also dissimilar to the other sites, and Site 3 has similar macroinvertebrate families over season.
