# Annual Bulk Entitlement Report

**Anglesea groundwater  
2020-2021**

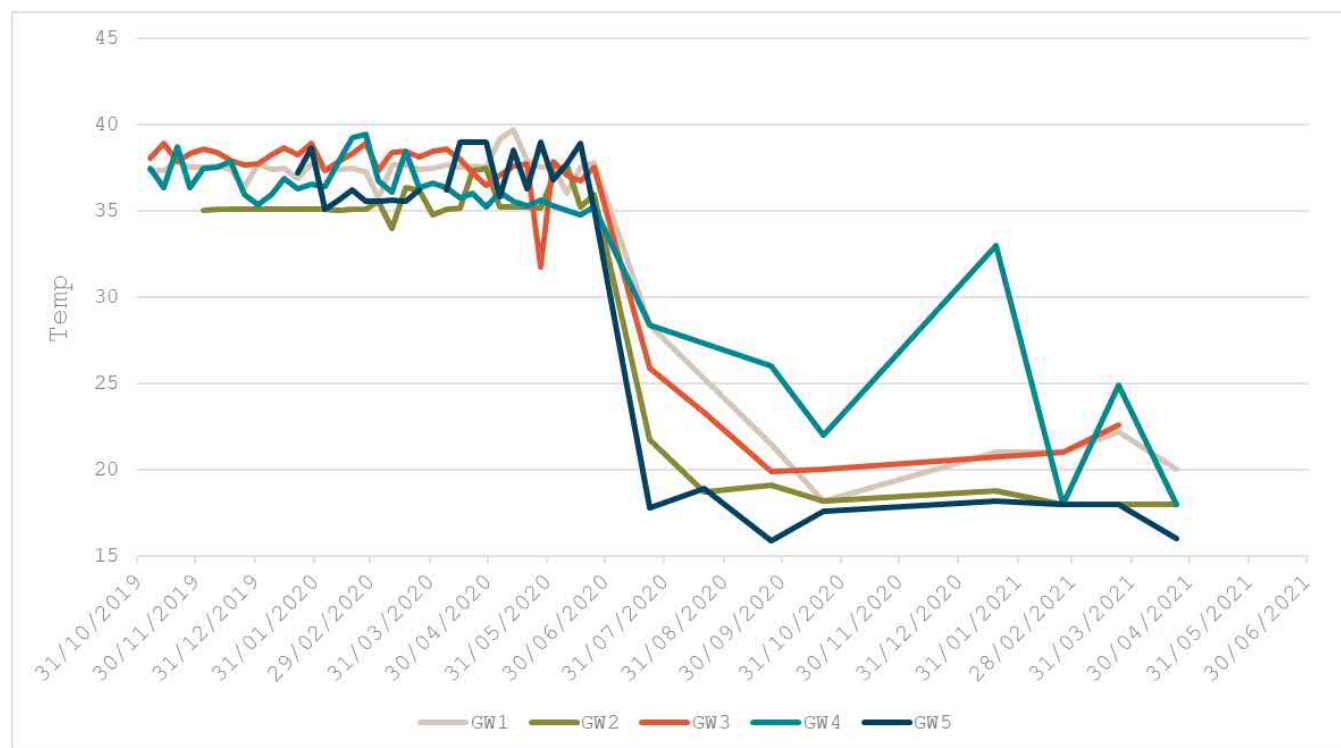
**Figure 1: Groundwater quality results for temperature – production bores**

Figure 1 and 2 below show weekly results of monitoring for temperature and electrical conductivity (EC) taken from telemetry on each bore while in operation. Production bores GW6 and GW7 are not featured as they were not in operation during the reporting period.

Due to the short operation time required for maintenance (<10mins) the temperature readings are not representative of the actual temperature in the LEVF due to cooling of the water as a result of the distance the water travels to the surface while in contact with the stainless steel casing of the production bore. Figure 1 shows the drop in the temperature measured for GW1-GW5 as result of the short operation time since operation of the borefield moved to standby mode in July 2020.

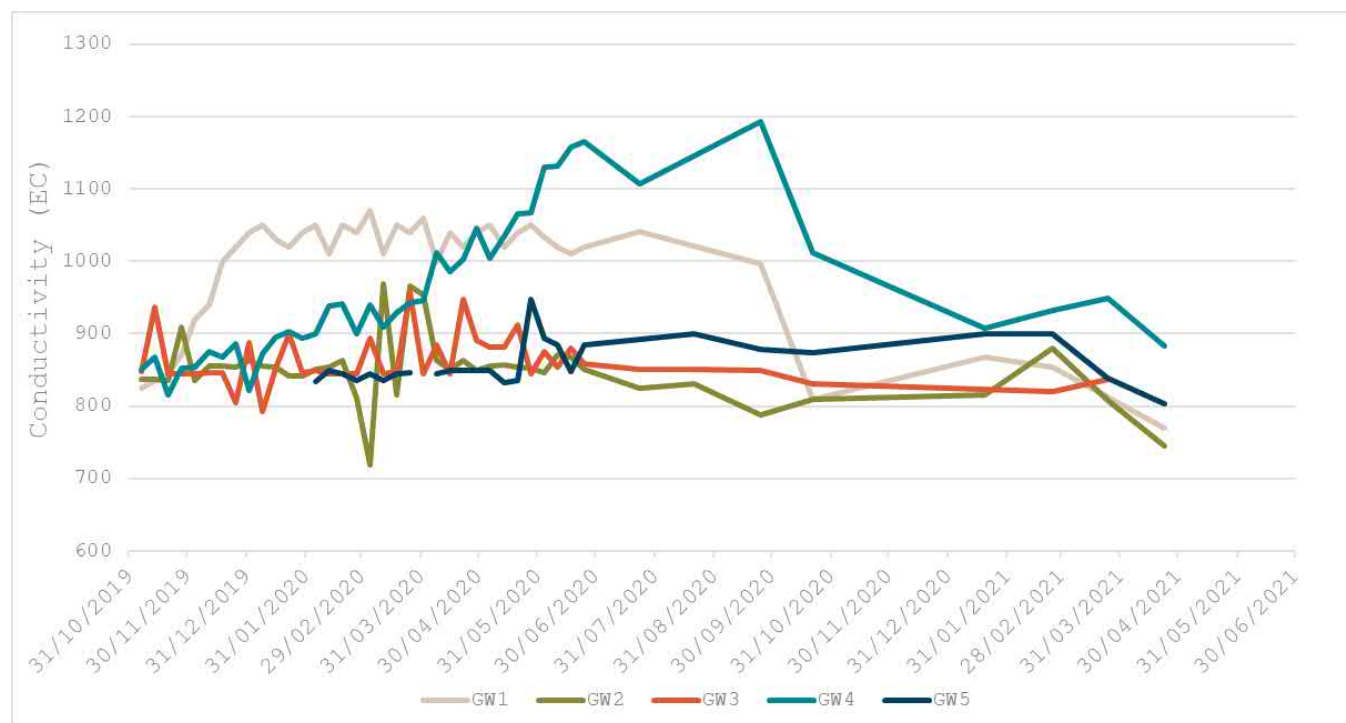
**Figure 2: Groundwater quality results for salinity (EC) – production bores**

It is understood through previous monitoring that the salinity levels in the LEVF are lower than what is expected in the UEVF. The data shows that EC remains relatively stable for all production bores except GW4 and GW1, which displayed an upwards trend. This was believed to be due to increased

interconnection between the LEVF and UEVF in proximity to GW4 resulting from observation bore WB9 screening both aquifers. Alcoa have since decommissioned observation bore WB9 in August 2020 as part of their mine rehabilitation works. As shown in Figure 2 the trend has returned to historic values since this decommissioning took place.

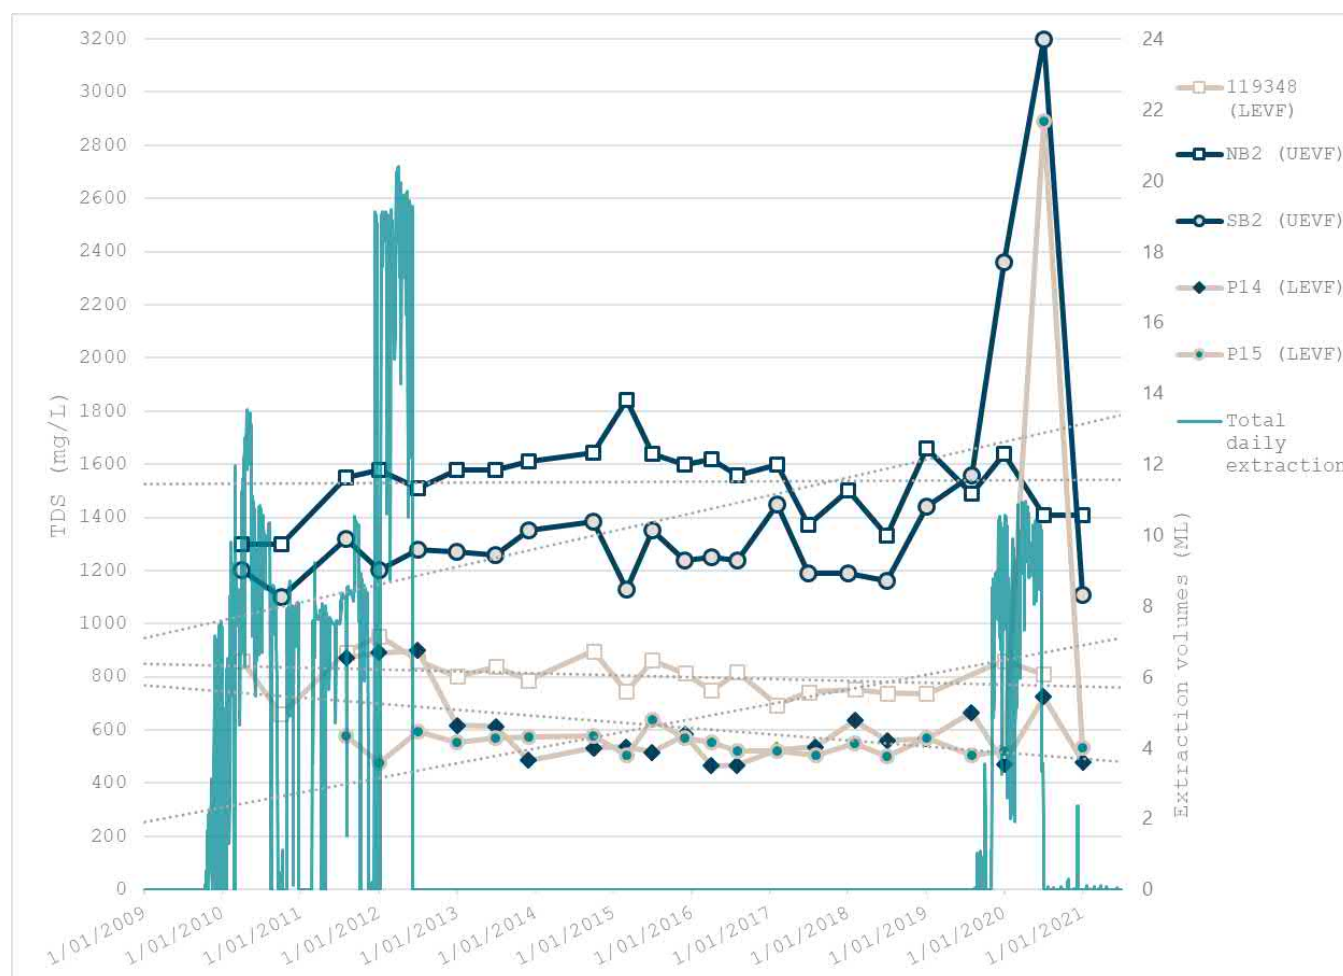
**Figure 3: Groundwater quality results – deep observation bores**

graphically in **Error! Reference source not found.3**. This figure depicts the salinity measurements against the groundwater extraction and recovery periods. A linear regression line has been developed for each site in order to compare the results over the monitoring period.

The field readings taken for the Electrical Conductivity (EC) are conducted during the bore purging process. Both the Total Dissolved Solids (TDS) and EC are taken to measure the salinity in groundwater samples. The TDS readings are taken in controlled laboratory conditions by weighing the residual solids that remain after the water from the sample is evaporated. This method is proven to be much more accurate than the EC readings, where an electrical current is passed through the sample and measured. Since the TDS yields more accurate results, these results have been used to analyse the trends in the groundwater salinity.

As highlighted in the 2019-2020 annual report, the salinity results from the sampling undertaken in January 2020 at SB2 were higher than what we had observed through previous monitoring.

A further investigation was conducted which included conducting airlift of the bore to flush out any stagnant water that may have been sitting in the bore. In addition to this, monthly water quality testing was completed including groundwater quality monitoring at nearby bore 116459. A briefing note was provided to DELWP in March 2021 concluding that the airlifting appeared to have cleared the bore screen in SB2 and subsequently EC sample results have stabilised and returned to historical levels in recent water quality monitoring.

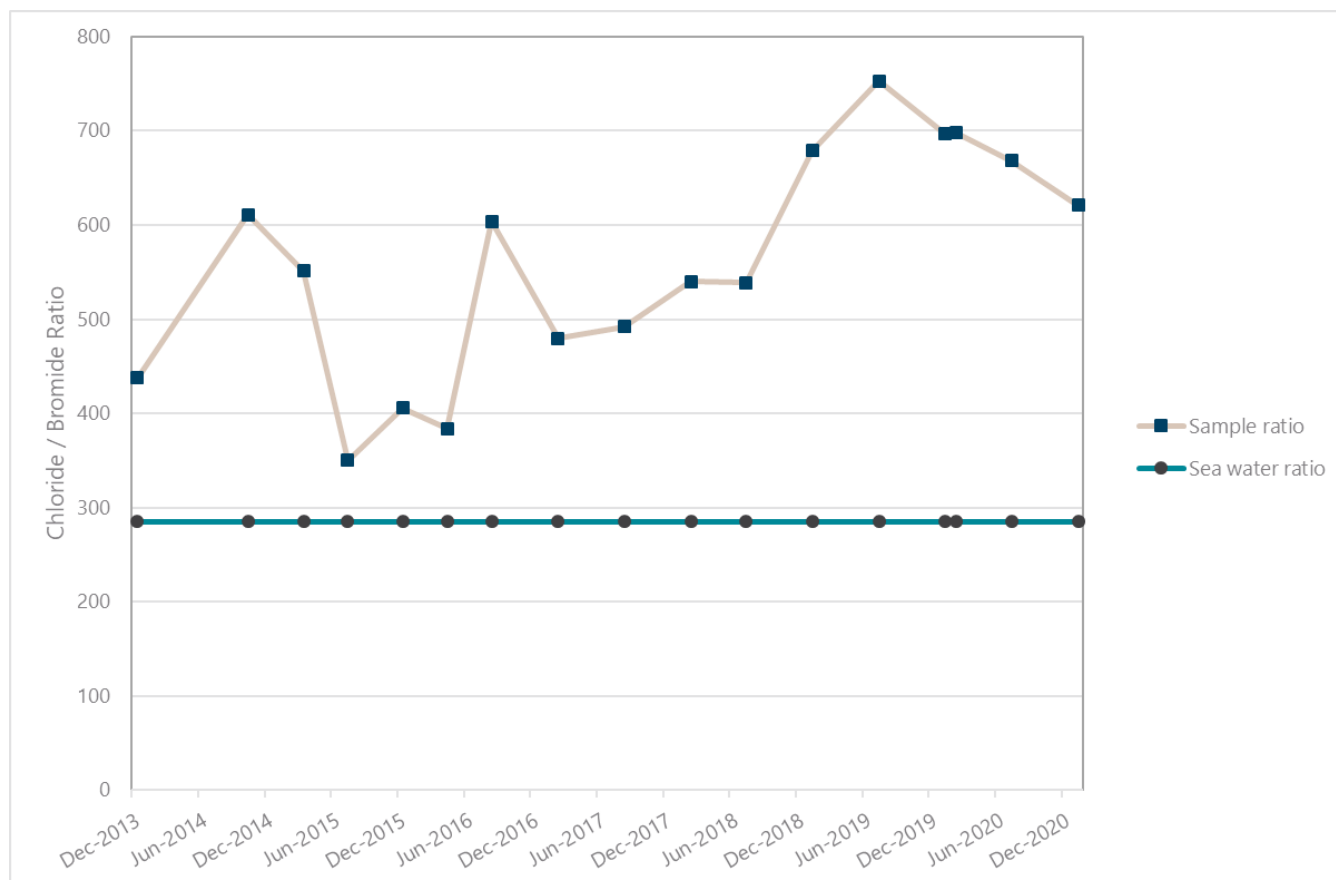
Given its proximity to the coastline, P14 is also tested for chloride and bromide to monitor for potential seawater intrusion. Seawater in an open ocean has a constant chloride/bromide ratio of approximately 285g/1g (285:1). Therefore, a decreasing chloride/bromide ratio, in conjunction with rising salinity can be indicative of saline intrusion.

Error! Reference source not found.illustrates the chloride/bromide ratios overtime. The trend remains above the 285:1 ratio associated with seawater. Hence there continues to be no indication of saline intrusion at P14 to date.

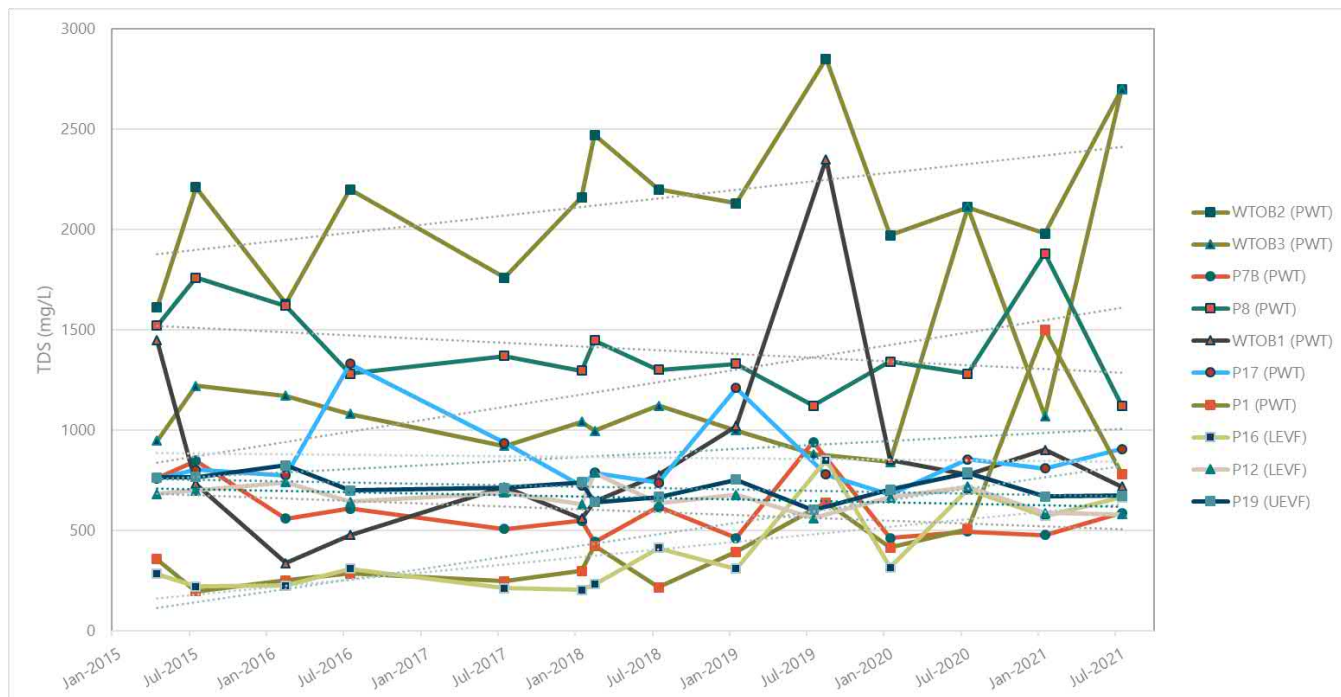
**Figure 5: Groundwater quality results – shallow observation bores**

The assessment of groundwater quality is primarily focused on salinity as the main indicator of changes in the aquifer system. Salinity levels in the perched water table generally fluctuate more in the upper or lower eastern view formations. This is potentially due to the variable nature of the water level in the perched water table as a result of climatic variation. When considering the impact of the climate verses pumping it is important to consider P17 which is outside the area of influence from pumping. Results for shallow observation bore water level versus salinity level is provided in Appendix G.

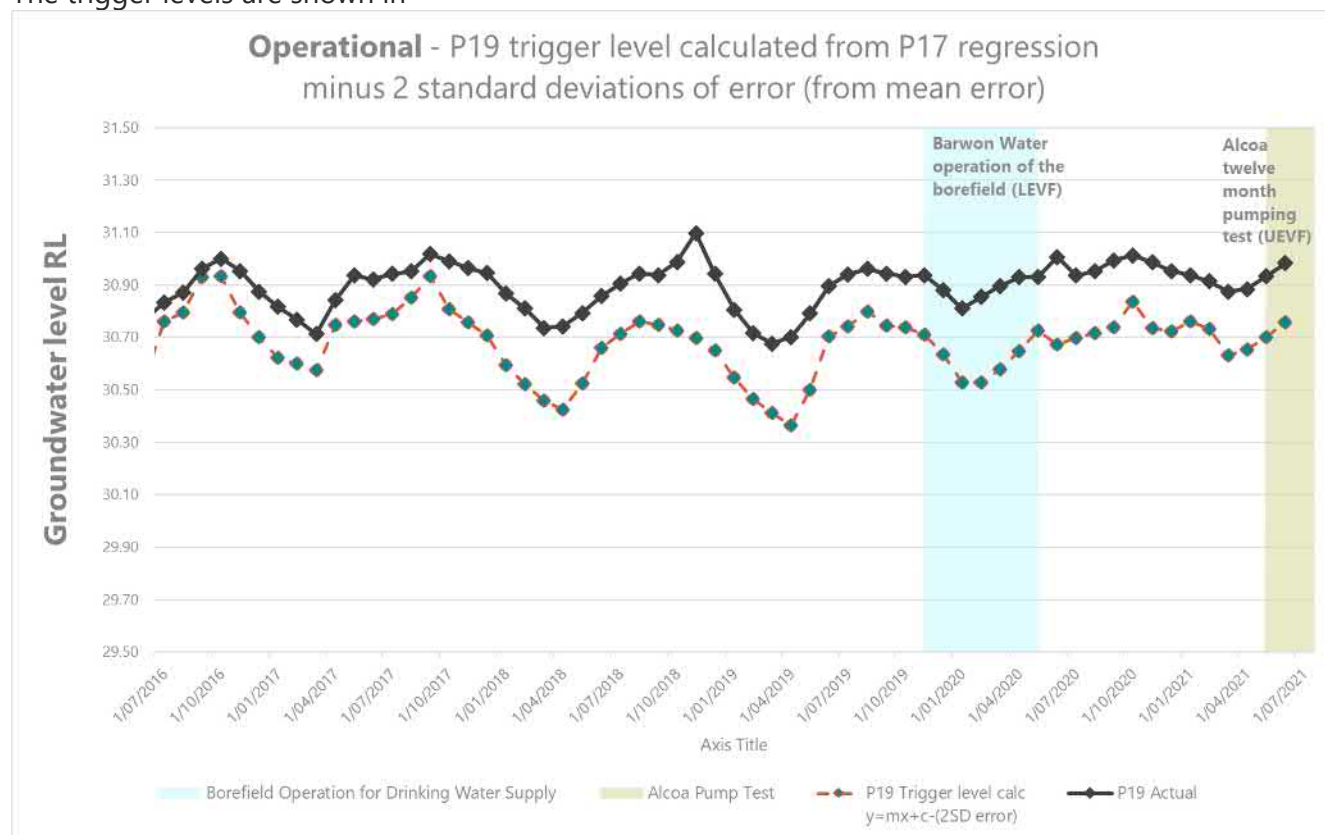
It should be noted that these formulae are the amended calculation as discussed in section 5.2. The trigger levels are shown in

Figure and Figure . At all times during 2020-2021 the groundwater levels were above the required trigger levels.

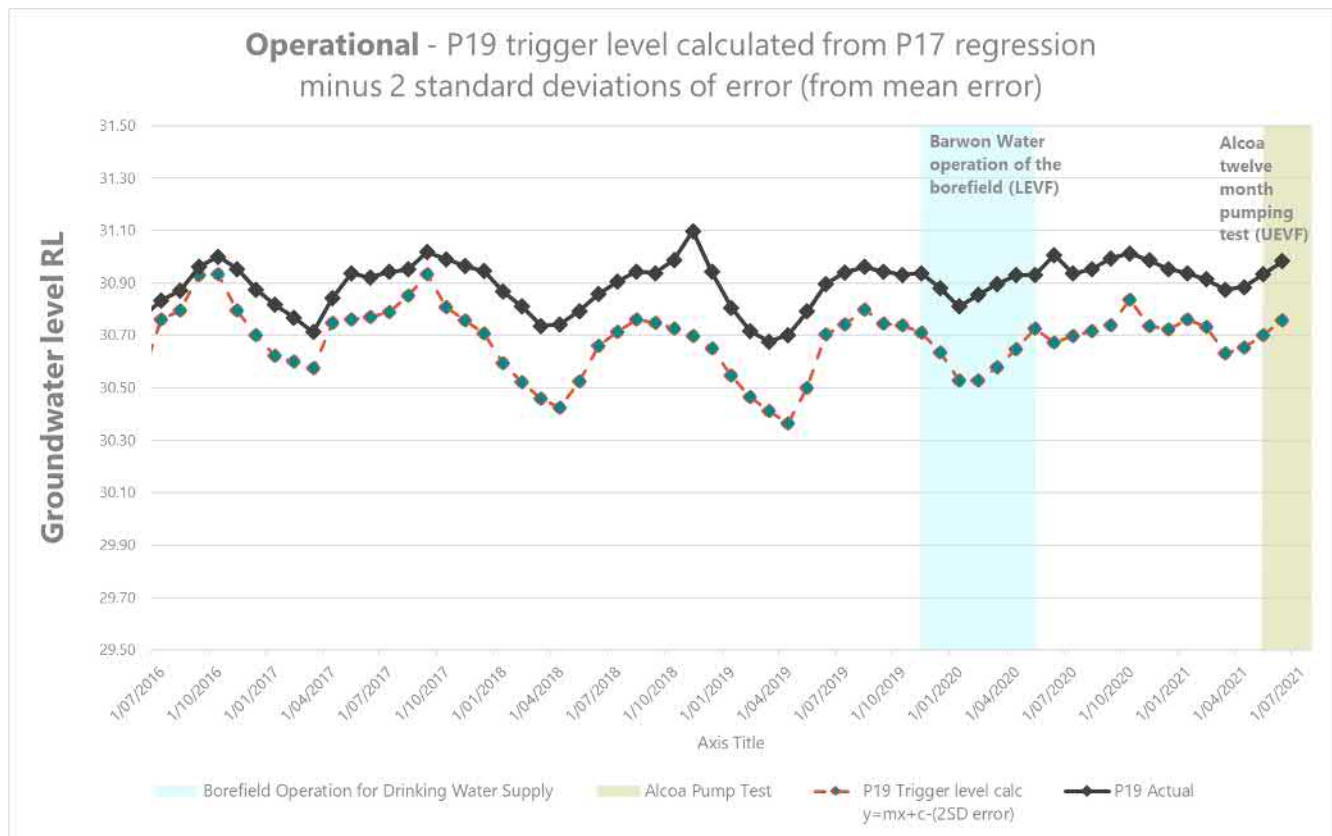
**Figure 7: Groundwater level and the trigger level for P19 in the upper eastern view formation.**

The trigger mechanism accounts for the seasonal variation in the groundwater levels using groundwater levels measured at bore P17, which sits outside the area of influence for the Anglesea Borefield. These trigger levels use daily recorded values, which are converted to a monthly average and are calculated based on the following formulae:

$$P8 = 0.3131 * P17 + 9.4666 - 2 \text{ Standard Deviations of Error}$$
$$P19 = 0.2391 * P1 + 16.82 - 2 \text{ Standard Deviations of Error}$$

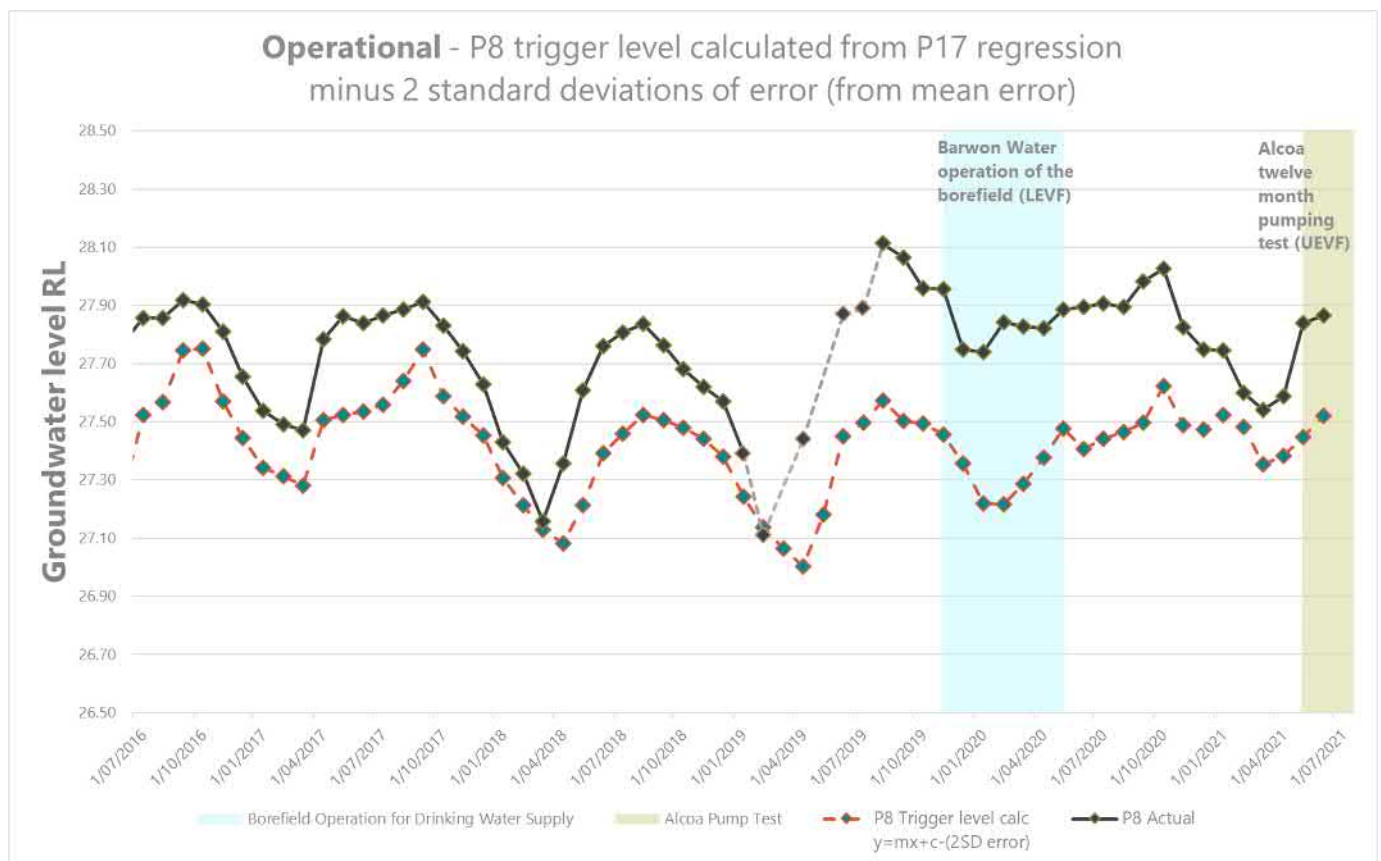
**Figure 8: Groundwater level and the trigger level for P8 in the perched water table.**

During February 2019, Barwon Water was not extracting water; however, based on the data available, P8 exceeded the trigger level. This followed the warmest January (2019) on record for Victoria, coupled with below average rainfalls across the state, with some areas like Aireys Inlet recording its lowest

January rainfall on record. This demonstrates the conservative nature of the triggers and the strong influence of climate – hot, dry days in summer can lead to the triggers being exceeded without pumping.
